# Steering failure involving *Matthew Flinders III*

8 km north of Waterhouse Island, Bass Strait, Tasmania, on 23 July 2025

## ATSB Transport Safety Report

MO-2025-009

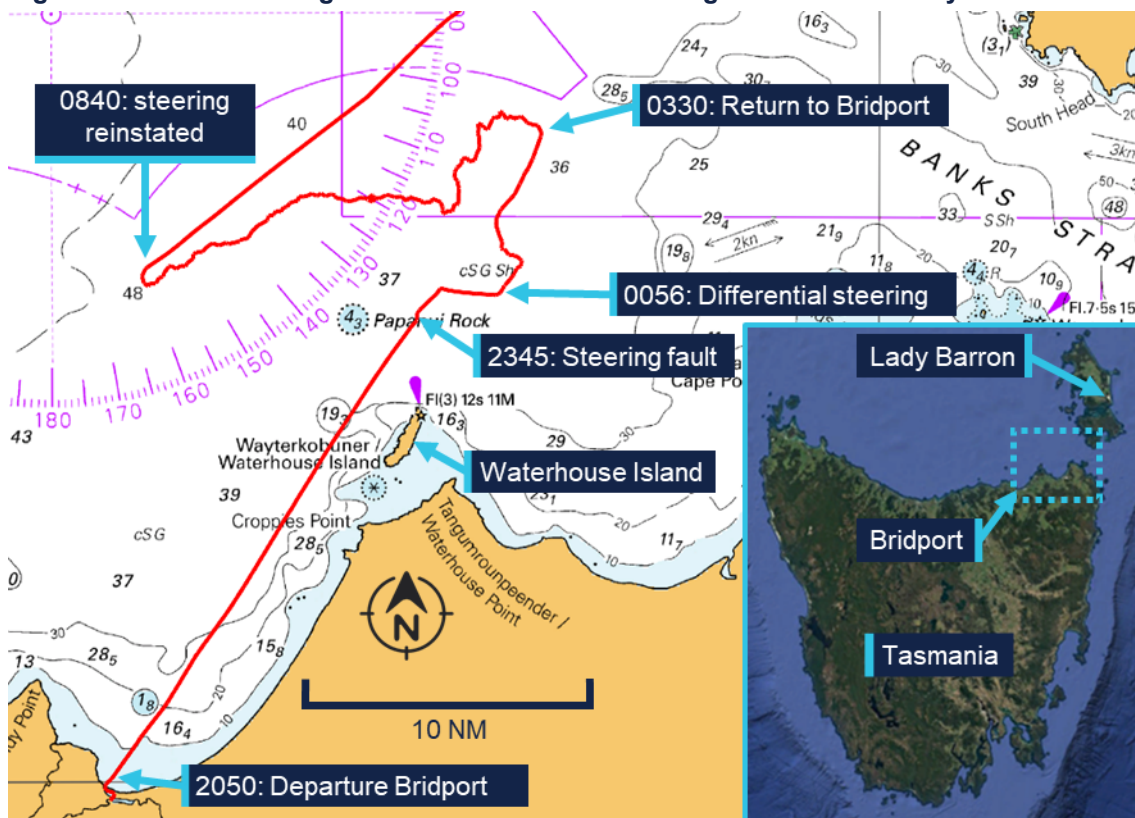
**Figure 1: Section of navigational chart Aus 487 showing the location of key events**

At about 2345, the ship was approximately 4 miles<sup>1</sup> north of Waterhouse Island when an alarm activated on the autopilot system, indicating a loss of rudder response. At the same time, the master noticed that the rudder angle indicator for the ship's twin-rudders was showing the 'hard to port' position and the ship was turning to port. The master immediately responded by reducing engine power and placing the engine controls in neutral, before notifying the engineer and requesting emergency steering to be engaged.

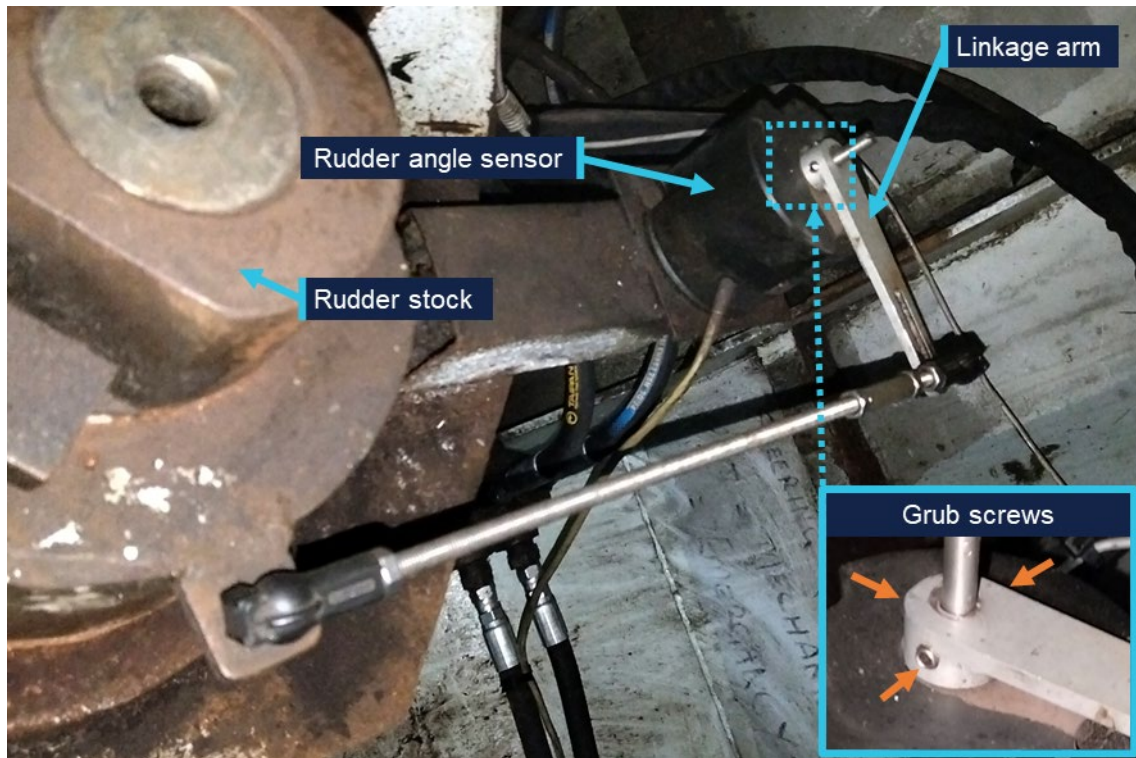
**Figure 5: Rudder angle sensor and grub screws**

The required feedback signal for both modes was provided by a single dedicated rudder angle sensor, actuated via a linkage arm off the port rudder stock (Figure 5). The linkage arm was secured on the angle sensor shaft by 3 grub screws.

Loose grub screws on the rudder angle sensor linkage arm led to a loss of the rudder feedback signal to the autopilot system. This resulted in the failure of the autopilot and non-follow-up steering system, locking the rudders hard to port.

- Loose grub screws on the rudder angle sensor linkage arm led to a loss of the rudder feedback signal to the autopilot system, this resulted in the failure of the autopilot and non-follow-up steering system, locking the rudders hard to port.

The ship slowly made its way back to Bridport, while the crew continued investigating the problem. At about 0815 the engineer identified a loose linkage arm associated with the steering control system. After re-tightening, steering was restored and the ship continued its voyage to Lady Barron.

At about 0815, while the engineer was checking the rudder angle sensor (see the section titled *Steering arrangement – Steering control signals*), the master noticed a change in the indicated rudder angle on the autopilot control unit. The master informed the engineer, who then identified that the angle sensor linkage had slid down over its shaft, and that the grub screws securing it were loose. After the engineer and the mate re-aligned the linkage and secured the grub screws, the autopilot system feedback functioned normally. After reconnecting the steering cylinders, automated steering was restored and the ship continued its voyage to Lady Barron without further incident.

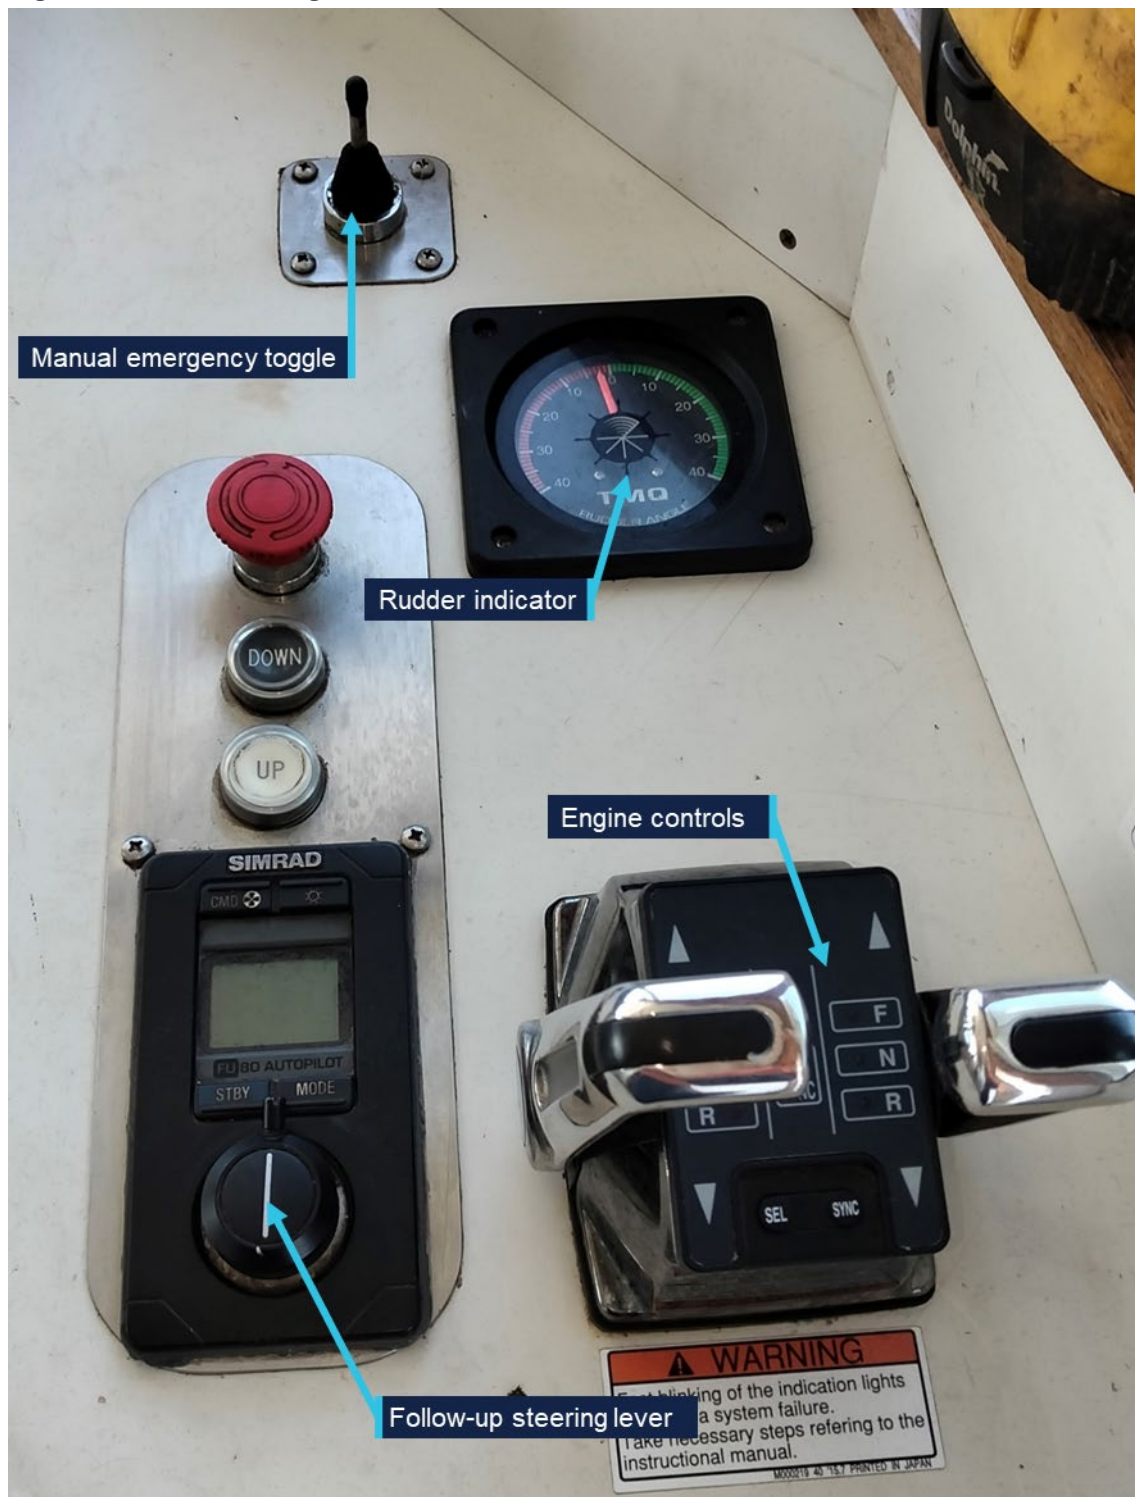
Figure 6: Starboard wing control station

A backup control system was installed in case of autopilot system failure. It consisted of 3 unlabelled steering toggles, one mounted on the centre console and one at each wing control station (Figure 6).

The toggles activated the port or starboard solenoid of the selected (main or emergency) system, allowing for steering control in open-loop or non-follow-up mode. Activating any of the 3 toggle switches moved the rudder in the appropriate direction until the rudders reached their end stop, or the toggle was released.

Clear operating instructions, including a block diagram showing the procedures for changing between systems, were not displayed on the navigation bridge and in the steering compartment as required under the requirements of Marine Order 21. Additionally, industry guidance for bridge control design recommended that all control elements should be clearly labelled with their function.

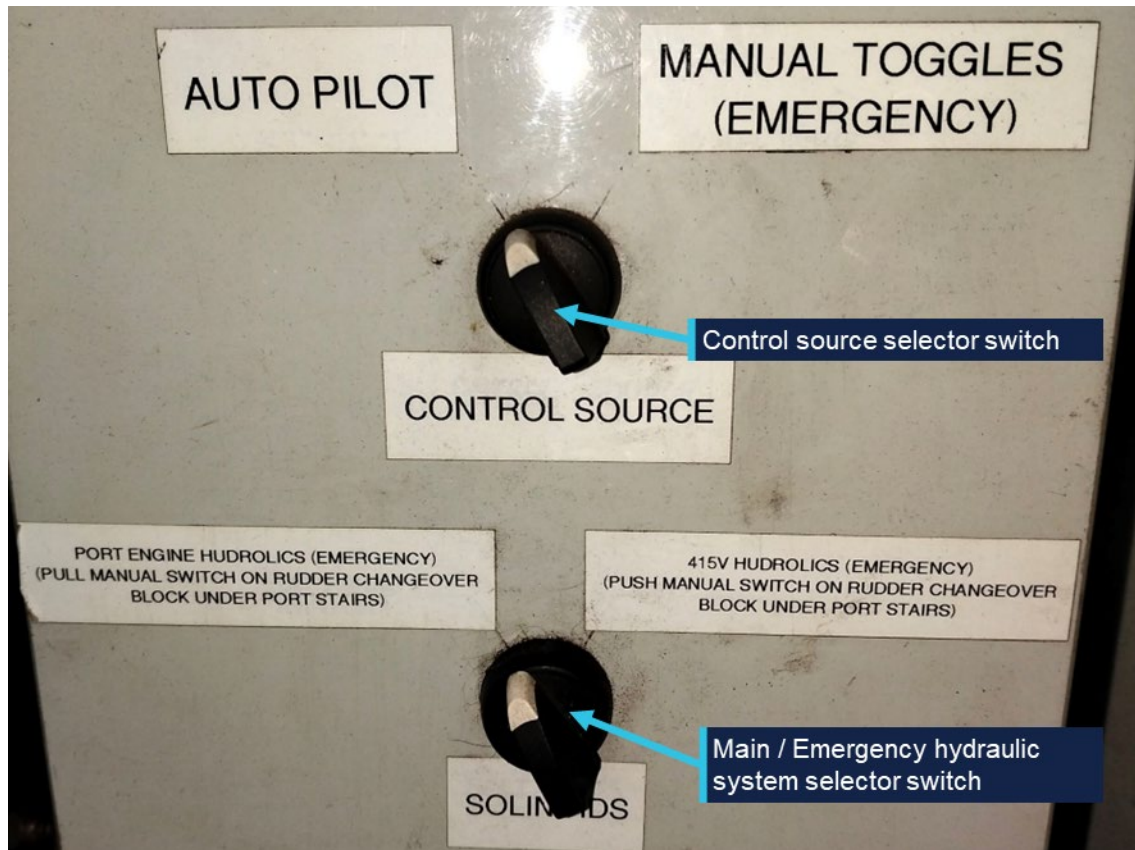
Figure 7: Engine room rudder control panel

The backup control could only be activated from the rudder control panel in the engine room. This required switching the control source switch to the 'manual toggles (emergency)' position (Figure 7).

The switching of steering modes from the autopilot system to the non-follow-up toggles could only be done from the engine room. This delayed the recovery of steering following failure of the autopilot or the connected follow-up system.

- The switching of steering modes from the autopilot system to the non-follow-up toggles could only be done from the engine room. This delayed the recovery of steering following failure of the autopilot or the connected follow-up system.
