# Collision with terrain, Garlick Helicopters UH-1H, VH-HUE

24 km south-east of Talbingo, New South Wales, on 17 April 2018

## **ATSB Transport Safety Report**

AO-2018-031

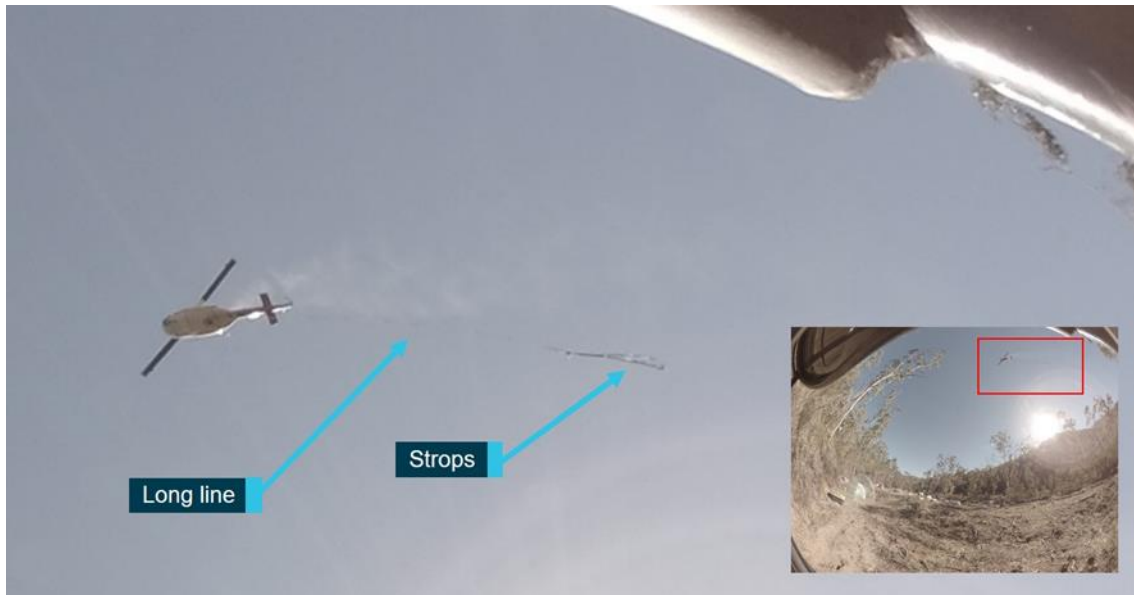
**Figure 3: Light coloured gas or mist from the helicopter above the drill site**

Just prior to the engine failure, HUE was about 200 to 250 ft above ground level, with a forward airspeed of about 20 to 25 kt, based on global positioning system (GPS) data, eye-witness reports, and the pilot reporting flying into a slight headwind. From fuel-burn calculations by the ATSB, the weight of HUE was estimated at 2,900 kg at that time.

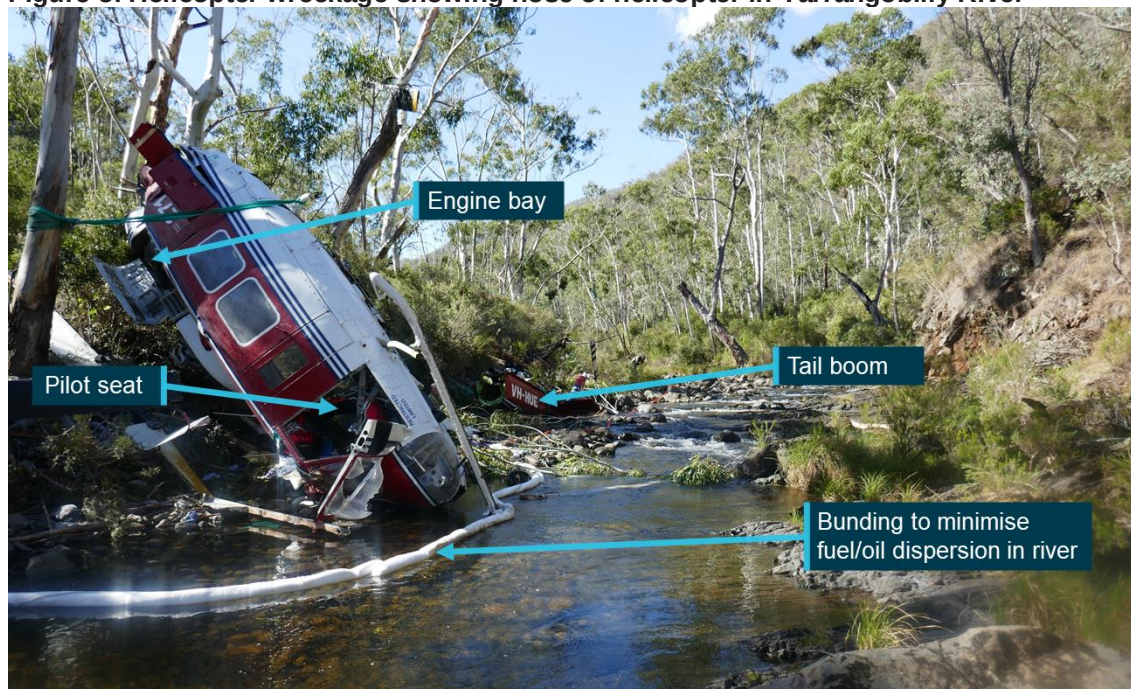
**Figure 5: Helicopter wreckage showing nose of helicopter in Yarrangobilly River**

Examination of the wreckage and ground impact marks indicated that the helicopter had impacted the ground in a nose high, slightly right side down attitude. The tail boom of the helicopter struck the ground during the impact, detaching from the fuselage. The landing gear assembly showed evidence of deflection during the main impact of the fuselage with the ground. The helicopter likely bounced off the skids, leading to the fuselage coming to rest in a nose low, slightly inverted position (Figure 5).

Note: Wreckage of VH-HUE looking upstream toward the drill site, showing the nose of the helicopter and pilot's seat.  
Source: ATSB

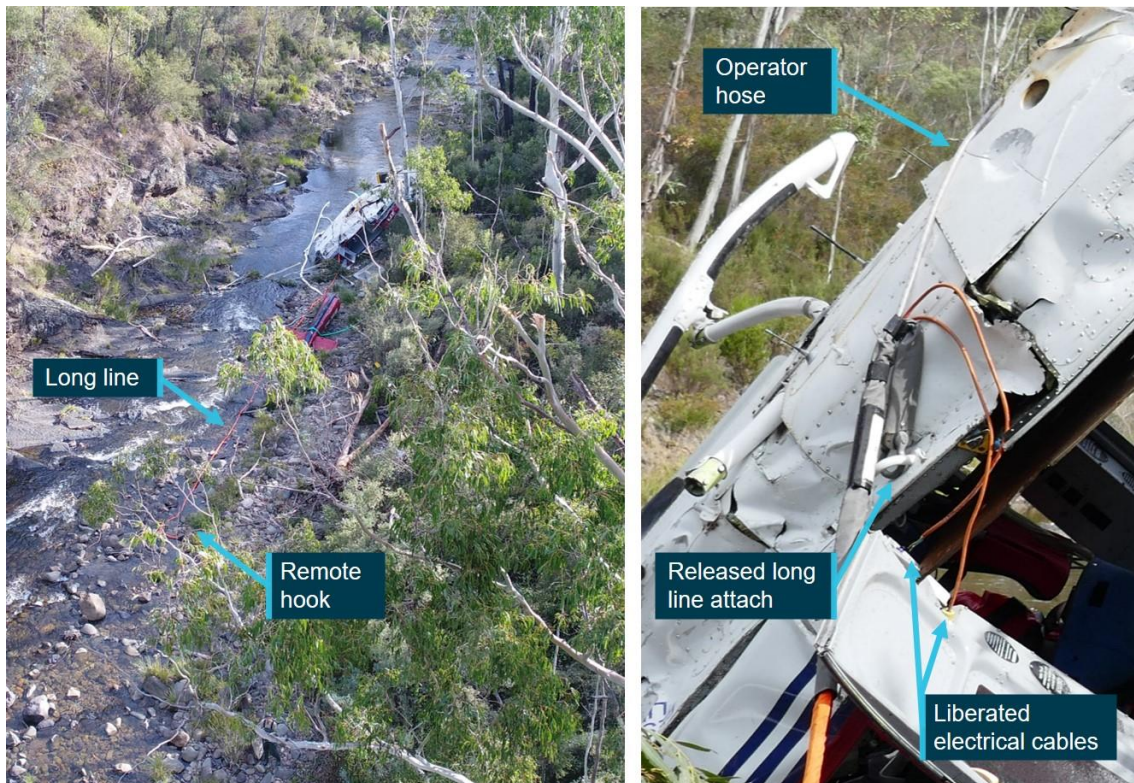
**Figure 6: Failed to detach long line**

For the lifting operations on the day of the accident, a 100 ft/30 m long-line was being used, with lifting strops attached at the remote hook. The site and wreckage examination revealed that, during the accident sequence, the long-line had detached from the belly hook, and the strops had released from the remote hook. This indicated that the long-line and strops were likely jettisoned during the accident sequence, as per emergency procedures. Although the pilot could not recall jettisoning the load, photographs confirmed that both the long-line and strops were attached to these hooks prior to the emergency, and the long-line did not appear to have snagged on any trees during the accident sequence. However, the long-line remained tethered to the fuselage due to the Sacksafoam hose line, which had failed to separate (refer to section titled *Retention of the long-line*) (Figure 6).

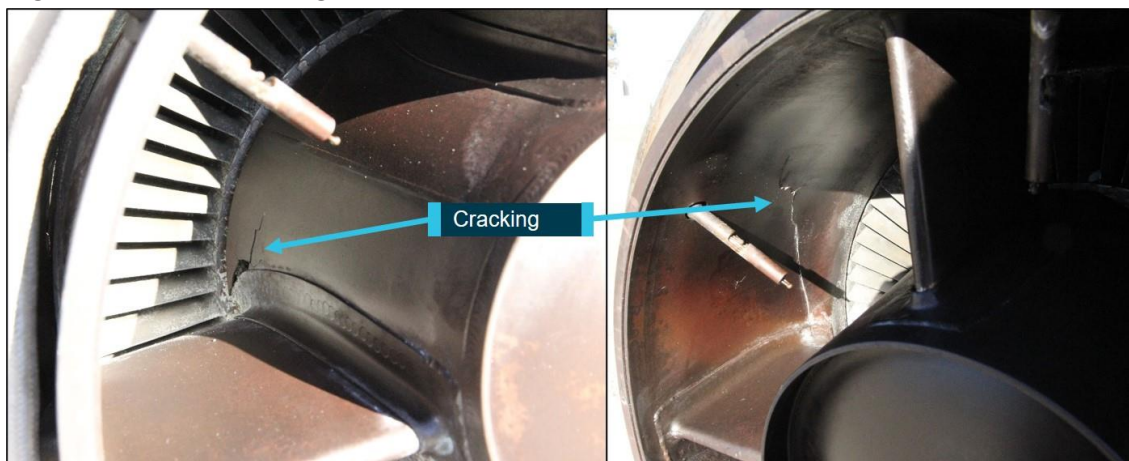
**Figure 7: Visible cracking in the exhaust diffuser area**

During the examination of the wreckage, the ATSB identified cracking and material loss visible in the exhaust diffuser area (Figure 7 and Figure 8). In addition, the exhaust diffuser cover attachment bolt was not lock-wired, as required by the US Army maintenance manual applicable to HUE (Figure 8). Examination of the engine, including the exhaust diffuser assembly is discussed in the next section.

This indicated that cracking and missing material on the inner cone of the exhaust diffuser, as observed by the ATSB after the accident, was likely visible during maintenance inspections prior to the accident. Further, Honeywell stated:

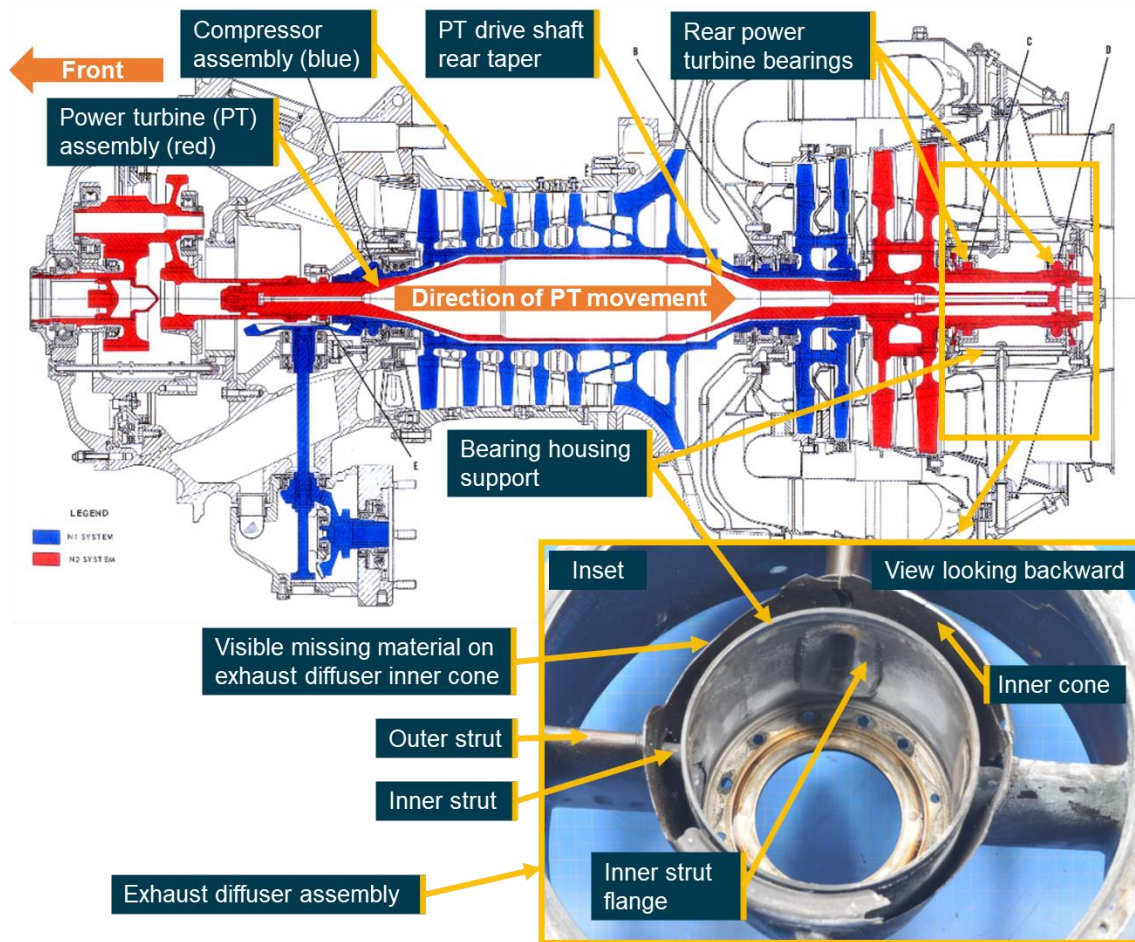
Figure 10: Illustration of T53 engine and exhaust diffuser inner cone (inset)

The Honeywell engine teardown identified extensive fatigue cracking in the exhaust diffuser inner struts (Figure 10 inset). The inner struts were a critical engine component that supported the rear of the power turbine assembly through the number 3 and number 4 bearings (Figure 10). Note for reference that Figure 10 (inset) shows missing material in the exhaust diffuser inner cone also shown in Figure 8. Honeywell identified the location of the cracking for each of the four inner struts:

- two of the four inner struts were separated around the full circumference of the inner strut flange welds
- another strut exhibited cracking around most of the circumference of the inner strut flange welds, although the inner strut remained attached to the inner cone by a small welded section
- one strut was separated through the strut with no visible weld separations.

The analysis by Honeywell determined that the cracking in the inner struts resulted in the complete loss of structural integrity of the four struts. This led to the power turbine assembly moving rearward, indicated by the arrow labelled 'direction of PT movement' in Figure 10. The rearward movement was sufficient for the rear tapered section of the power turbine drive shaft (labelled 'PT drive shaft rear taper') to contact the adjacent rear shaft of the compressor assembly, highlighted in blue. Due to the compressor and turbine assemblies rotating in opposite directions, the contact resulted in considerable friction, and deformation of the rear compressor shaft. This led to the compressor assembly contacting the walls of the engine case.

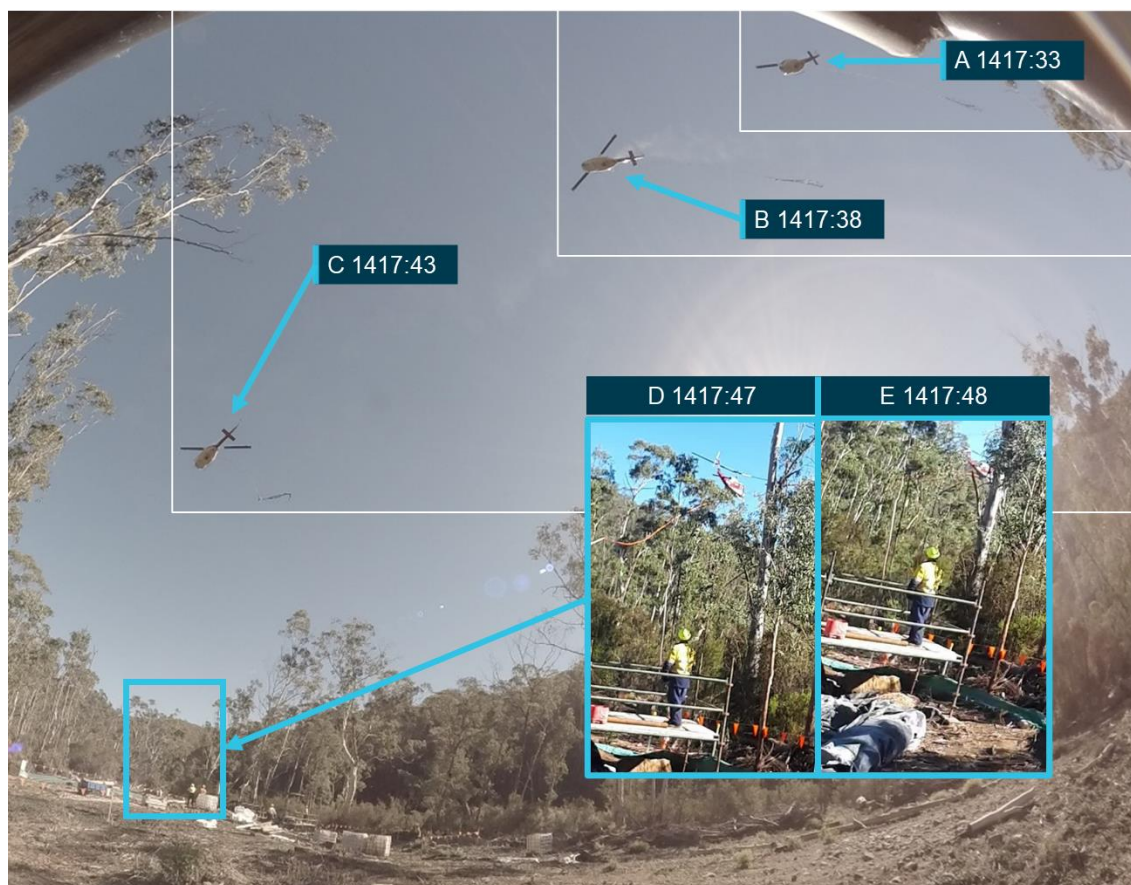
**Figure 13: Time-lapse composite showing helicopter engine failure location and forced landing**

The GPS data, time-lapse images (location shown in Figure 12), supplied camera footage from eyewitnesses and witness statements were evaluated to determine the sequence of events from the engine failure to the collision with terrain. At 1417:33, the helicopter was observed approaching the drill site (indicated by Figure 13 'A'). Following the loss of engine power (Figure 13 'B'), the aircraft started descending and began to accelerate (Figure 13 'C'). As the helicopter approached the line of trees at the end of the clearing, the helicopter had accelerated to about 40 kt and was close to the height of the tree canopy (Figure 13 'D' and 'E'). Around this time, GPS flight data indicated a notable shallowing of the descent profile.

The shallowing descent path was consistent with witness reports describing the helicopter as appearing to 'float' over the trees, and that it was not descending quickly until over the trees. Comparison of this glide performance with the published performance charts for HUE revealed this ratio was shallower than the autorotation range performance based on the speed and rate of descent. The pilot reported that, during this time the main rotor speed (RPM) became low. Audio analysis<sup>12</sup> by the ATSB using witness phone footage established that the main rotor speed was about 214 RPM as the helicopter passed over the first line of trees, about two-thirds below the optimal speed of 314 RPM. This suggested that the pilot increased collective pitch of the rotor system to avoid the line of trees prior to reaching the gap in the canopy created by the river below. The pilot stated during interview that the helicopter's rotor system carried a lot of inertia, and as a result, elected to fly over the trees, knowing that the rotor speed would decay. The pilot's response was consistent with guidance in the US Army operator's manual, which stated that a 'landing in trees should be made when no other landing area is available'. The reduction in rotor speed is a concern during an autorotation as this equates to energy available in the rotor system. As a result, the energy available to arrest the descent rate during landing or to cut through tree branches was reduced.

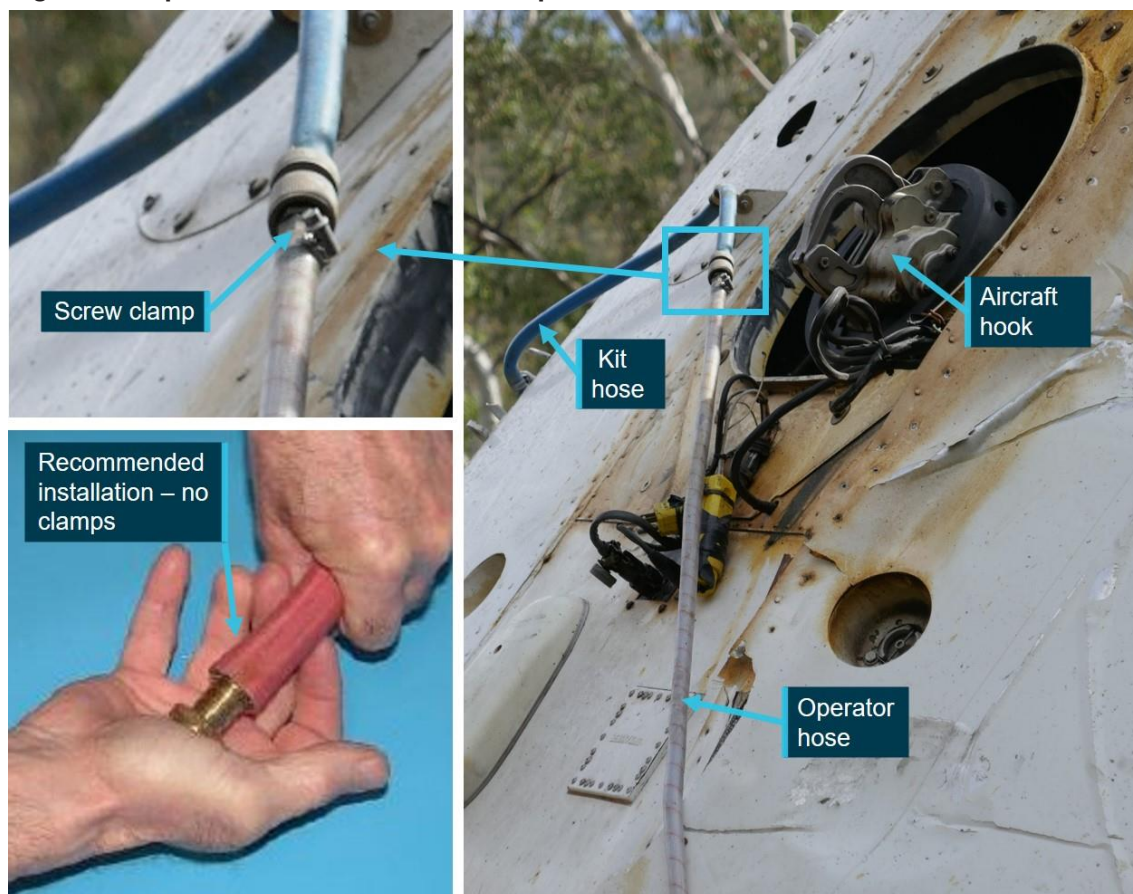
**Figure 14: Operator hose with screw clamp installed**

The pilot reported that the screw-clamp had been fitted (Figure 14), in addition to the barbed fitting, to prevent the hose from 'popping', and leaking corrosive foam from the hose junction.

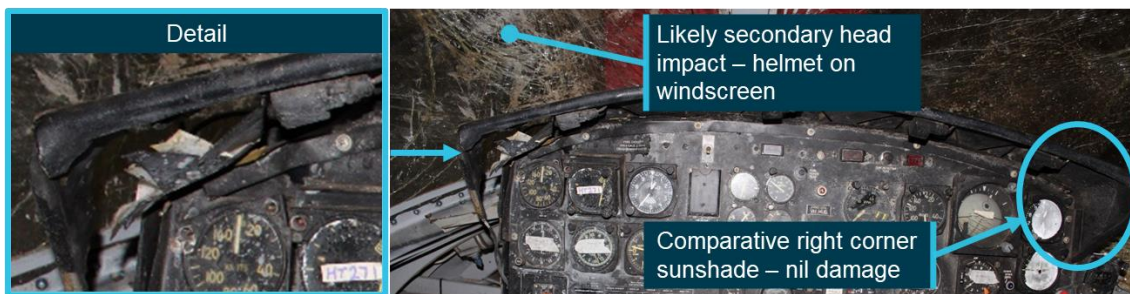
Figure 15: Interior instrument panel sunshade and windscreen damage adjacent to pilot

The left side of the instrument panel and sunshade were damaged, consistent with being pushed forward from within the cabin in front of the pilot's seat (Figure 15). For comparison, the right-side dash panel was undamaged. Although the windscreen exhibited extensive cracking, a localised concentration of damage was present in front of the left pilot seat, the position occupied by the pilot. The damage to the cockpit and injuries sustained were consistent with the pilot's upper torso flailing forward during the accident sequence, sufficient for the pilot's helmet and face to strike the instrument panel sunshade and windscreen.

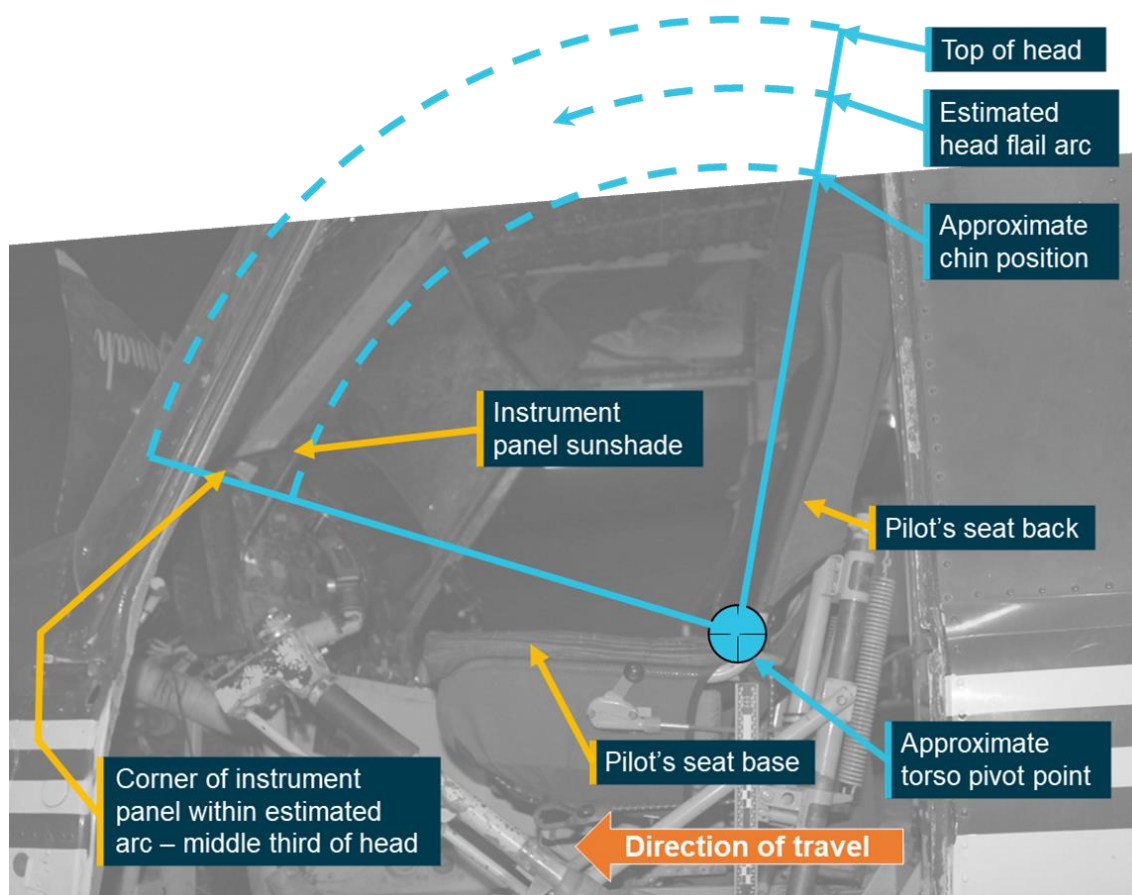
**Figure 16: Pilot seat and cockpit side view with circular arc based on pilot sitting height**

Figure 16 shows a head forward flail circular arc, which indicated that the pilot's head could contact the instrument panel and windscreen if restrained only by the lap-belt. Projections indicated the middle third of the pilot's head aligned with the instrument panel and sunshade.

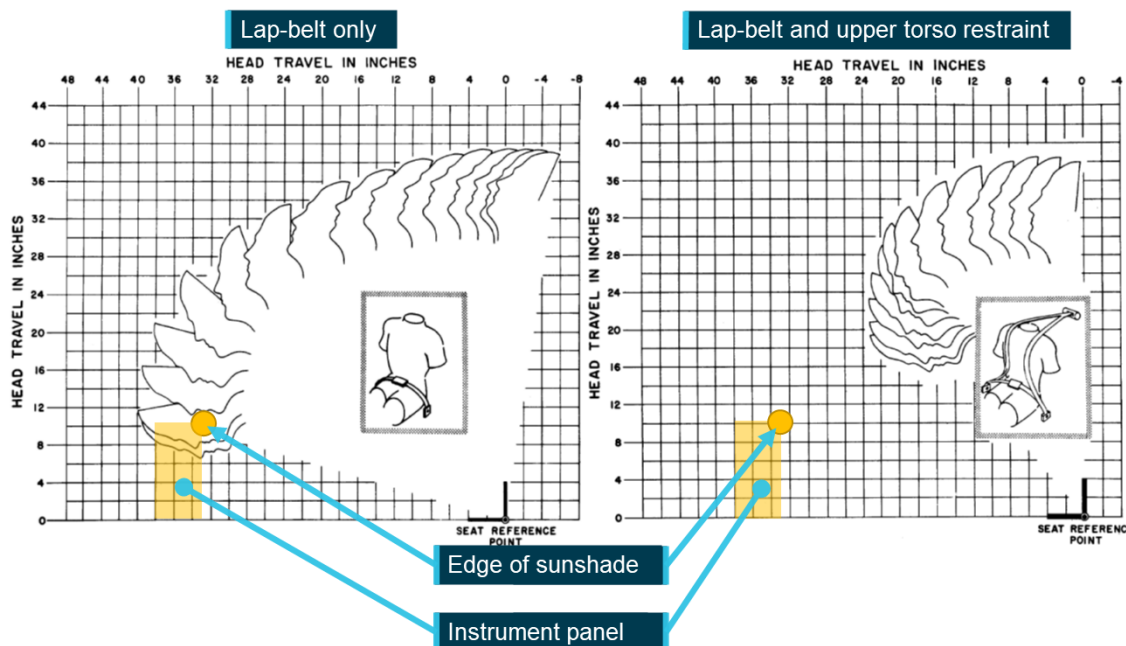
**Figure 17: Comparison of lap-belt and UTR effectiveness, with approximate location of HUE instrument panel and sunshade**

Young's (1967) study compared the effectiveness of lap-belts combined with various UTRs and lap-belt only. This study found that there was a significant difference in forward and downward motion between using any shoulder harness and lap-belt compared to wearing only a lap-belt. This was based on head kinematics recorded in the vertical plane for a dummy weighing 82 kg and a sitting height of 97 cm, on a sled travelling at about 45 km/h prior to impact. Using the results of this study, assessments were performed by the ATSB to indicate the range of forward movement of the accident pilot for two scenarios – with, and without the use of a UTR (Figure 17).

The left diagram of Figure 17 shows the empirical projections of the dummy wearing a lap-belt only (from Figure 4 of Young (1967)) intersecting the approximate location of the instrument panel and sunshade. In contrast, the right diagram shows considerable distance between all dummy projections and the instrument panel (Figure 11 of Young (1967)). These results were consistent with the instrument panel damage and injuries sustained by the pilot.
