# Flight control system event involving a Fokker 100, VH-FZO

near Argyle aerodrome, Western Australia, 7 March 2014

**ATSB Transport Safety Report**  
Aviation Occurrence Investigation  
AO-2014-045  
Final – 6 August 2014

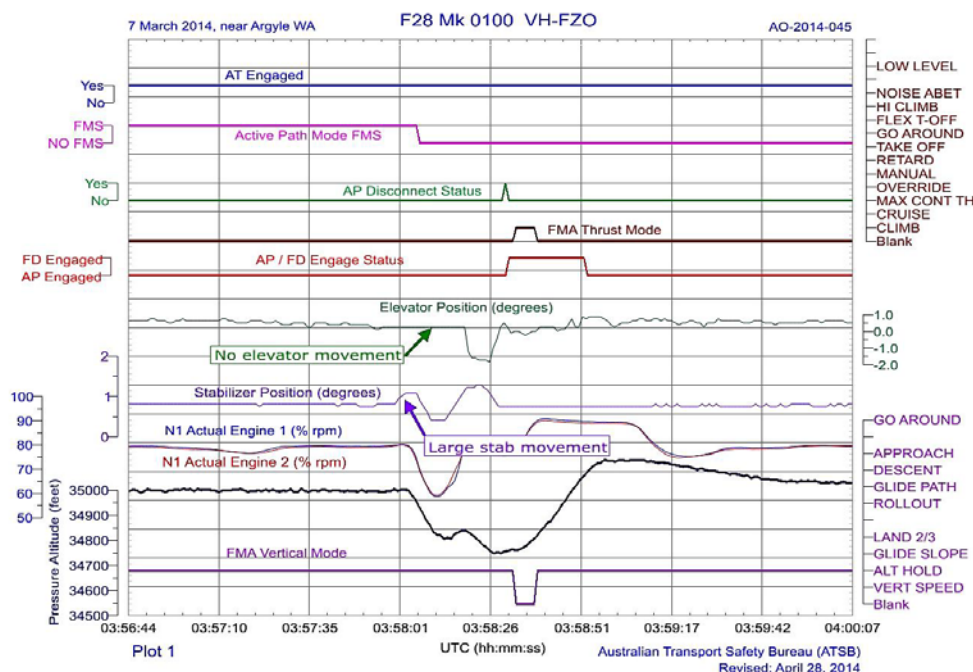
Figure 1: Flight data for VH-FZO

The ATSB analysed the flight data and determined the following with regard to the stuck thrust lever (Figure 1):

- There is no thrust lever parameter from which to derive what position it was stuck. At 1,081 ft AGL, the autothrottle disconnected and the aircraft reverted to manual speed mode.
- The lowest airspeed in this section of the flight was 129 kt calibrated airspeed (CAS) at about 1,008 ft AGL. This then increased gently to 154 kt at about 687 ft AGL. The final approach was flown at between 140 kt and 125 kt in a generally descending trend. The  $V_{ref}$  speed was 120 kt and  $V_{app}$  130 kt and therefore the approach was conducted within normal parameters.

- The data indicated that the uncommanded descent was caused by a stuck elevator.
- The recorded altitude deviation in the descent was 253 ft and maximum vertical speed about 1,400 fpm, based on pressure altitude changes.

Fokker also analysed the flight data in relation to the uncommanded descent and found that the elevator had become stuck for about 20 seconds. Immediately prior to the loss of altitude, autopilot 1 was engaged but there was no elevator movement. At the same moment there was stabilizer deflection. The elevator servo was unable to deflect the elevator, thus current continued to run through the elevator servo motor because the autopilot continuously tried to correct the flight path. The automatic trim function steered the stabilizer to minimize the current running through the elevator servo motor.
