# Flight below minimum altitude involving a Beechcraft 200, VH-NMW

near Sydney Airport, New South Wales, 5 June 2014

**ATSB Transport Safety Report**  
Aviation Occurrence Investigation  
AO-2014-107  
Final – 6 August 2014

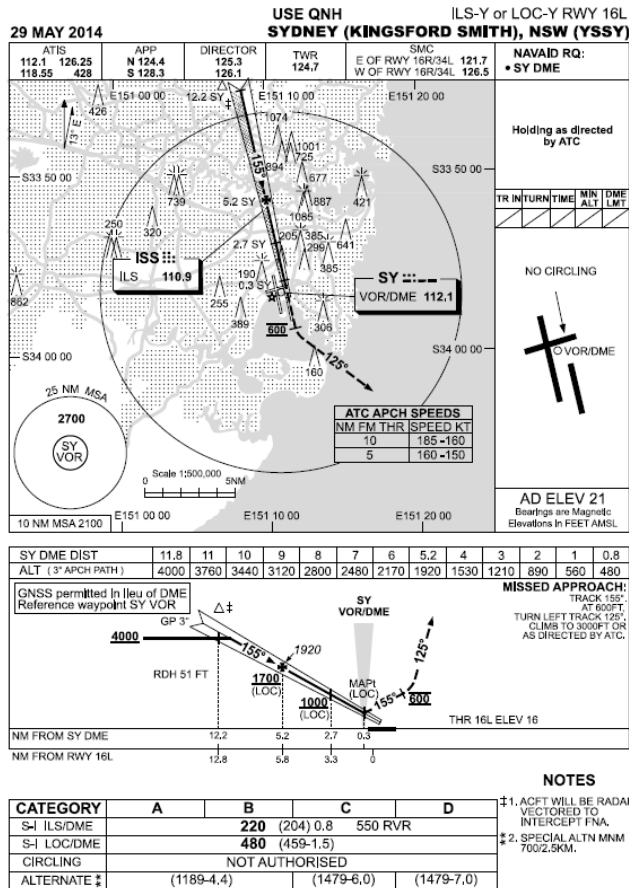
Figure 1: Sydney ILS-Y or LOC-Y RWY 16L

During the cruise, when in the vicinity of Scone, the pilot received a clearance from air traffic control (ATC) for a standard arrival route to Sydney, and entered the arrival and approach into the flight management computer. There were showers in the vicinity of Sydney airport and the pilot requested runway 16 Right (16 R) due to thunderstorm cells to the east, however ATC advised the pilot to expect an instrument landing system (ILS) approach to runway 16 Left (16 L) (Figure 1).
