# Collision with terrain involving Cessna 310R, VH-BWZ

near Mildura Airport, Victoria | 6 November 2015

**ATSB Transport Safety Report**  
Aviation Occurrence Investigation  
AO-2015-129  
Final – 30 October 2017

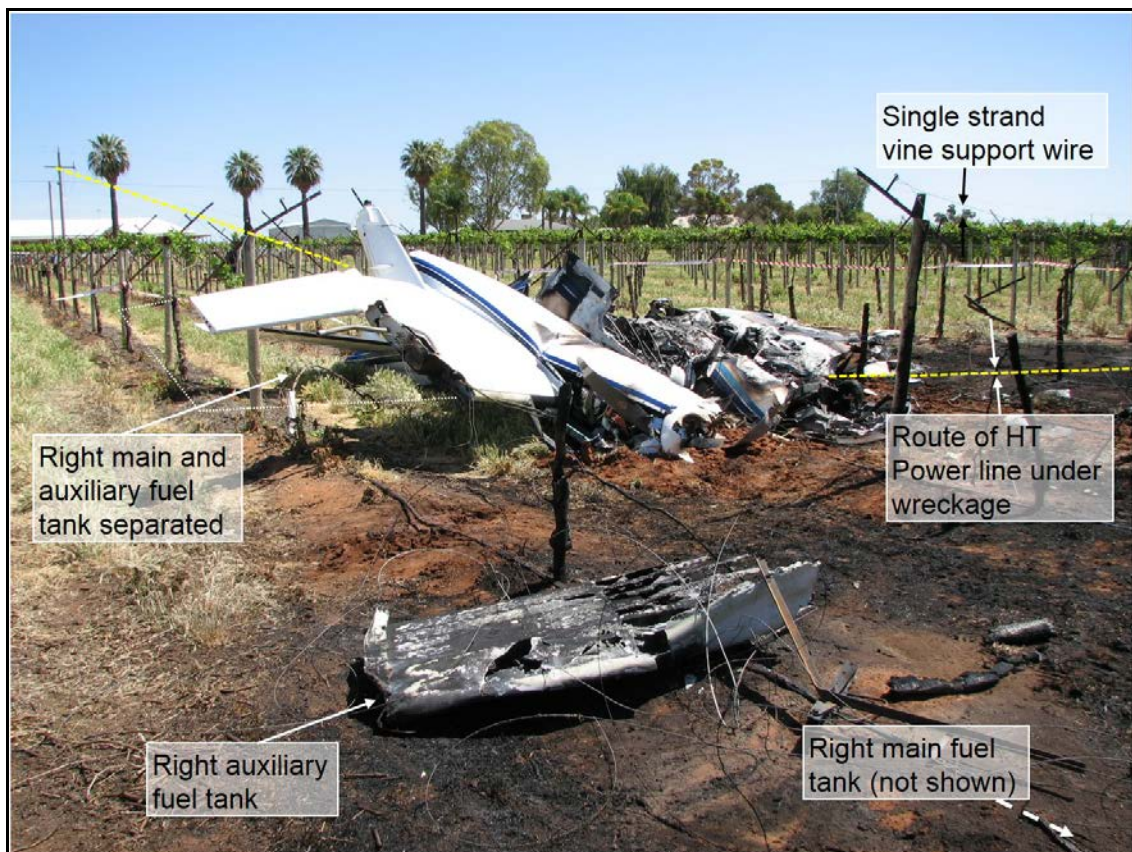
- There was nil evidence of a pre-impact structural failure or in-flight fire.
- All fuel caps were identified in the wreckage in a closed locked position. The left wing main fuel tank was found attached to the left wing tip, while the right main tank had separated from the wing and had been thrown forward about 10 m. Both were significantly melted, consistent with the fuel-fed fire. The outer section of the right auxiliary fuel tank had fractured and separated due to the impact forces, and was found forward of the main wreckage, also significantly melted (Figure1). The inner section of the right wing auxiliary fuel tank did not burn and contained an adequate quantity of fuel to obtain a sample. That sample was field tested and found to be consistent with aviation fuel of a suitable quality. In contrast, the left auxiliary fuel tank displayed only some degree of melting. In consideration of the left wing-down attitude at the time of impact, it was unlikely that the left auxiliary fuel tank contained a significant quantity of fuel.

**Figure 1 : Aircraft wreckage with evidence of fire and right wing auxiliary fuel tank in the foreground**

- The cockpit and cabin were severely fire damaged, consistent with a significant fuel-fed fire supplied from the right inboard section of the auxiliary fuel tank.
