# **Avionics/flight instruments occurrence involving Saab 340B, VH-ZRM**

3 km north-north-east of Townsville Airport, Queensland, on 19 November 2025

AO-2025-072

Final – 25 August 2026

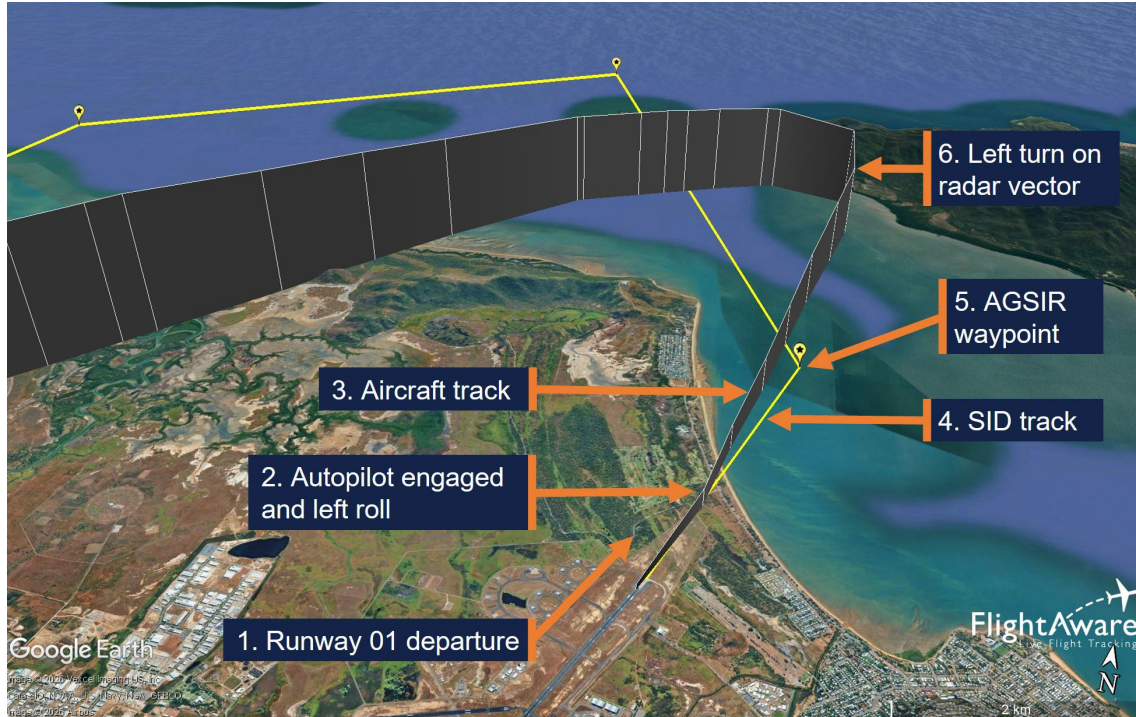
**Figure 1: Departure flight path with key events**

The PIC taxied the aircraft for an intersection departure from runway 01 and was cleared for take-off at 0742. After take-off, as the aircraft climbed through an altitude of 656 ft, tracking towards the first SID waypoint of AGSIR, the FO selected both flight directors ON, followed by the autopilot in the long range navigation mode, in accordance with their procedures. The aircraft immediately commenced a left roll, deviating from the departure track to AGSIR but consistent with the flight director indications. The PIC promptly disengaged the autopilot, reversed the left roll and returned the aircraft to an approximate departure heading.

The FO then selected the FMS flight plan page and observed that the FMS had sequenced the flight from Townsville direct to the waypoint CATEY. The FO also observed that all the CATEY ONE SID waypoints were present and in the correct order in the FMS but appeared different to the other waypoints and later reported that they might have been 'greyed out'.<sup>3</sup> They attempted to manually sequence the SID by selecting the 'Direct-To' function to a SID waypoint, but this was not accepted by the FMS. The FO opened the navigation page and again attempted to manually sequence the SID but was unsuccessful. They later reported that the SID waypoints either did not appear as options or that the FMS did not accept them.

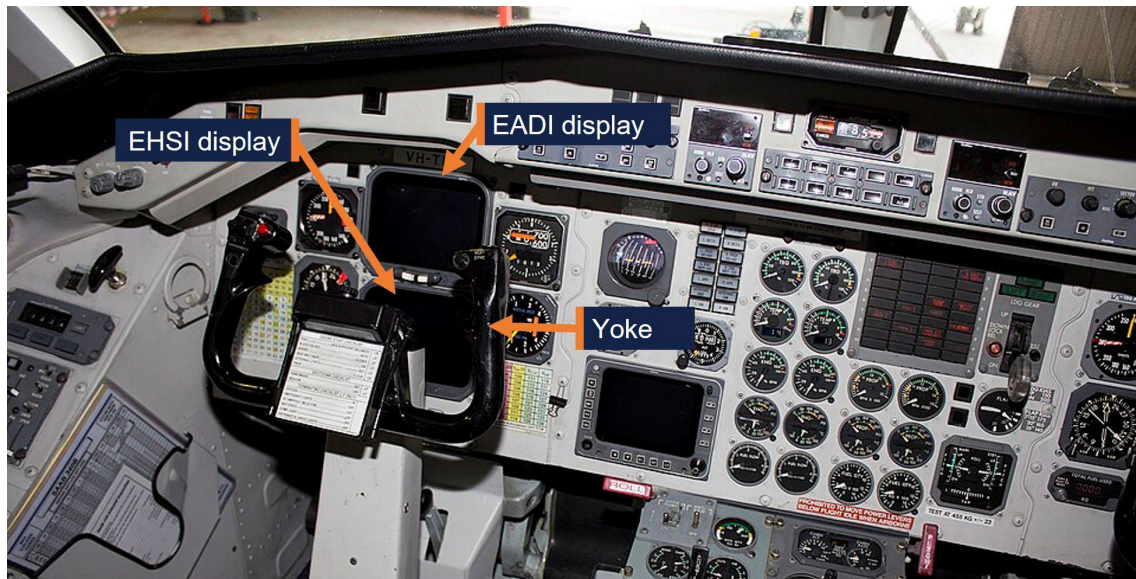
**Figure 2: Position of the flight displays relative to the yoke in the forward position**

The operator's aircraft were fitted with an electronic flight instrument system comprising an electronic attitude direction indicator (EADI) and an electronic horizontal situation indicator (EHSI) (also known as a navigation display). The EADI was positioned above the height of the yoke, but the EHSI was positioned below the EADI and partially obscured by the yoke when the yoke was forward (Figure 2).

The *Taxi checklist* included a check of the flight instruments. However, it did not include a check of the FMS programming, or a crosscheck of the navigation displays (EHSI) to verify that the correct information was displayed before take-off. The PIC reported that they did not crosscheck their navigation display with the SID before take-off because it was not required by the procedures and the operator acknowledged that there was no specific validity check of FMS data after engine start if the FMS was programmed on external power and then powered down for engine start. Furthermore, the navigation display can be partly obscured by the yoke if it is in the forward position.

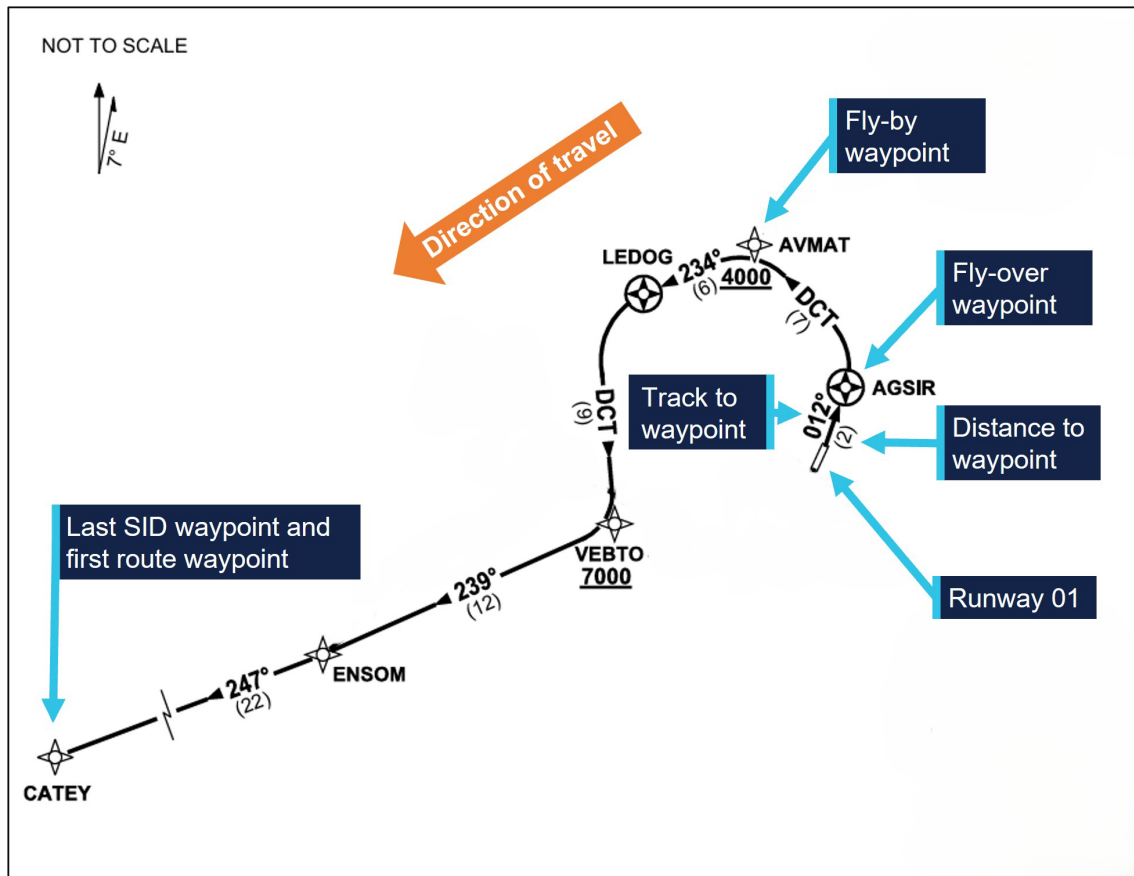
**Figure 3: Townsville runway 01 CATEY ONE standard instrument departure**

The CATEY ONE departure from Townsville runways 01/19 was an RNAV SID with the specification required navigation performance (RNP) 1<sup>5</sup> (Figure 3). The runway 01 magnetic direction was 017° and the first waypoint on the runway 01 SID was AGSIR, which was a fly-over<sup>6</sup> waypoint. It was located 2 NM upwind from the departure end of runway 01 on a track of 012°. Since AGSIR was a fly-over waypoint, the aircraft should not have turned before reaching it.

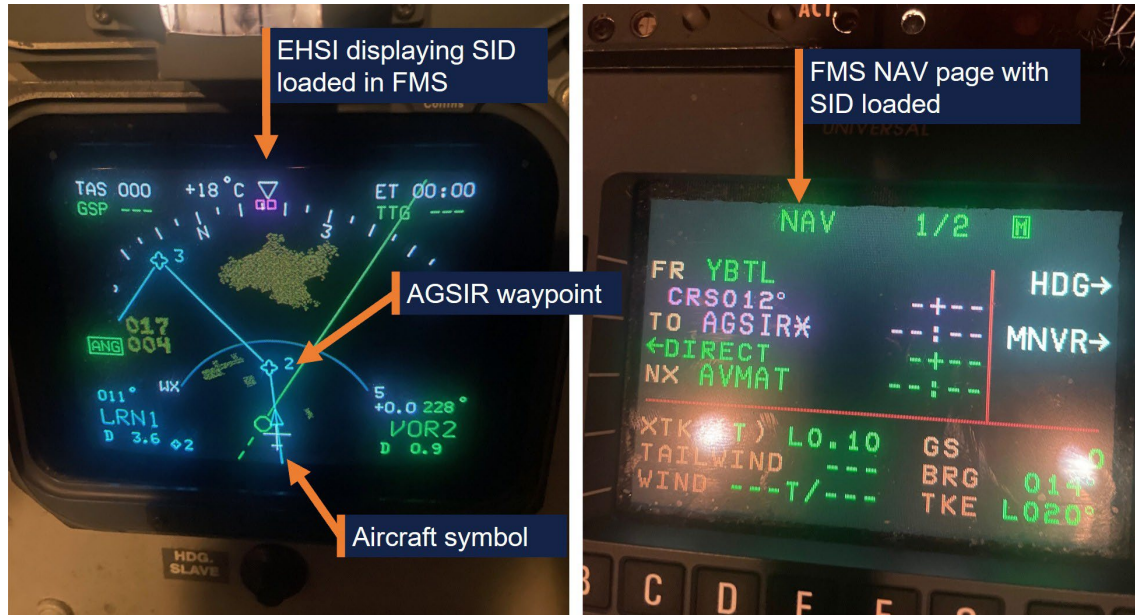
**Figure 4: EHSI display of SID (left) loaded in FMS (right)**

The *Taxi checklist* included a check of the flight instruments. However, it did not include a check of the FMS programming, or a crosscheck of the EHSI displays to verify that the correct information was displayed before take-off. The operator confirmed that the flight instruments check in the *Taxi checklist* related to primary flight instruments and not to navigation instruments or an FMS check. The following figure depicts the EHSI display of the SID when loaded in the FMS (Figure 4).
