# Foreign object debris involving Airbus A380, VH-OQK

Sydney Airport, New South Wales, on 9 January 2026

## **ATSB Transport Safety Report**

AO-2026-004

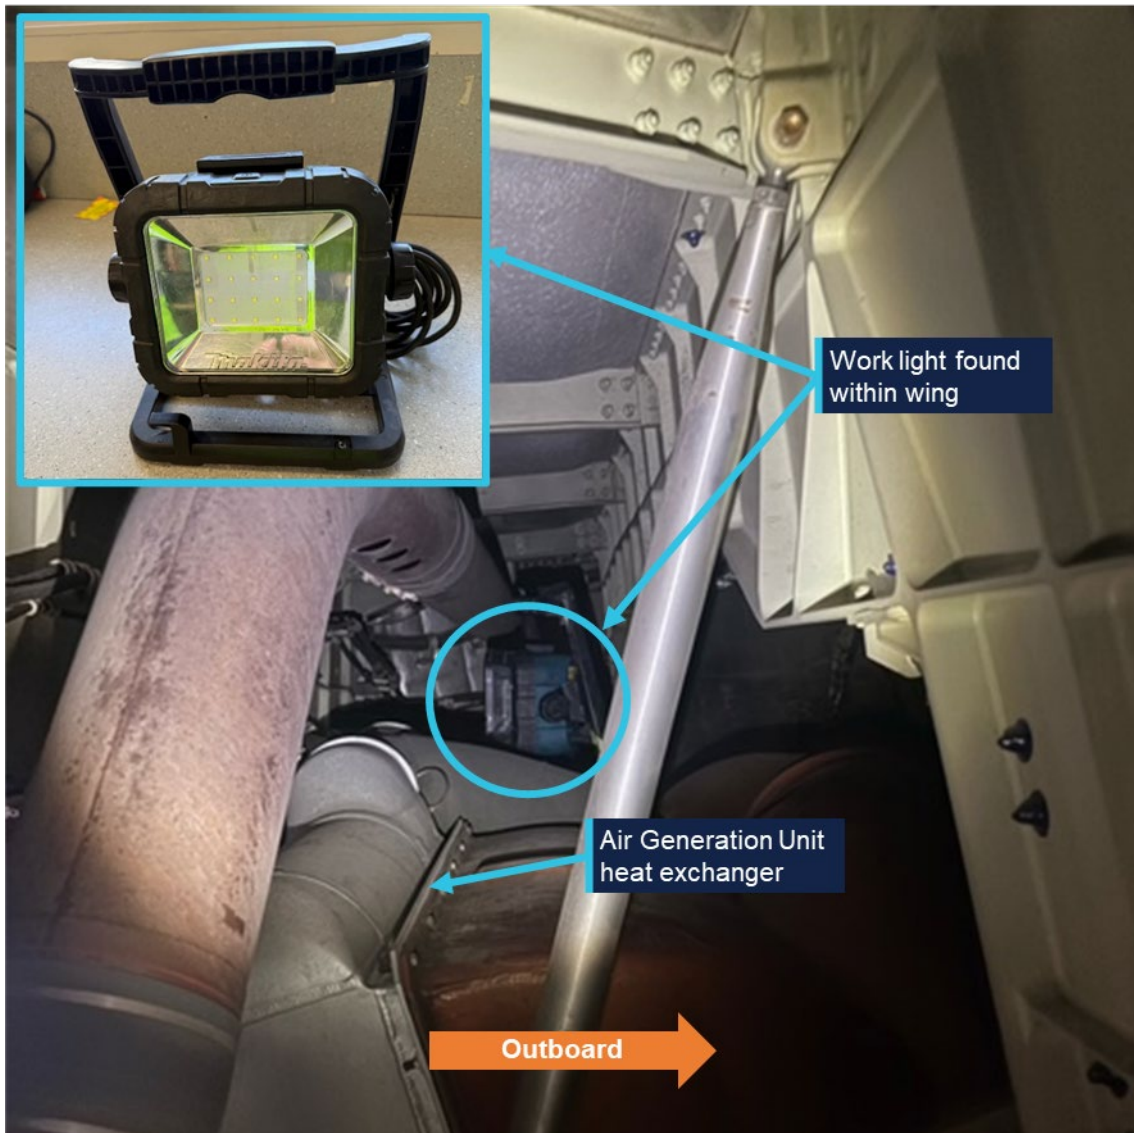
**Figure 2: Work light within wing of aircraft**

A lost tool search was initiated, and the missing work light was subsequently located inside the wing of the aircraft (Figure 2). No adverse consequences, structural damage, or system disruptions resulted from the work light remaining in the wing.

The work light, as shown in Figure 2, was a Makita corded and cordless LED work light capable of being powered by the cord or by attaching a compatible rechargeable battery to allow for portability. During the replacement of the temperature sensor, the work light was powered with an attached battery. The dimensions of the work light were 214 mm (length), 261 mm (width) and 328 mm (height). The work light was predominantly black in colour with a teal backing.

The work light power was found in the off position; however, when turned on, the light functioned normally, indicating that the battery retained sufficient charge.

- The work light had been selected off when the crew went to the cockpit to run the air conditioning unit.
- The confined workspace within the wing with low lighting combined with the work light colours making it difficult to visually identify.
- The high temperature within the confined workspace likely reducing the time spent conducting the clearance inspections.

The aircraft maintenance engineers and licensed aircraft maintenance engineer did not observe a work light that remained in the left wing during their foreign object clearance inspections following maintenance on the aircraft air conditioning system.
