# Fuel exhaustion resulting in a forced landing, involving Cessna 172P, VH-CIY

58 km west of Latrobe Regional Airport, Victoria, on 14 April 2026

Aviation Occurrence Investigation (Short)

AO-2026-072

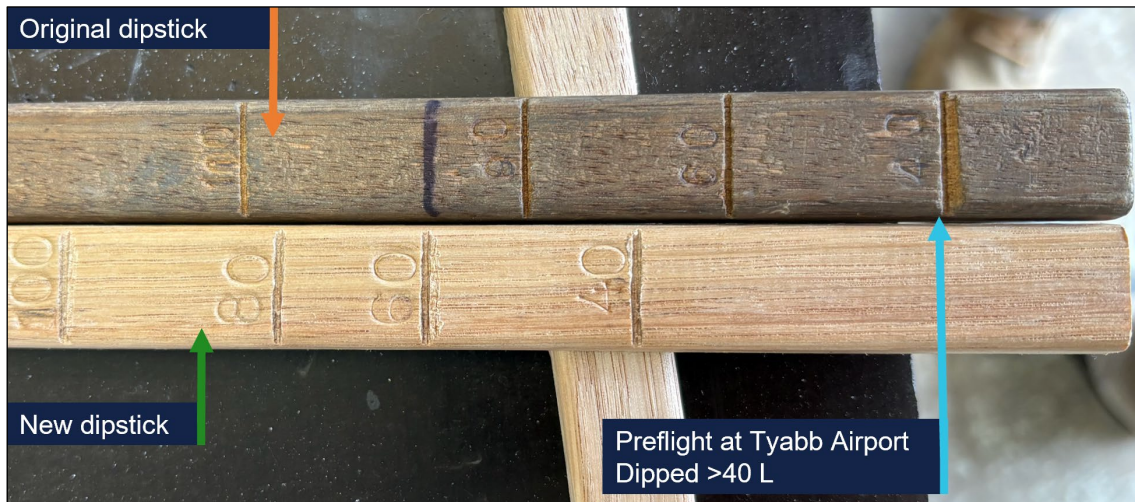
**Figure 3: Old dipstick and new dipstick**

Post-occurrence, the aircraft's dipstick was found to be incorrectly calibrated to the amount of FOB, and a new, calibrated dipstick was subsequently generated. Figure 3 shows the variation between the 2 dipsticks and the indication for recorded FOB when checked at Tyabb (40 L per side). The ATSB was unable to establish how the incorrectly calibrated dipstick came to be in use.

Once the aircraft was back at Tyabb airport the operator established that the aircraft's dipstick was over-reading the amount of FOB. A new dipstick was manufactured and calibrated to the aircraft.

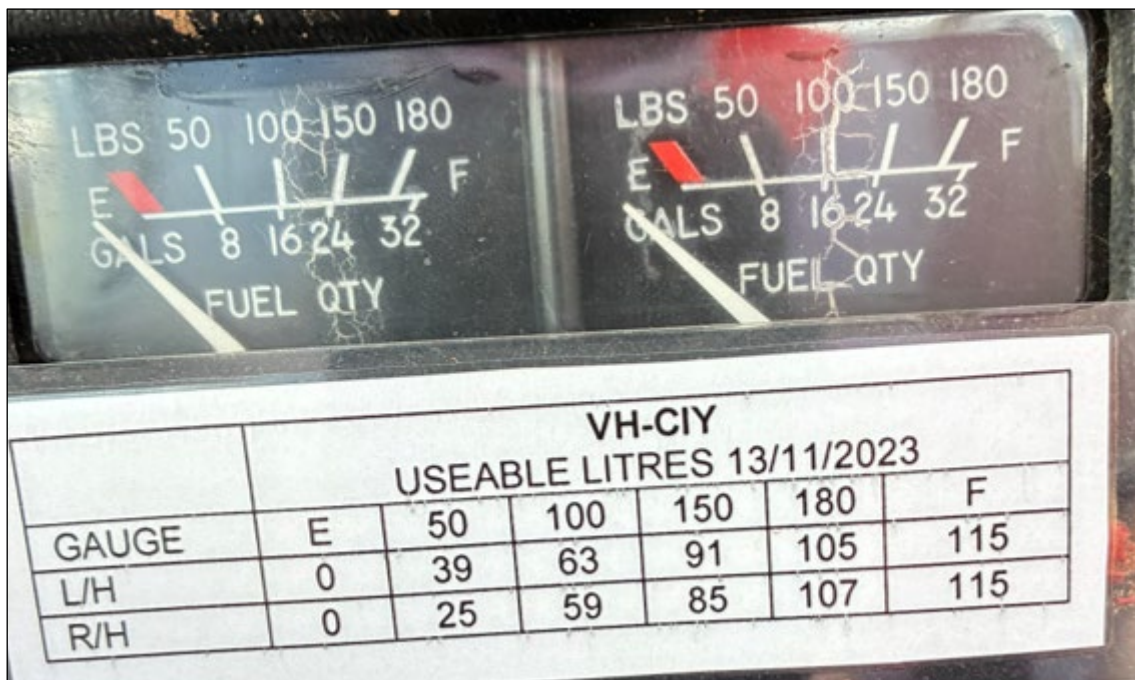
**Figure 4: Fuel quantity indicators and placard on the aircraft**

The fuel quantity was measured by 2 float-type fuel quantity transmitters (one in each tank) and indicated by 2 electrically operated fuel quantity indicators on the left side of the instrument panel. An empty tank was indicated by a red line and the letter E (Figure 4). A placard giving a conversion to fuel in litres from the indicated quantity in pounds (LBS) was also placed below the fuel indicators.

The pilots involved in the occurrence reported not trusting the fuel indications on the aircraft and instead relied on the dipstick indication to develop an understanding of the FOB. The PICUS advised that this was in part due to the aircraft's fuel quantity indicators not accurately reflecting the fuel quantity measured by the dipstick. Both pilots reported that they trusted the dipstick measurement.

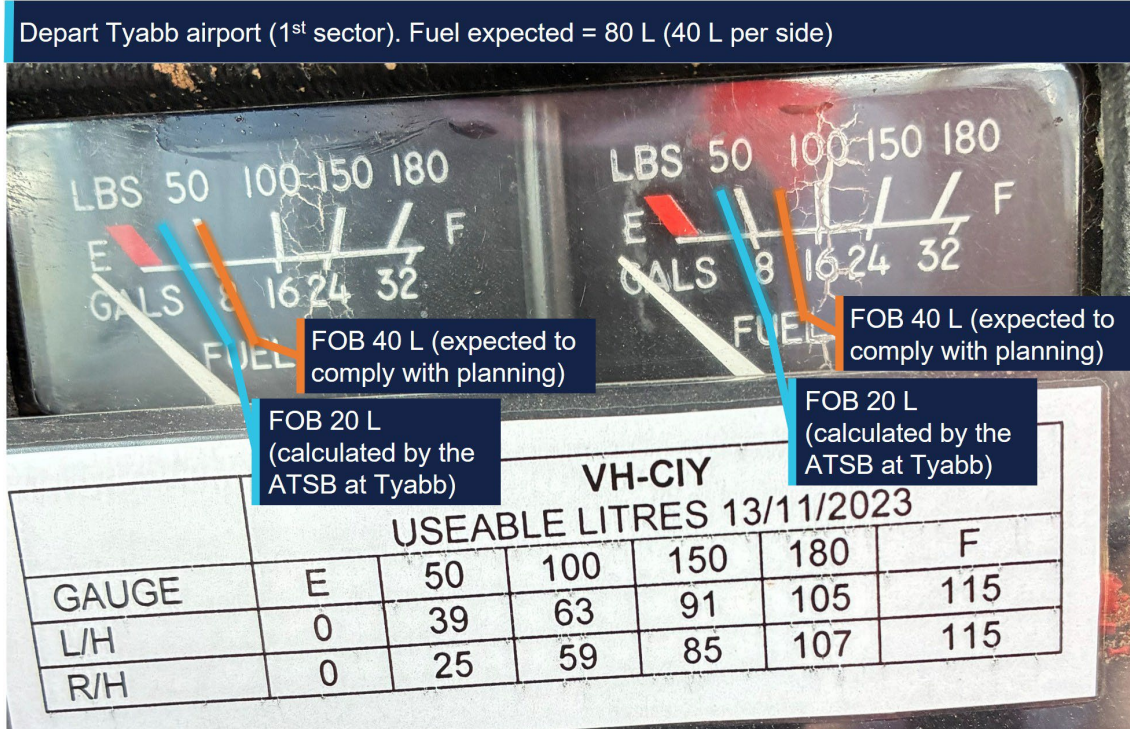
**Figure 6: Estimated discrepancy between expected and actual fuel indications on Tyabb departure**

Both pilots relied on the pre-flight fuel quantity measurement and did not use the fuel indicators to crosscheck the amount of fuel on board, prior to or during either flight.

On departure from Tyabb, the expected fuel on board was measured at 40 L per side (dipped), for 80 L total. The actual fuel on board was approximately half of the expected amount, based on the fuel consumption planning figures and a recorded flight time of 1.2 hours. Source: Operator, annotated by the ATSB
