# Near collision with road vehicle at level crossing, involving train 0348

Wallan, Victoria, on 25 April 2026

**ATSB Transport Safety Report**  
Rail Occurrence Investigation  
RO-2026-003  
Preliminary – 18 August 2026

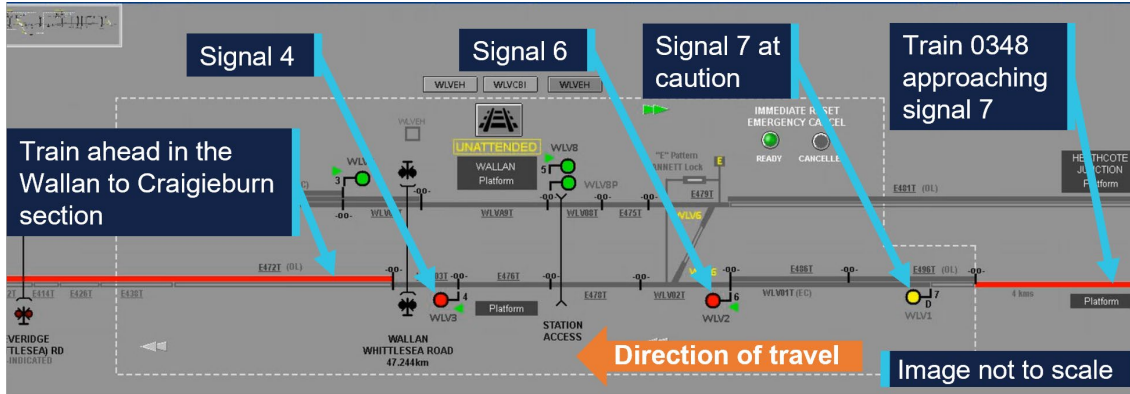
**Figure 2: Signalling system playback at 1427 showing signal 7 at caution**

The status of signals and the movement of trains were captured by a signalling system event recorder. The signalling system playback showed that the train approached Wallan<sup>1</sup> at about 1427 and received a yellow aspect (caution indication) at distant signal 7 (Figure 2).<sup>2</sup> Signal 7 was at caution because a train ahead was in the Wallan to

Craigieburn section. The train passed signal 7 at about 49 km/h at 1428 and then approached home signal 6, which showed a red aspect (stop indication). Signal 6 was located about 1 km from signal 7. The driver slowed the train to about 15 km/h on the approach to signal 6.

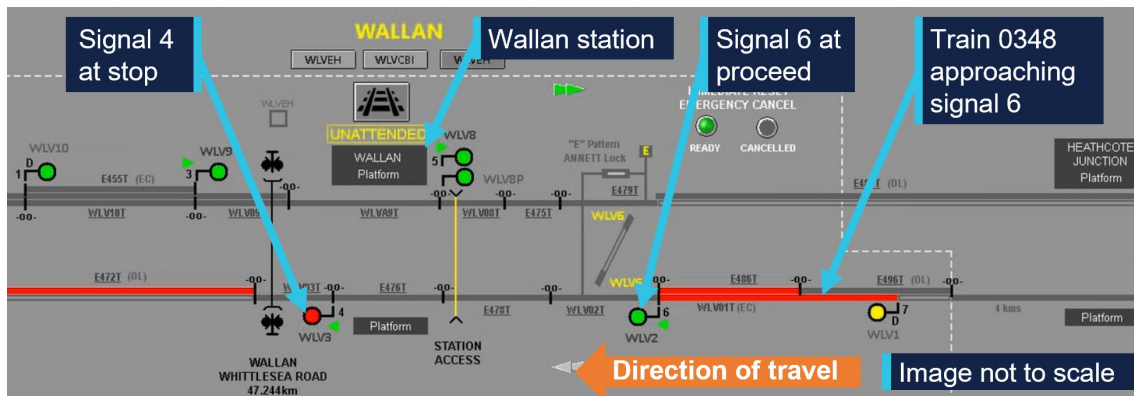
**Figure 3: Signalling system playback at 1430 showing signal 6 at proceed**

The driver received a green aspect (proceed indication) on signal 6 at about 1430 (Figure 3) and proceeded past the signal towards Wallan station.

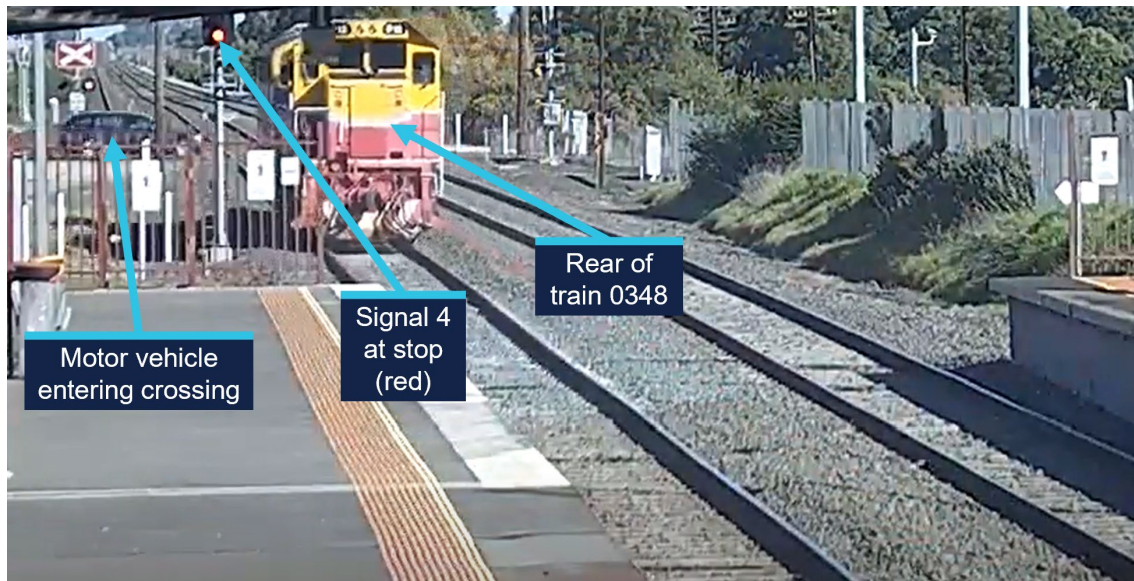
**Figure 4: Train 0348 proceeding towards Wallan–Whittlesea Road level crossing**

On passing through Wallan station at about 1431 the driver sighted home signal 4 showing a red aspect (stop indication). In response, they made a brake application and sounded the train horn. The train was about 150 m from signal 4 and travelling at about 85 km/h when train braking was applied. About 7 s later the train passed signal 4 at stop and proceeded towards the Wallan–Whittlesea Road level crossing (Figure 4). The crossing was about 90 m past signal 4.

The Wallan–Whittlesea Road level crossing was equipped with flashing lights, bells and boom barriers. The crossing lights started to flash about 1 s after train 0348 was detected having passed signal 4. CCTV showed a road vehicle entering the level crossing, travelling from east to west, at about the same time as the level crossing lights started to flash (Figure 4).

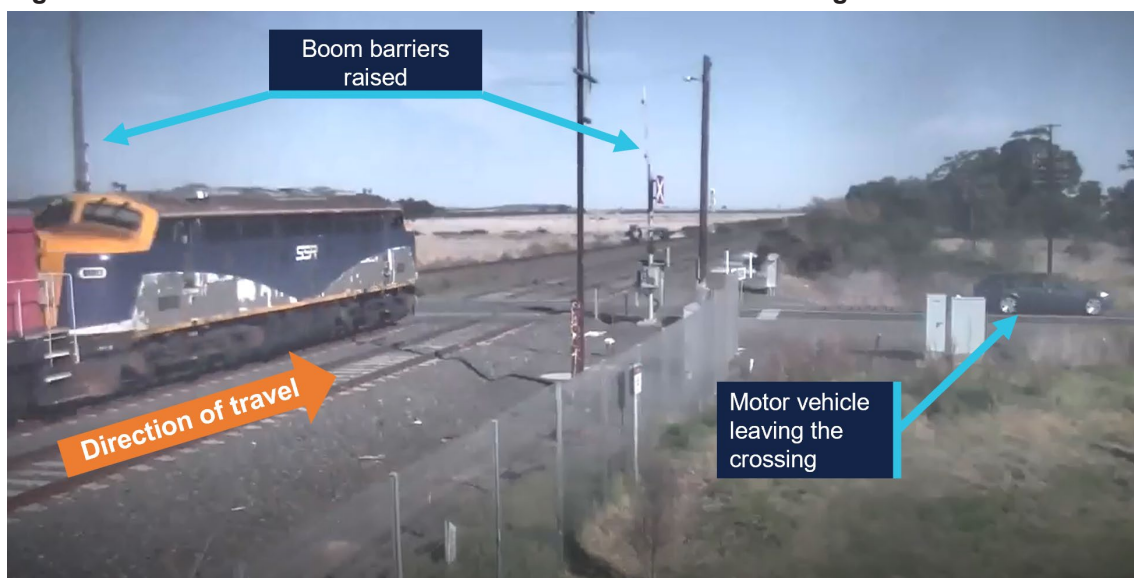
**Figure 5: Train 0348 enters Wallan–Whittlesea Road level crossing**

The train entered the level crossing about 4 s after passing signal 4. The road vehicle had travelled about 15 m past the crossing when the train entered the crossing (Figure 5). The boom barriers remained raised as both the road vehicle and train passed through the crossing.

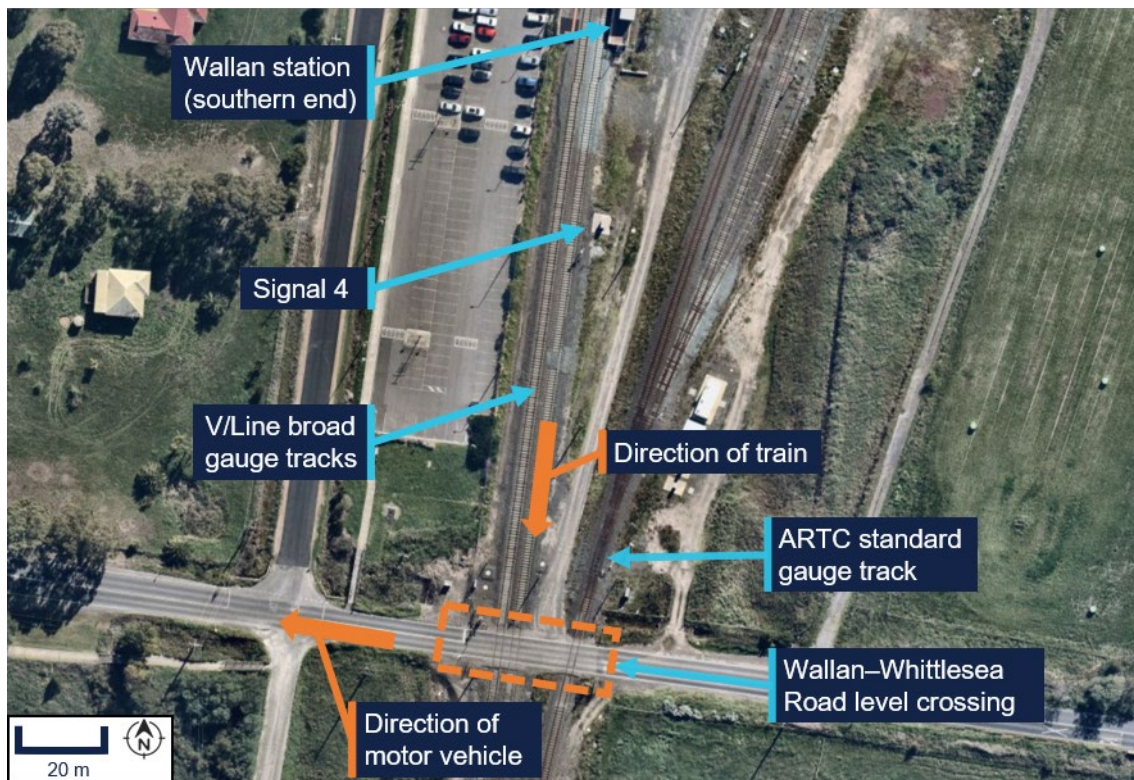
**Figure 6: Rail infrastructure from Wallan railway station to the level crossing**

The near collision incident occurred near Wallan railway station, about 44 km north of Melbourne. Rail infrastructure through the location consisted of 2 adjacent broad gauge unidirectional lines and standard gauge lines to their east (Figure 6). The broad gauge track was managed by V/Line, and the standard gauge track by the Australian Rail Track Corporation (ARTC). When signals were at proceed, the maximum permitted speed for train 0348 through Wallan railway station and the level crossing was 100 km/h.

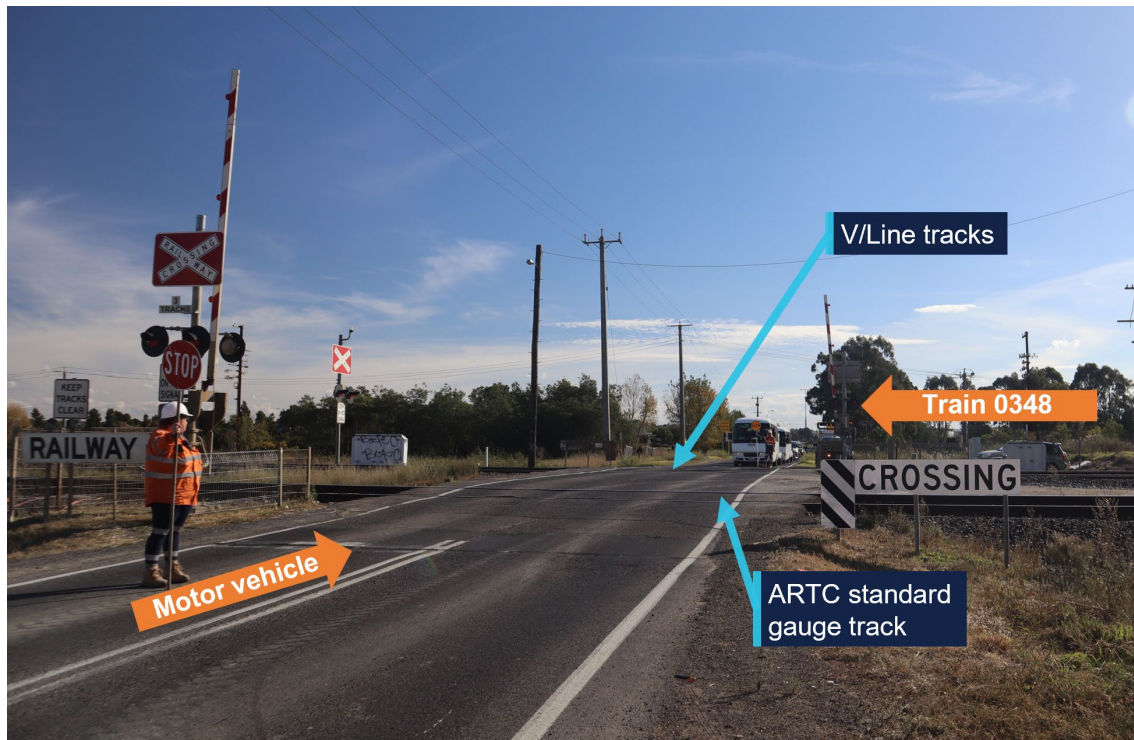
**Figure 7: Wallan–Whittlesea Road level crossing, looking west**

The protection equipment at the level crossing for road vehicles consisted of boom barriers, flashing lights, warning bells and warning signage on each side of the crossing (Figure 7). Active advance warning signs were fitted at the level crossing on the side of the road, about 150 m prior to the crossing on each approach. V/Line was responsible for the level crossing control equipment for trains on the broad gauge tracks.

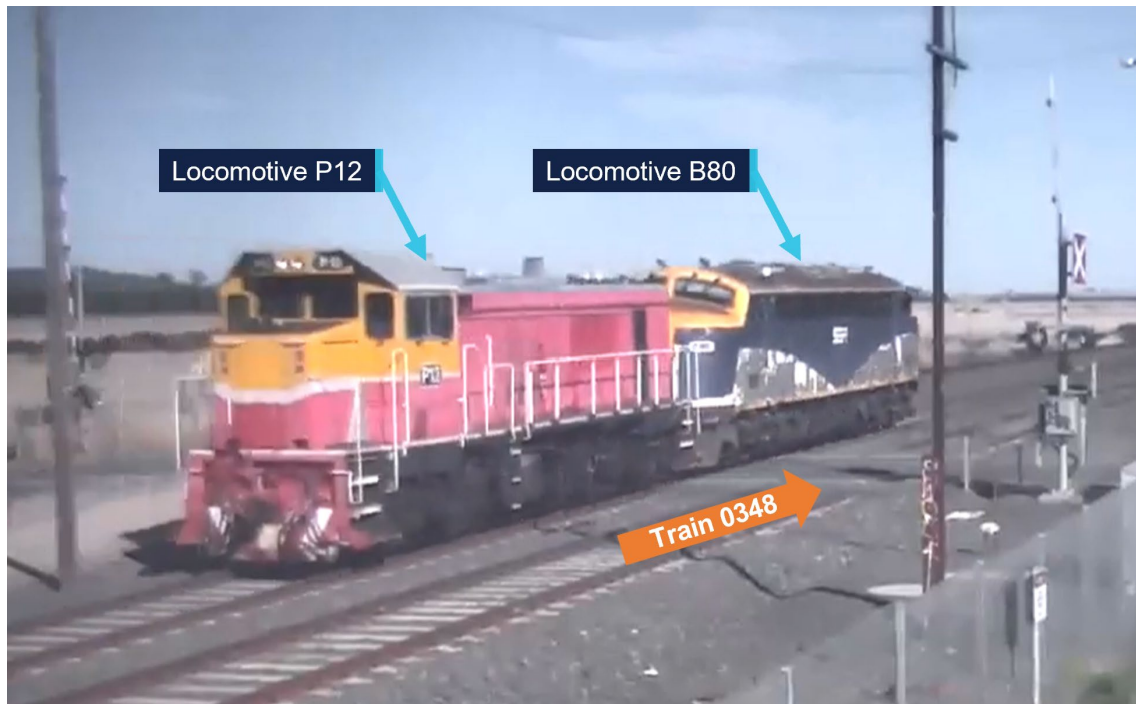
**Figure 8: Train 0348 passing through Wallan–Whittlesea Road level crossing**

SSR train 0348 comprised 2 coupled locomotives, operated by a crew of 2 SSR drivers. SSR was a business unit of Consolidated Rail Holdings Pty Ltd (Holdco). The leading locomotive was B80 and the trailing locomotive was P12 (Figure 8).
