# Engine failure involving a Eurocopter AS350-BA, VH-SFX

Whyanbeel Valley, Queensland, 2 November 2015

**ATSB Transport Safety Report**  
Aviation Occurrence Investigation  
AO-2015-124  
Final – 17 October 2017

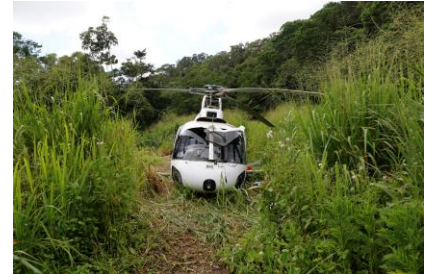
### VH-SFX at accident site

The passengers adopted the brace position and the helicopter landed heavily with the skids digging into the uneven terrain and breaking off. The navigator in the front seat received minor injuries and the pilot received serious back injuries from the impact forces.

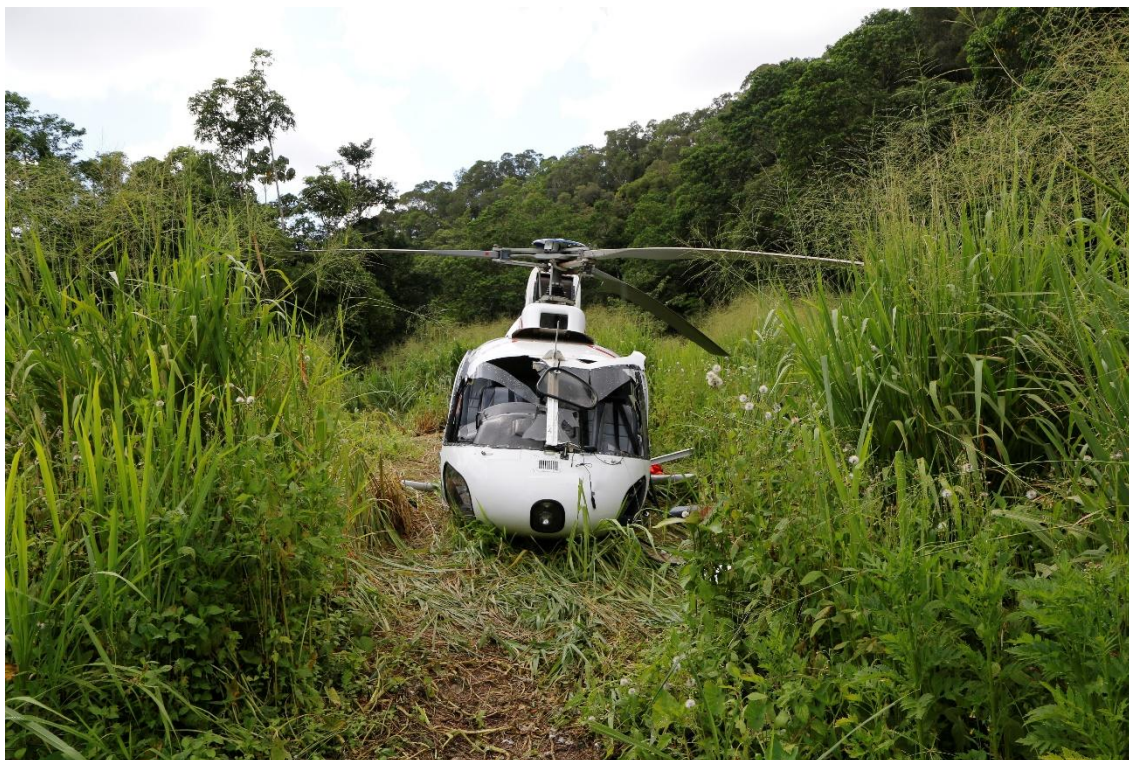
**Figure 2: VH-SFX at the accident site**

The on-site examination found that the helicopter struck the ground tail rotor first, with the skids subsequently digging into the uneven terrain and separating from the fuselage (Figure 2).

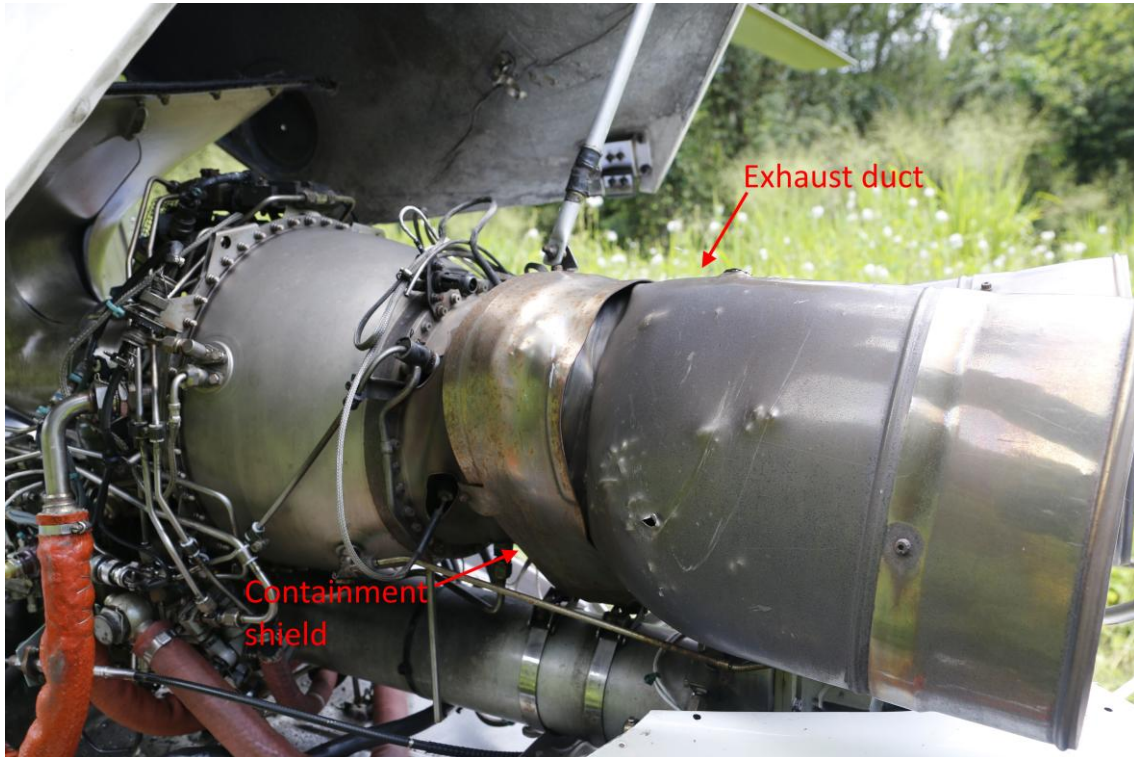
**Figure 3: View of the helicopter engine at the accident site**

The engine had sustained damage consistent with a high-energy failure. The power turbine separated from the disc and the containment shield was twisted and deformed. The exhaust duct was bulged and puncture marks from internally liberated engine debris was evident (Figure 3).

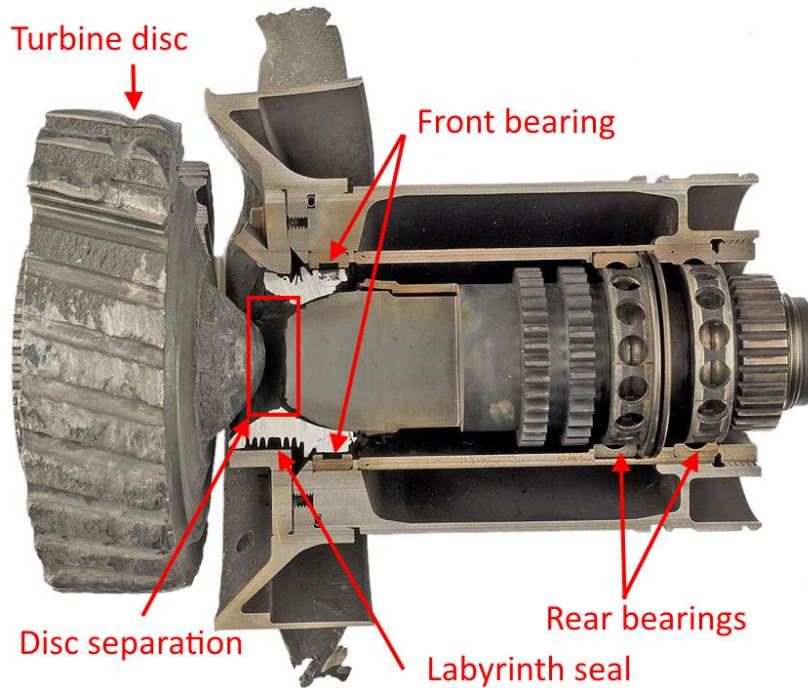
- The power turbine disc had fractured in overstress and separated from the power turbine shaft (Figure 6). The power turbine disc sustained a complete loss of power and the turbine blades had separated from their respective stations. Fracture of many of the blade inter-recesses within the disc had also occurred.

**Figure 6: Cross-section through the power turbine assembly from the engine showing that the disc had separated from the shaft and the blades had fractured**

The combined effects of the front bearing seizure and the axial coupling of the components led to excessive heating and a subsequent critical reduction in mechanical properties for the shaft. Consequently, the turbine shaft was unable to sustain the operating stresses and it eventually fractured at the interconnection with the disc.

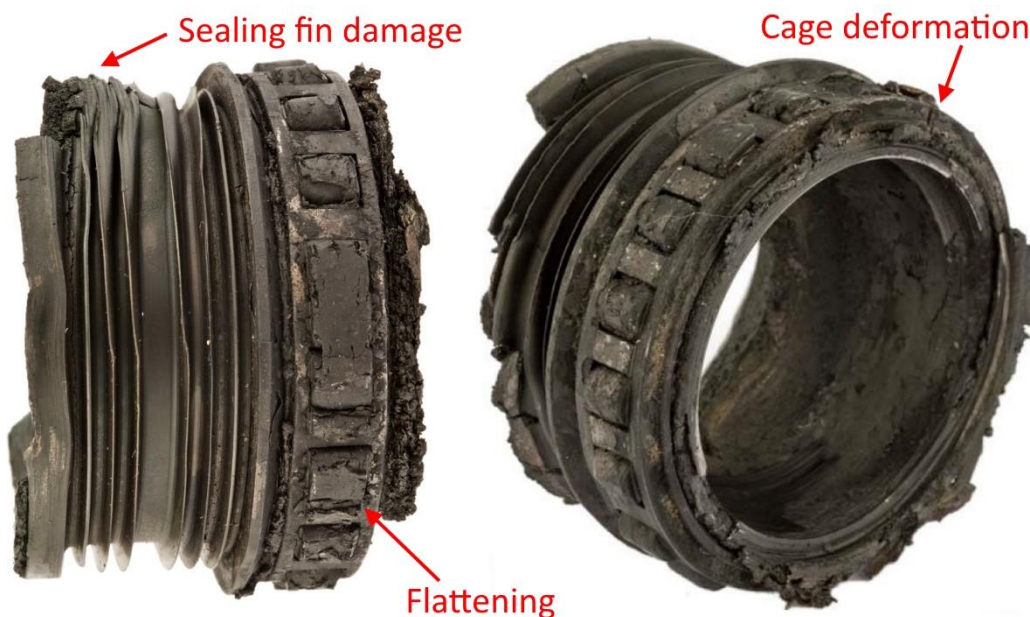
- The front bearing of the power turbine shaft had totally seized (Figure 7). Evidence of roller skidding, metal contamination and gross overheating was found within the bearing assembly. The accumulation of hardened coking products and varnish deposits from oil degradation was also found within the rolling elements.

- As a result of extreme frictional heating, the oil-air labyrinth seal, just forward of the front bearing, had melted and fused with the power turbine shaft.

**Figure 7: The seized front bearing and labyrinth seal, showing blackening from severe heat distress, flattening of the rollers, deformation of the cage and sealing fins**

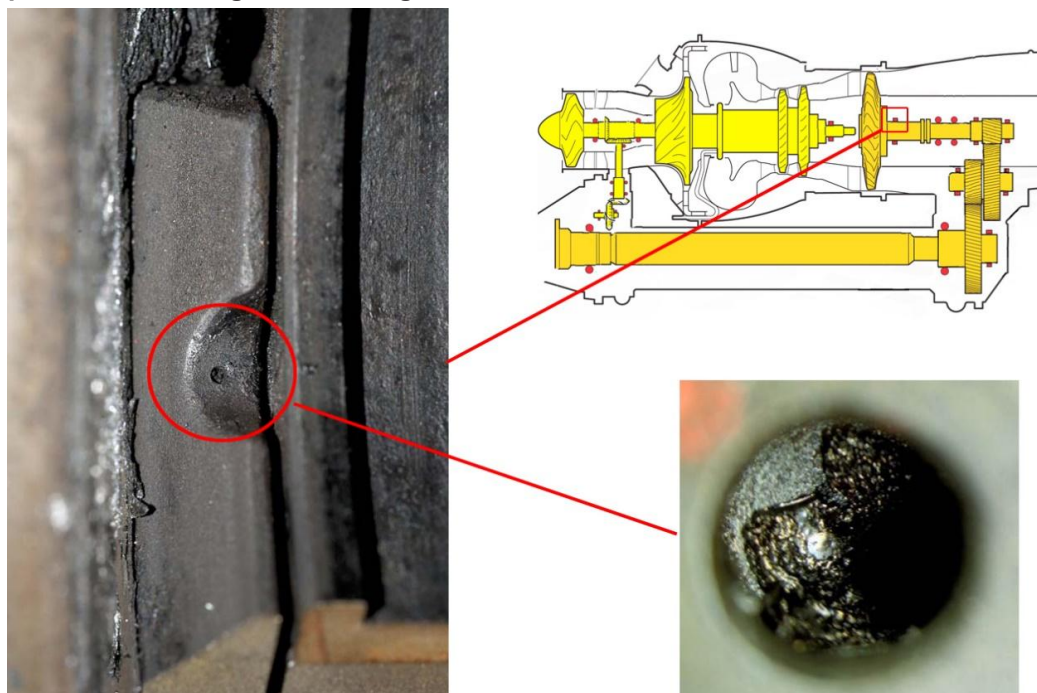
- Examination of the oil jet and surrounding oil ducts to the front bearing of the power turbine shaft identified that the jet outlet was blocked with an accumulation of coke particles (Figure 8).
- Examination of the splined nut that was threaded to the rear of the power turbine shaft assembly revealed evidence that it had tightened. The location of the nut determined the position of the shaft and any potential axial preload of the shaft bearings. No evidence was found of the adhesive that was required to have been applied between the threads on the rear shaft and the nut (Figure 9).

**Figure 8: Close up of the blockage (circled) at the oil jet to the front bearing, as positioned in the general arrangement view**

The observed coking of the front bearing and its oil jet duct was likely a result of the engine oil exposure to abnormally high temperatures in the area. While there were clogging inspection procedures of the power turbine rear bearings, no preventative maintenance actions existed that allowed for the identification of coking within the front bearing.

The engine manufacturer reported that a design trait of the power turbine is that the fluid velocity is lower at the bottom of the oil jet duct to the front bearing. For a given volume, this trait can lead to increased convective heating of the oil and depending on the temperatures in that region, may lead to coking.

The engine manufacturer (Safran Helicopter Engines) has amended their procedure manual to include systematic cleaning of the power turbine front bearing assembly oil jet and oil jet supply pipe. Safran HE have initiated a number of training and process changes to ensure the adhesive bonding between the power turbine and the rear nut is maintained during service.

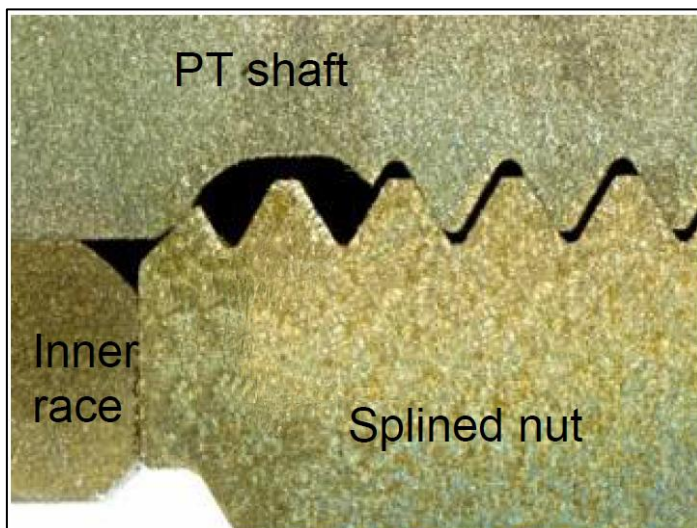
**Figure 9: Cross-section of the rear splined nut contacting the rear bearing inner race**

Failure to adequately bond the nut could result in a tightening of the rear nut when abrupt changes in torque occur, leading to axial displacement of the turbine shaft in excess of the designed amount. This displacement would result in contact between the turbine shaft and the front bearing inner race, resulting in frictional heating, and damage to the turbine shaft.

The engine examination identified that the rear nut fitted to the rear of the power turbine shaft had not been adhesively bonded, as required.

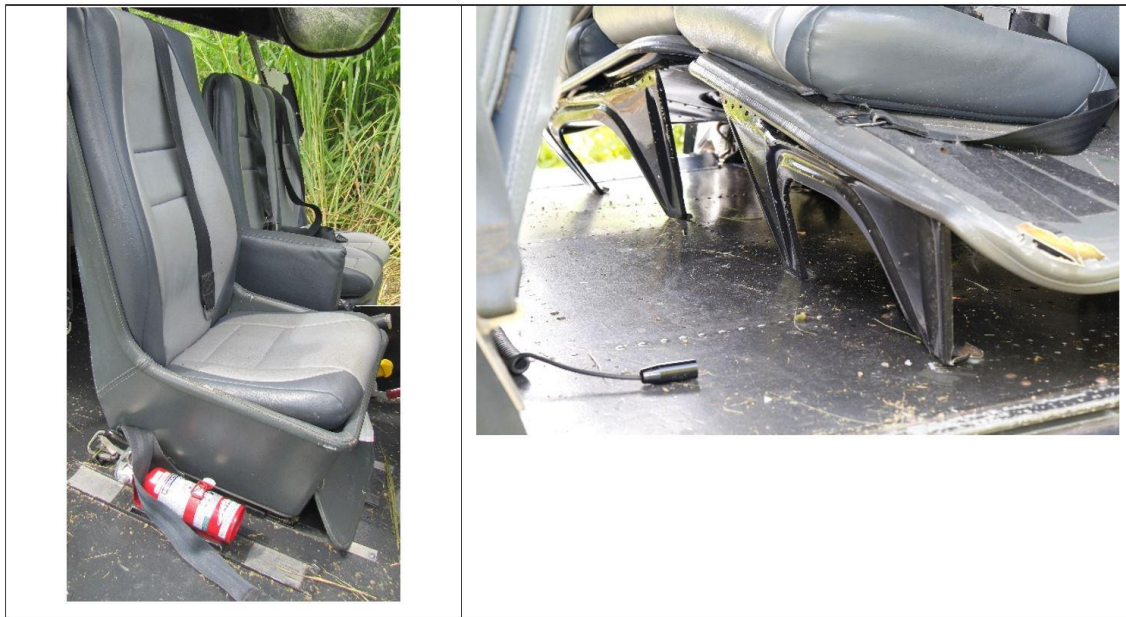
A service information bulletin issued by the helicopter manufacturer in 2010 recommended that AS350 helicopter operators consider the safety benefits of installing energy-absorbing seats. Had these seats been installed, the forces imparted to the pilot during the accident sequence may have been reduced.

**Figure 10: VH-SFX front seats (left) and rear passenger seats (right)**

The manufacturer also published a service bulletin (EC SB AS350 No. 25.00.57) recommending the installation of the energy-absorbing seats on AS350 helicopters. A European Aviation Safety Authority (EASA) safety information bulletin, SIB 2010-05, reiterated the safety benefits associated with the installation of energy absorbing seats.
