# Erratic airspeed indications, Boeing 787-8, VH-VKE

450 km north of Darwin, Northern Territory, 21 December 2015

**ATSB Transport Safety Report**  
Aviation Occurrence Investigation  
AO-2015-149  
Final – 14 June 2017

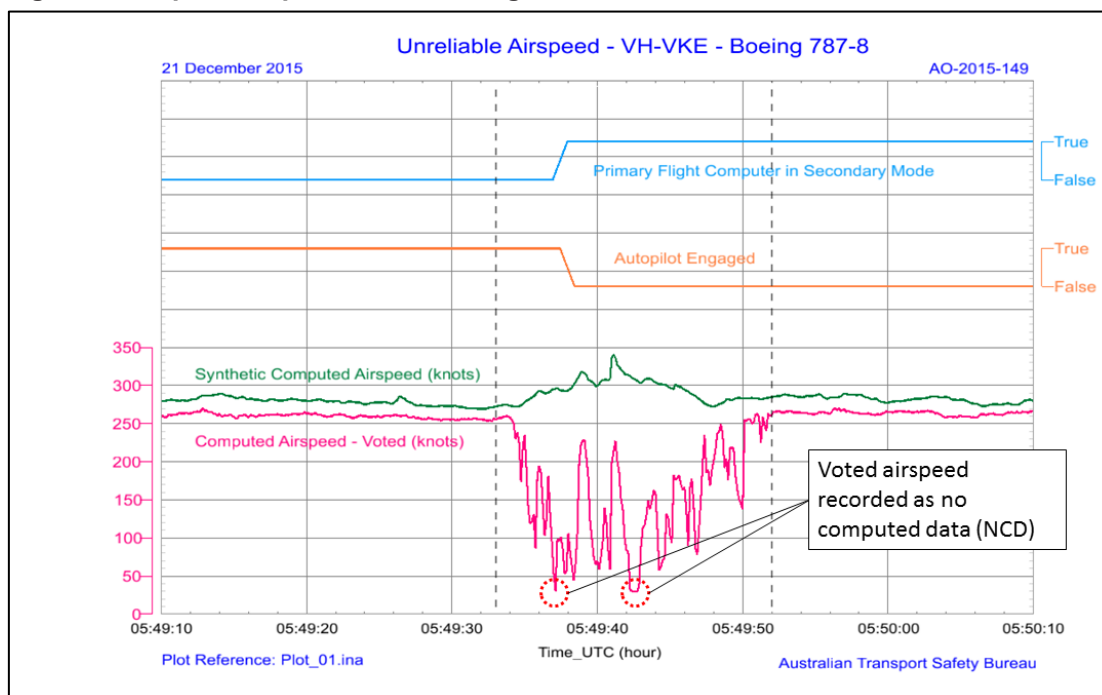
**Figure 1: Graphical representation of flight data**

Flight data from the occurrence shows that the voted airspeed value became erratic for approximately 17 seconds. The voted airspeed values deviated significantly below the independent AOA speed calculated by the aircraft flight computer. As indicated in Figure 1, the voted airspeed was NCD for more than 0.1 seconds twice throughout the event.

This figure illustrates the discrepancy between the recorded values of voted airspeed and synthetic AOA speed. Within 5 seconds of the diverging values the autopilot and flight computer mode reversion had occurred. The airspeed disagreement lasted for a total of around 17 seconds.

A drop in recorded airspeed to, or below, a threshold level is referred to as a No Computed Data (NCD) state. Throughout the recorded airspeed fluctuations, there were two occasions where the value of voted airspeed went NCD for a sufficient time to revert the flight control system to secondary mode.

Boeing has taken action to revise the software in the flight control computer related to the secondary mode reversion. This revision has increased the time required in an NCD state to revert to secondary mode.
