# Traffic management occurrence involving Airbus A320, VH-VQS and Beech Aircraft Corporation BE-76, VH-EWL

Ballina/Byron Gateway Airport, New South Wales on 14 January 2016

**ATSB Transport Safety Report**  
Aviation Occurrence Investigation  
AO-2016-003  
Final – 19 May 2017

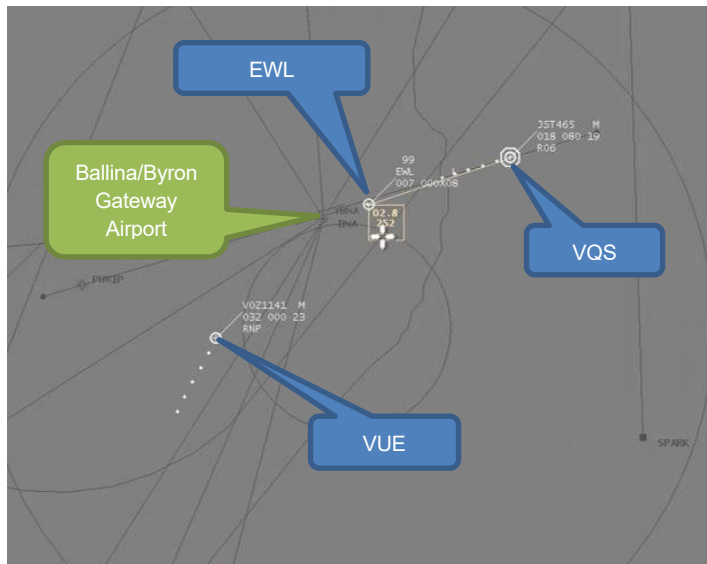
The crew of VQS stated that on assessing that the aircraft was clear of EWL and accelerating away (Figure 1), they manually re-established a normal climb out pitch attitude and thrust setting. At approximately 1,700 ft VQS conducted a right turn to intercept the outbound track, which was contrary to the left turn stipulated in the Jetstar Airways departure procedures. The remaining flight to Melbourne was normal.

**Figure 1: A screenshot of the radar display depicting the positions of VQS (JST 465) and EWL in the vicinity of Ballina. VUE (VOZ 1141) is also seen approaching from the south-west**

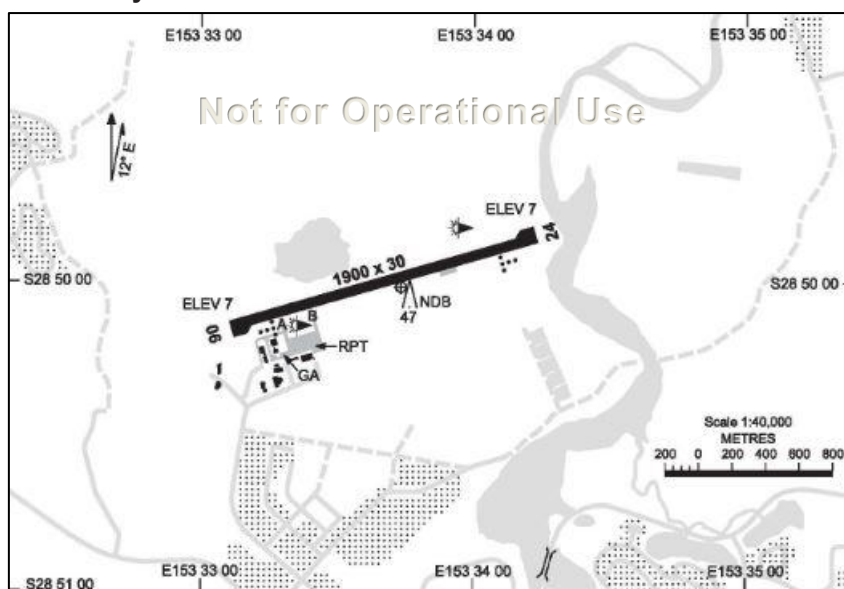
Ballina/Byron Gateway Airport (Ballina airport) was a certified aerodrome with a single, sealed 1,900 m long and 30 m wide runway. The runway was orientated in a 062°/242° magnetic (north-east/south-west) direction with an elevation of 7 ft above sea level. The airport did not have taxiways parallel to the runway for use when positioning aircraft for departure or after arrival. Therefore, aircraft were often required to backtrack on the runway prior to take-off and after landing. The airport had GPS-based instrument approaches and a non-directional beacon ground-based navigation aid. Runway 06 was designated as a right-hand traffic pattern and circling to the north of runway 06/24 was not permitted for aircraft conducting instrument approaches. These requirements were due to the higher terrain to the north of the runway (Figure 2).

**Figure 2: Navigational chart depicting the Ballina airport runway and position of the regular public transport (RPT) apron areas. Note there are no taxiways running parallel to the runway**

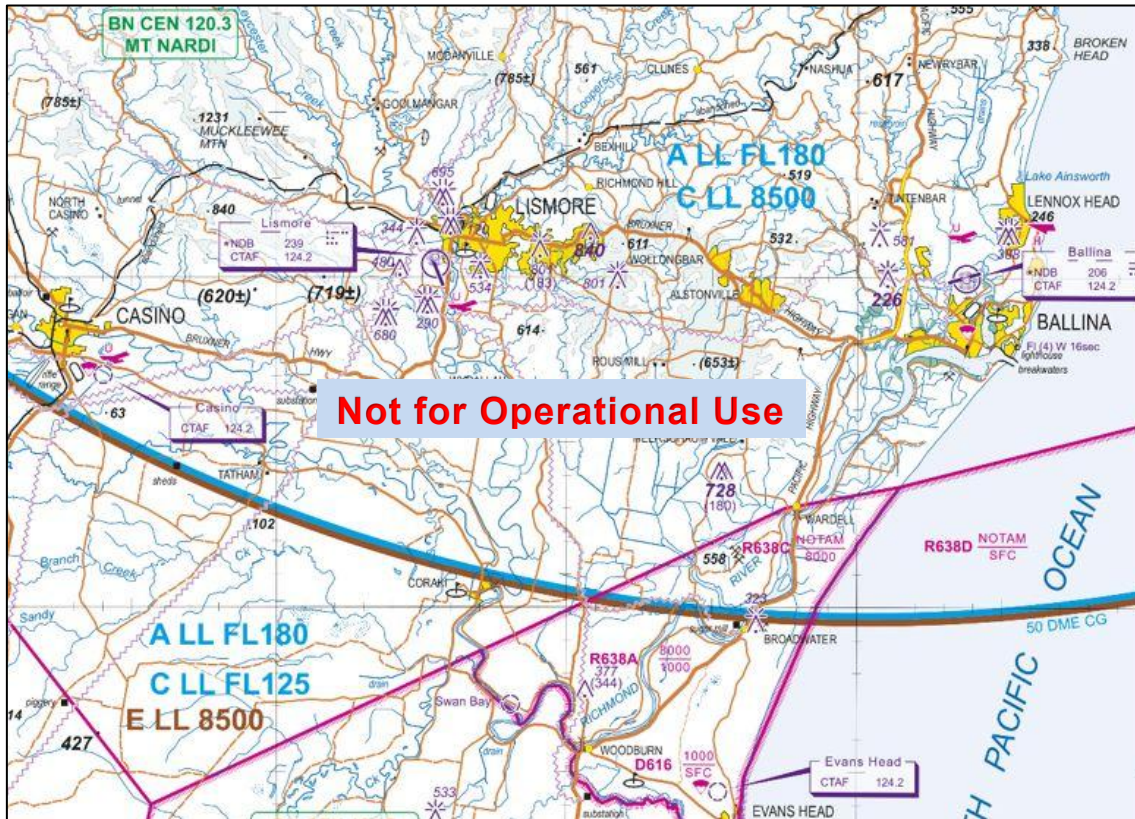
being able to use ‘see and avoid procedures’, which were stipulated in various regulations and guidance material for non-controlled aerodromes. See and avoid also relies on voice communication using the Common Traffic Advisory Frequency (CTAF). Due to their close proximity, the Ballina airport CTAF was shared with Casino and Lismore airports. As such, a pilot using this frequency would be affected by all radio transmissions from traffic at any one of these airports (Figure 3).

**Figure 3: An extract of the Visual Terminal Chart of the Ballina area. The Casino and Lismore airports are depicted and share the CTAF of 124.2 MHz with Ballina airport. Also depicted in magenta are the restricted areas to the south Ballina, and the lower limit of the class C controlled airspace overhead those airports of 8,500 ft (in blue)**

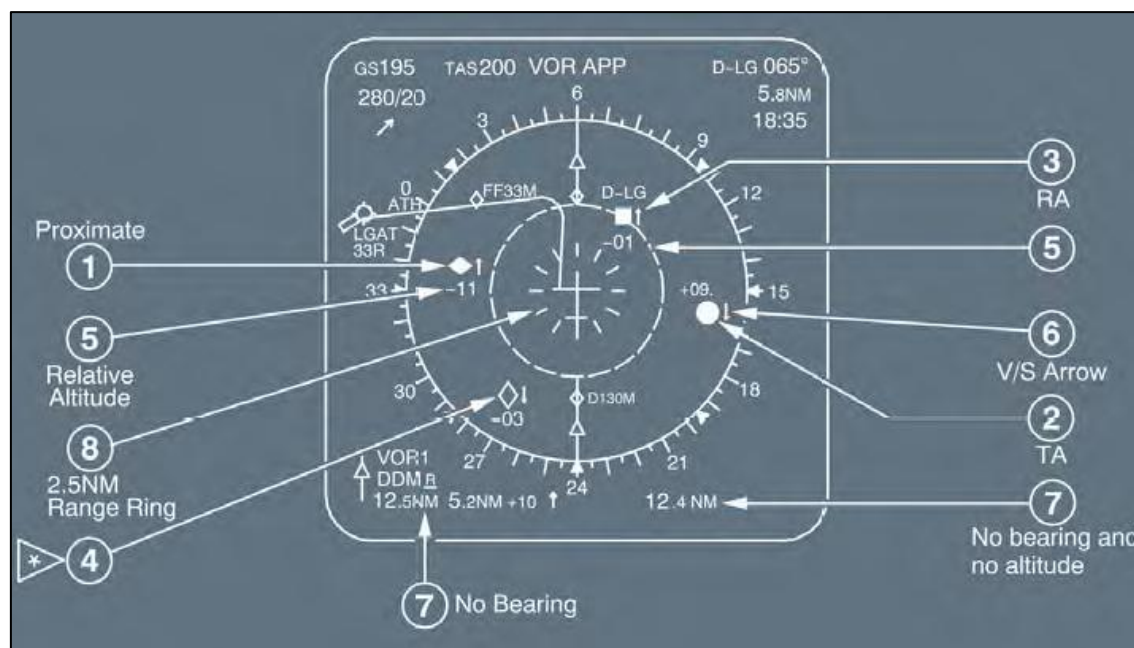
**Figure 4: Typical Airbus A320 navigation display depicting the various representations of TCAS intruders. The number of each representation accords with the numbered list above**
