# Loss of separation involving Boeing 737 aircraft, VH-YFN and VH-VZV and Robinson R44, VH-WYR

near Essendon Airport, Victoria, on 26 January 2016

**ATSB Transport Safety Report**  
Aviation Occurrence Investigation  
AO-2016-005  
Final – 9 March 2017

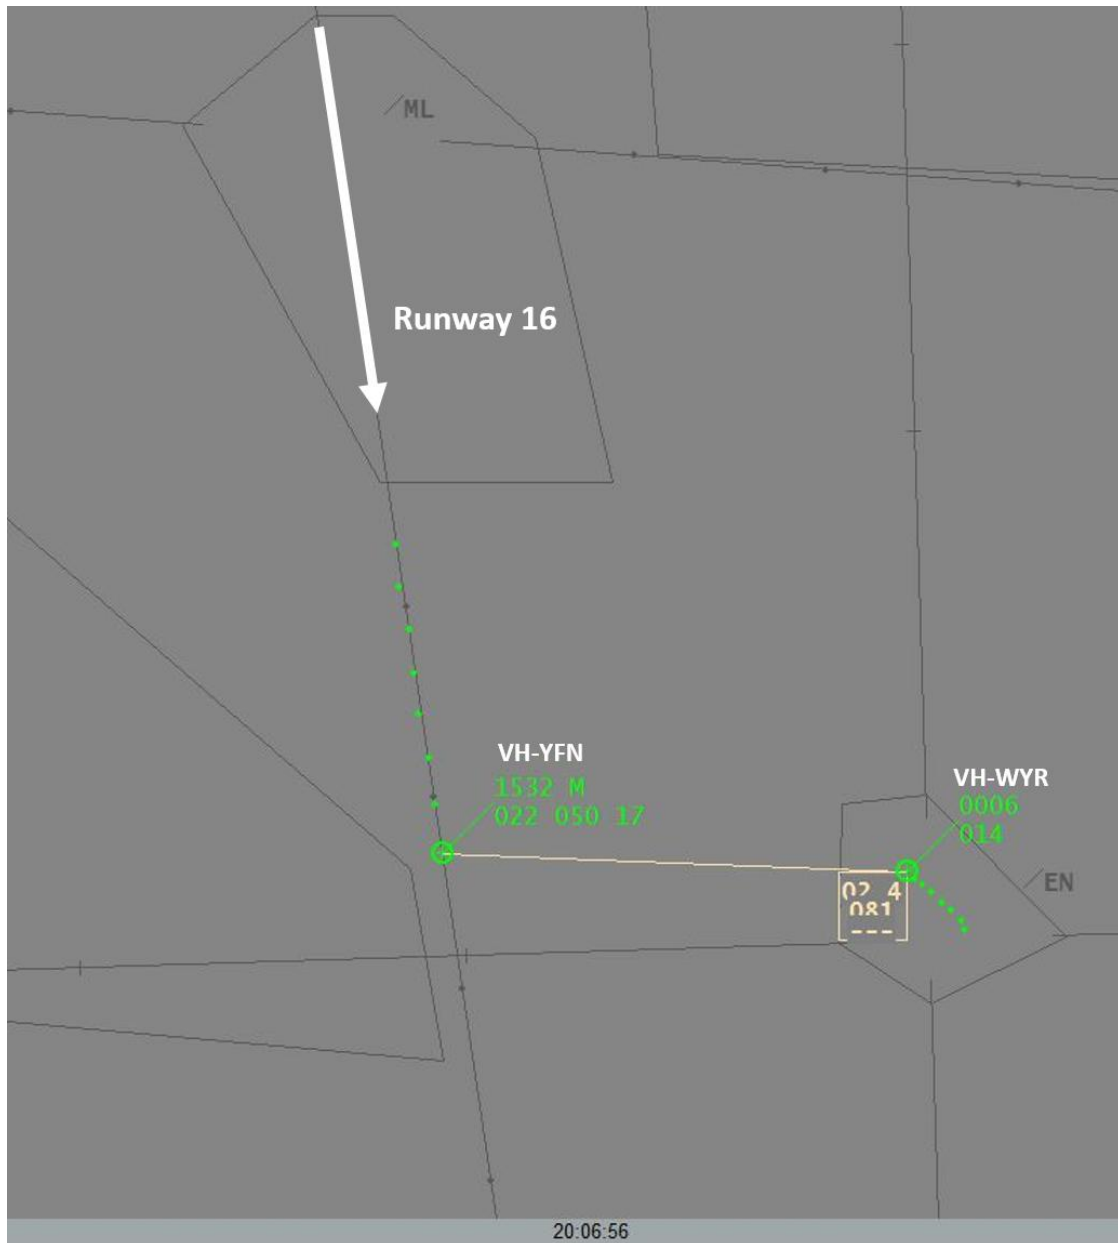
A review of the surveillance data confirmed two losses of separation between WYR and the 737 aircraft (Figures 3 and 4). The required separation was 3 NM (5.6 km) or 1,000 ft, but separation reduced to 2.4 NM (4.4 km) and 800 ft between WYR and the first 737, and 2.5 NM (4.6 km) and 800 ft with the second.

**Figure 3: Air traffic control surveillance image at 0706:56, showing VH-YFN 2.4 NM (4.4 km) from and 800 ft above VH-WYR at Essendon Airport<sup>12</sup>**

<sup>12</sup> The respective heights are VH-YFN at 2,200 ft, represented by the figure '022' and VH-WYR at 1,400 ft, represented by the figure '014'.

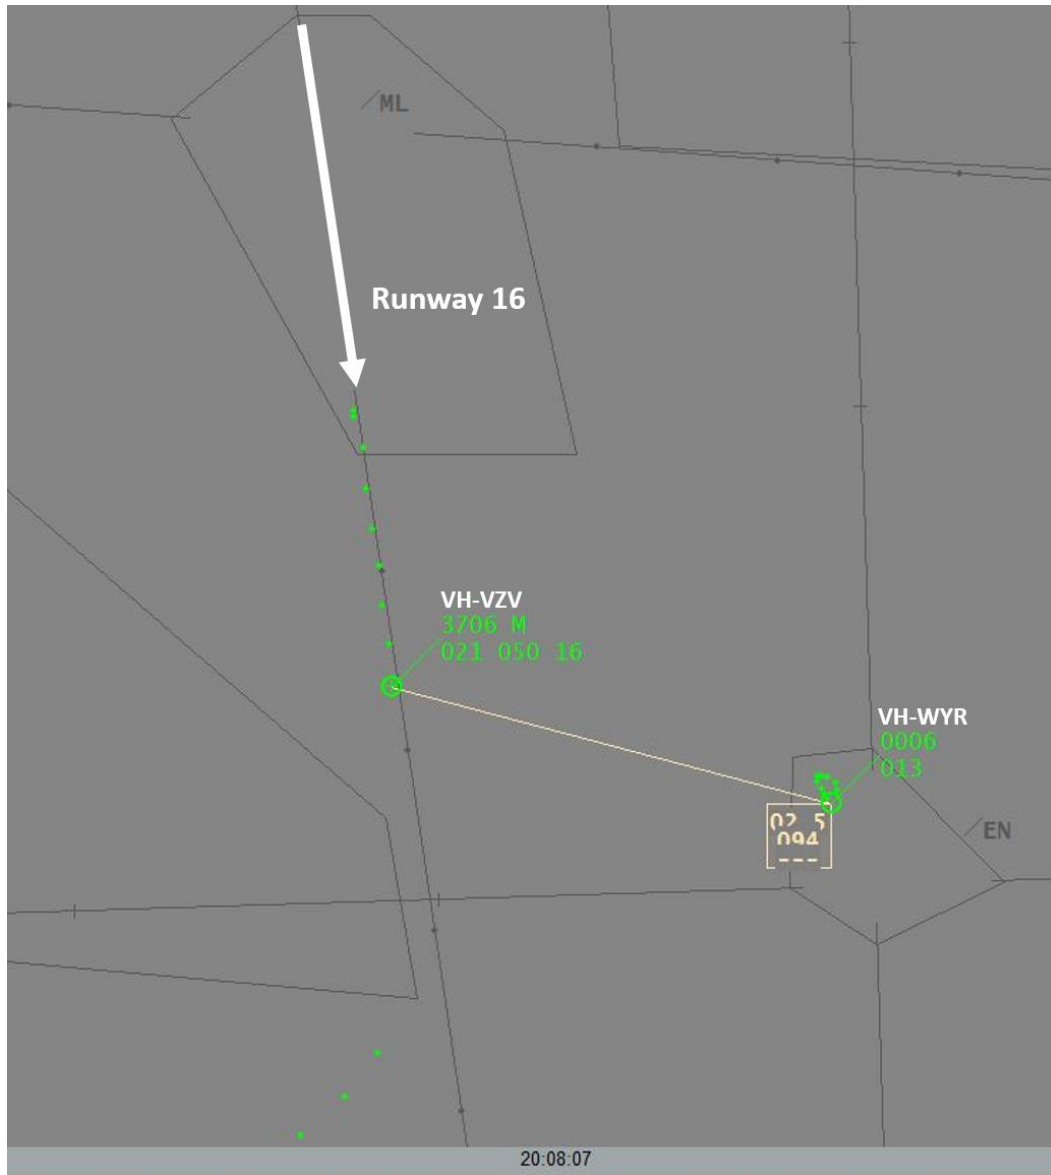
**Figure 4: Air traffic control surveillance image at 0708:07, showing VH-VZV 2.5 NM (4.6 km) from and 800 ft above VH-WYR at Essendon Airport<sup>13</sup>**

<sup>13</sup> The respective heights are VH-VZV at 2,100 ft, represented by the figure '021' and VH-WYR 1,300 ft, represented by the figure '013'.
