# Loss of control and collision with water involving Piper Aircraft Corp PA-28-235, VH-PXD

33 km SSE of Avalon Airport, Victoria on 29 January 2016

**ATSB Transport Safety Report**  
Aviation Occurrence Investigation  
AO-2016-006  
Final – 28 June 2017

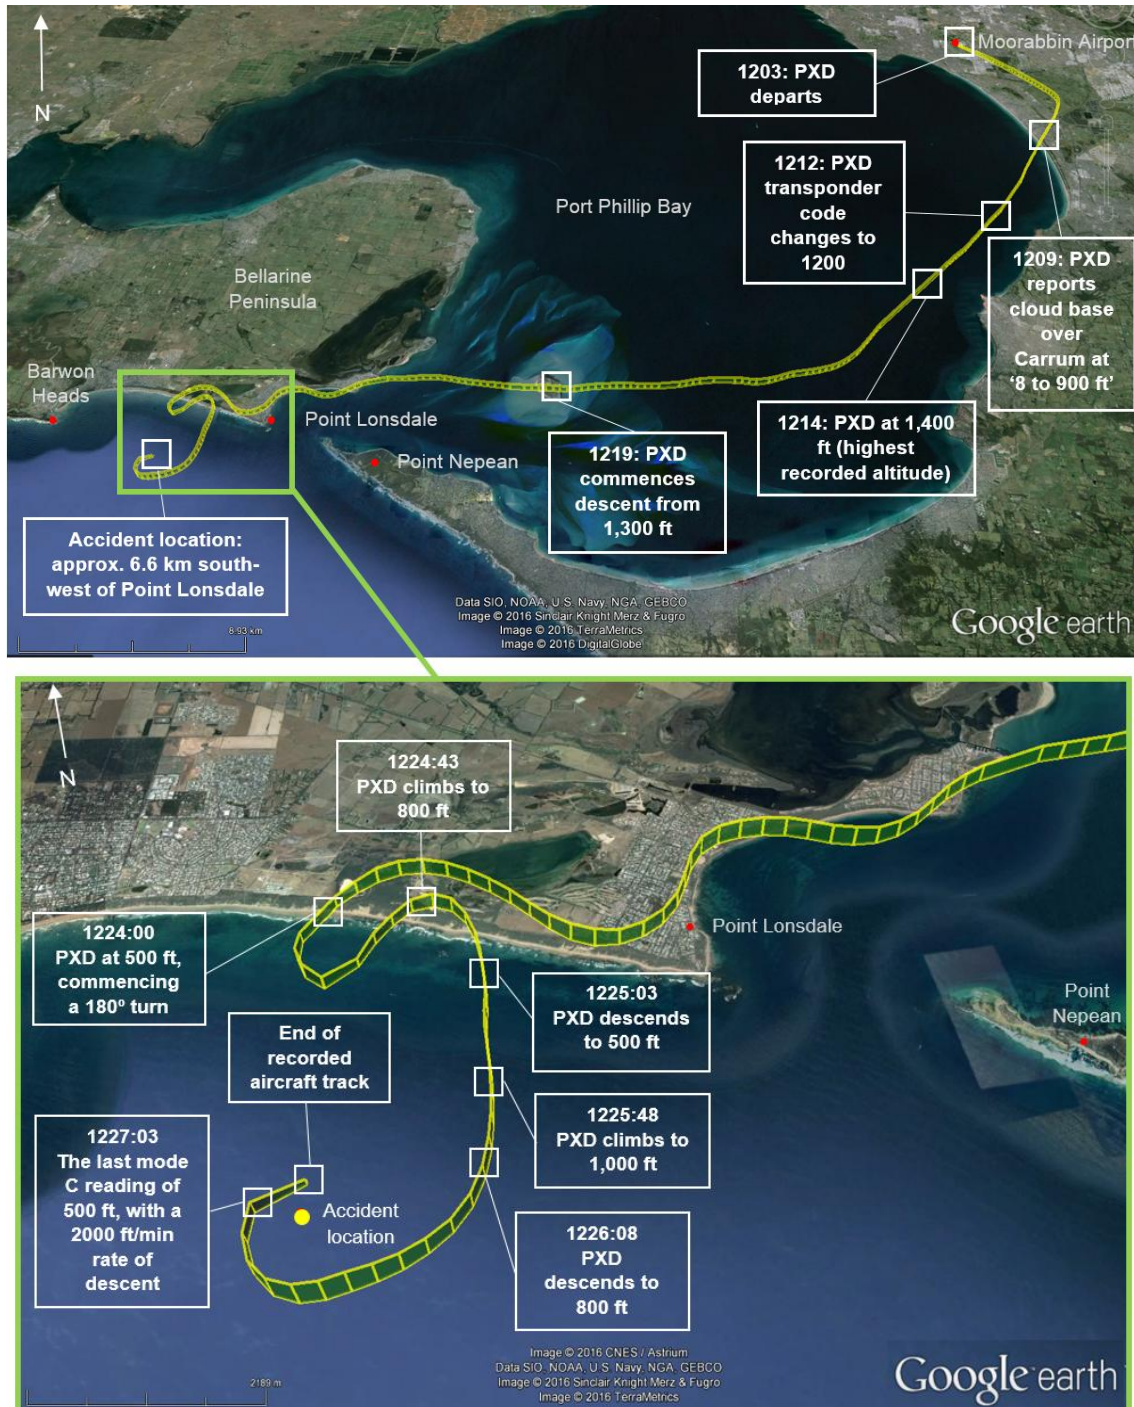
**Figure 1: PXD's track from Moorabbin Airport until the collision with water near Point Lonsdale with the area between Point Lonsdale and the impact with the water at inset.**  
**Noteworthy pilot actions and other observations are annotated.**

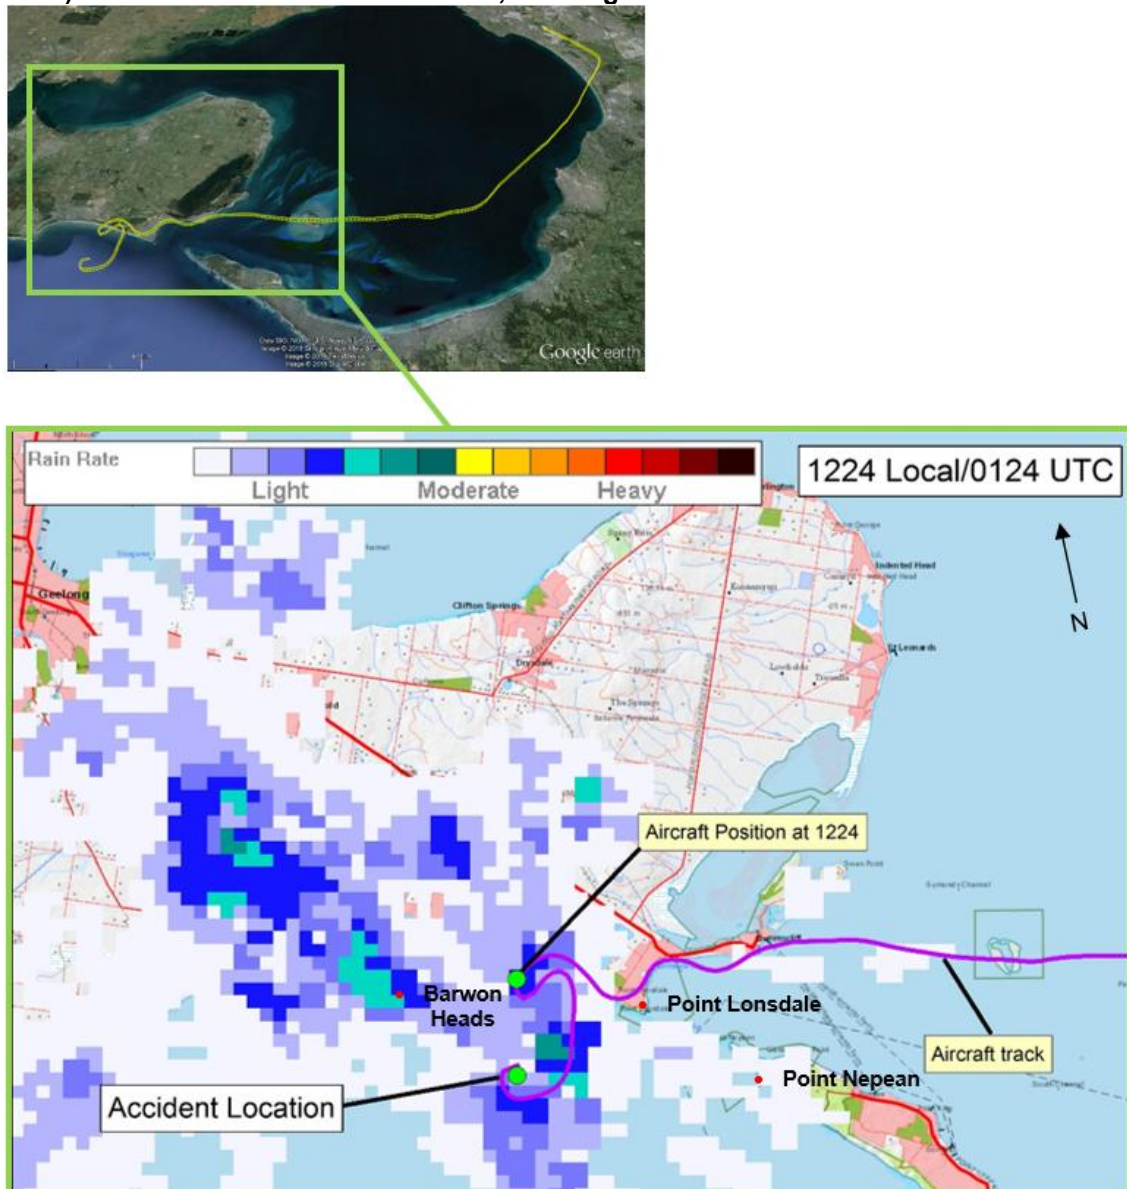
**Figure 4: Weather radar recording (orientated with reference to a Google earth map at inset) and associated 'Rain rate' at 1224, showing the aircraft's track**

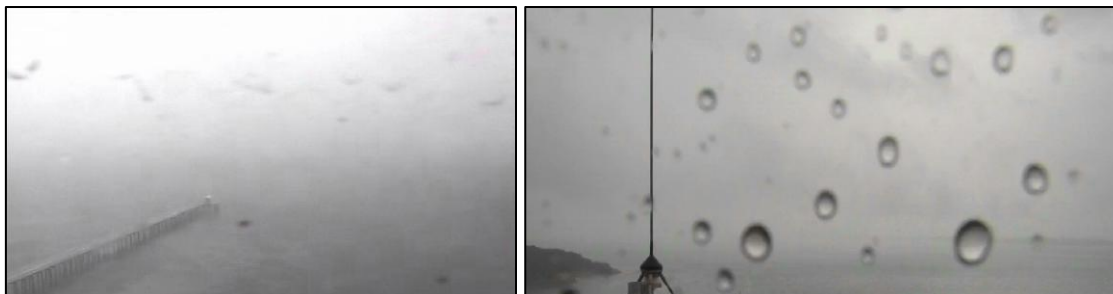
Closed-circuit television images from Port of Melbourne cameras facing east across the water from Point Lonsdale, and north from Point Nepean both showed drizzle, light rain and reduced visibility including little natural horizon as PXD tracked south along the eastern shore of Port Phillip Bay (Figure 5).

**Figure 5: Still images taken at 1215 from two different closed-circuit television cameras owned by the Port of Melbourne. One camera (left image) was positioned on the Point Lonsdale lighthouse facing east. The other camera (right image) was positioned at Point Nepean, facing north. The image quality is affected by contaminants on the camera lens, but the extent of the low visibility conditions in the area is evident**

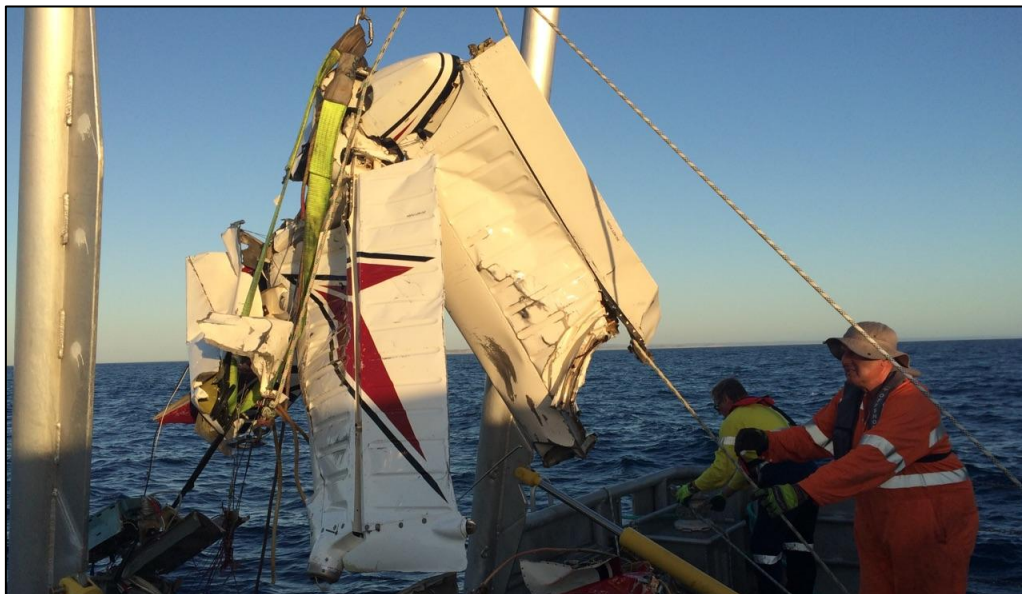
**Figure 6: Recovery by Victoria Police of the aircraft's fin and left horizontal stabiliser**

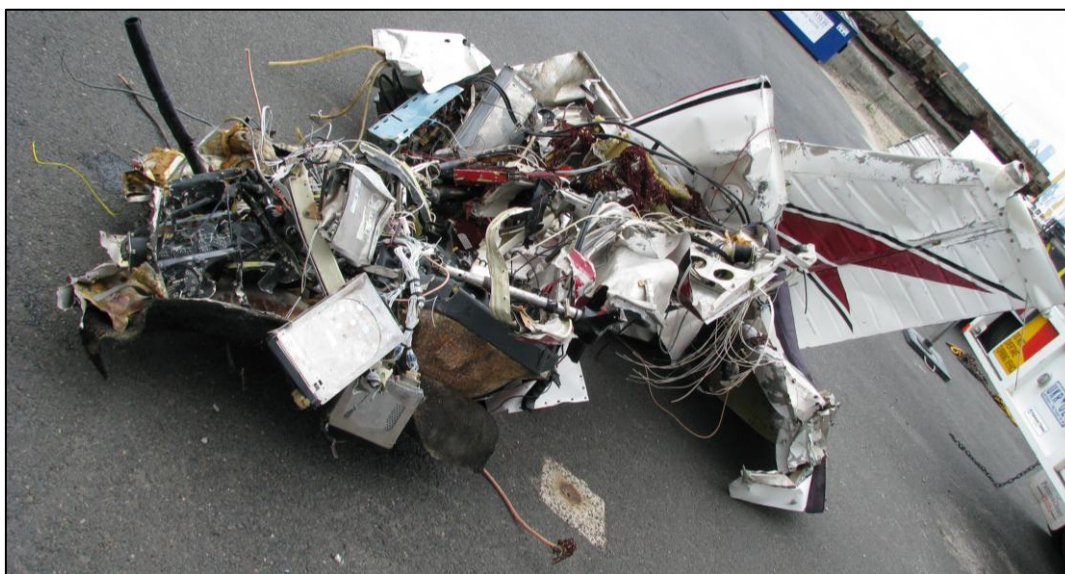
All identified fracture surfaces throughout the recovered wreckage were consistent with overload failure as a result of the impact with water. There was no evidence of pre-existing damage to the airframe, or failure of the primary control systems that may have contributed to the accident. However, the aircraft wreckage exhibited severe disruption.

Some components, such as the engine carburettor, right horizontal stabiliser assembly and left and right wing structures were not recovered.

**Figure 7: Some of the recovered aircraft wreckage. Note the extent of the disruption of the airframe**

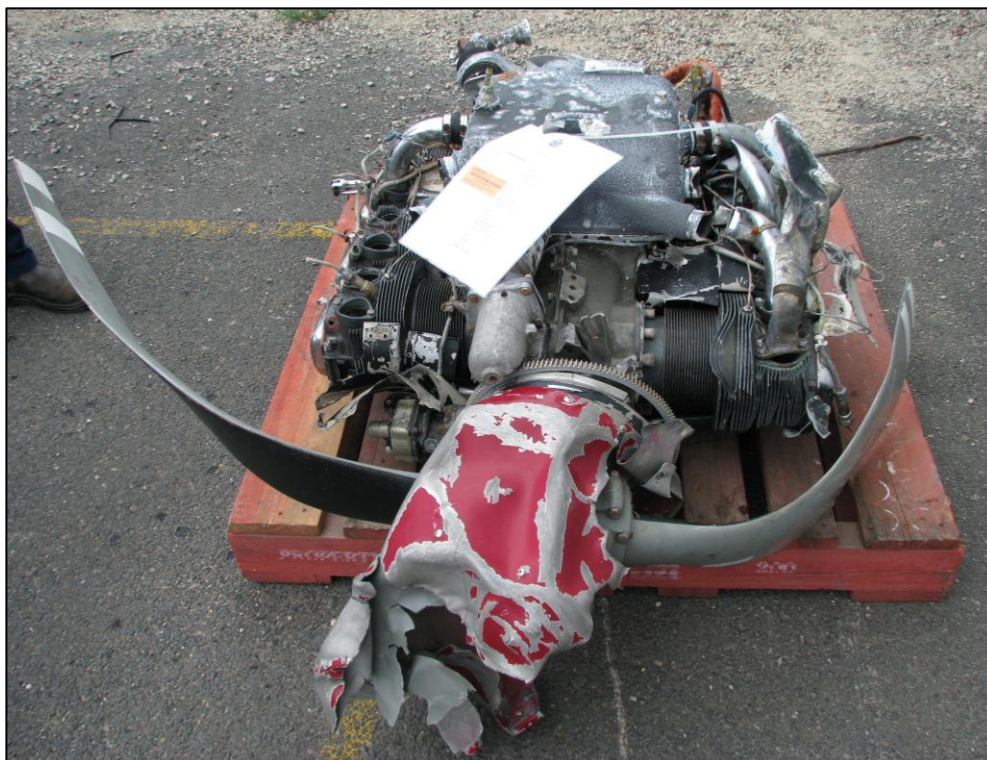
A detailed inspection of the engine and propeller was conducted in a CASA-approved maintenance facility. Nothing was identified during that inspection that may have contributed to the accident, or would have prevented the engine and propeller from normal operation.

**Figure 8: Recovered aircraft engine, propeller and propeller spinner, looking at the lower surface of the engine**
