# Wirestrike and collision with terrain involving Bell 206B helicopter, VH-WHU

near Carmila, Queensland on 25 March 2016

**ATSB Transport Safety Report**  
Aviation Occurrence Investigation  
AO-2016-027  
Final – 26 June 2017

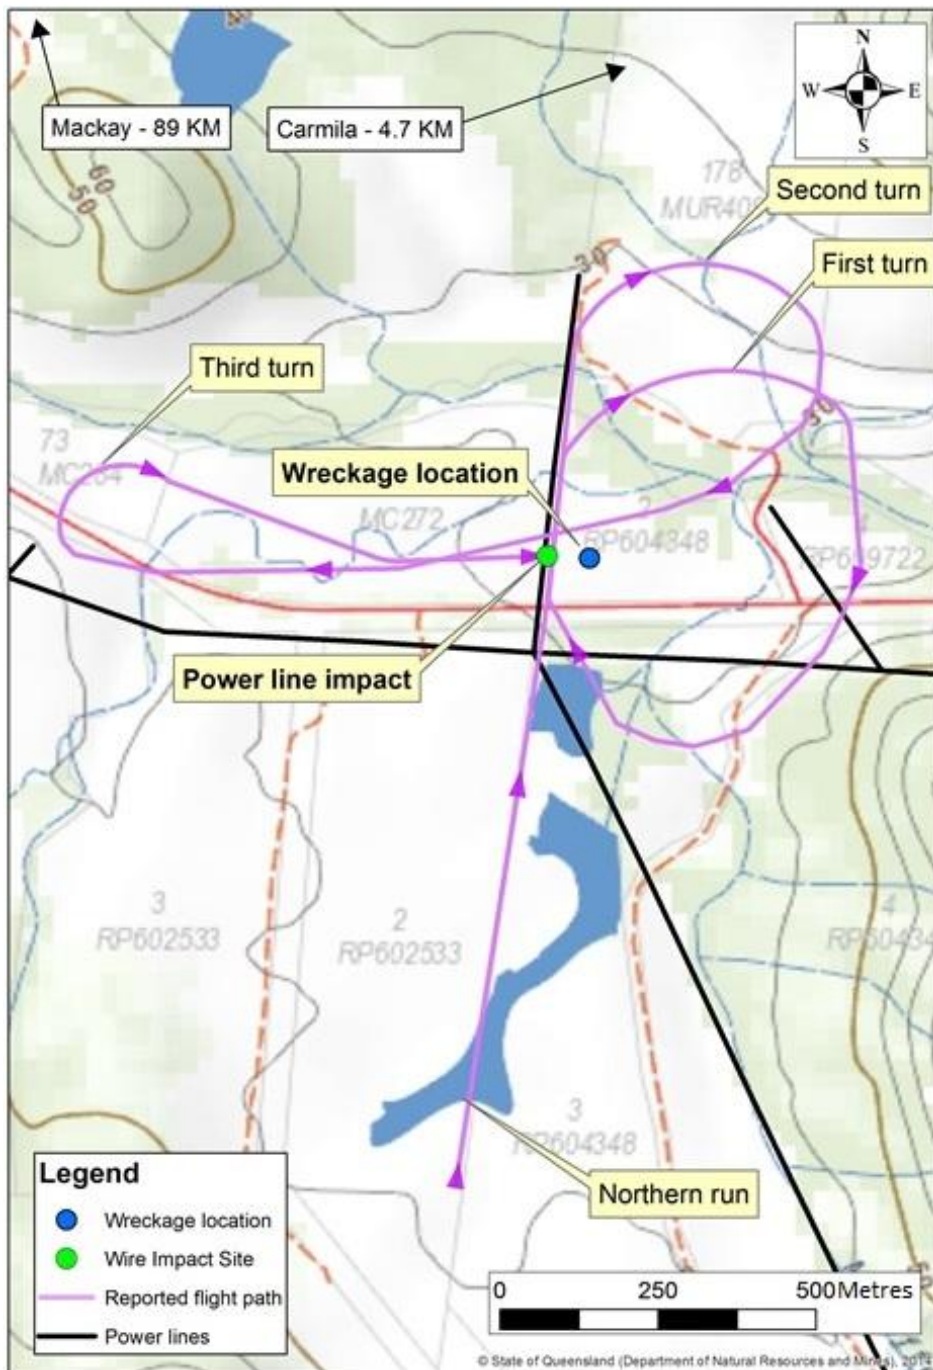
**Figure 1: WHU's flight path, as reported by witnesses**

At about 1028, the helicopter collided with the north-south powerline (Figure 1).

strung north-to-south, rusted and supported by three power poles over a distance of about 386 m (Figure 1). The poles to the north and south were located between tall trees (Figure 3). The centre of these poles was estimated to be about 3–4 m higher than the surrounding cane fields and was situated in a north–south clear area that was used as an access road.

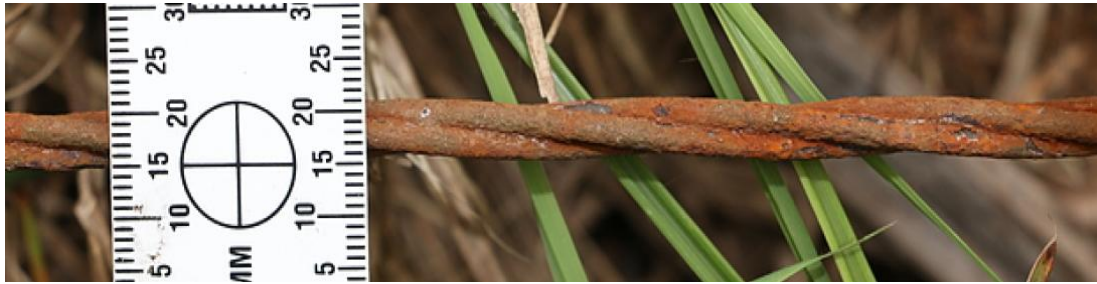
The area being sprayed was divided by powerlines that consisted of three cables, each made from three steel wires twisted together (Figure 2). The powerline that was struck by WHU was

**Figure 2: Power cable consisting of three steel wires twisted together (note the rust-like discolouration)**

- outer supporting power poles were obscured by trees as the pilot approached them, negating one of the visual cues often used by pilots to locate powerlines
- luminance of the power cables was reduced by their rust-like discolouration, reducing the likelihood of their detection by the pilot
- powerlines were not marked, and were not required to be marked, with visibility devices
- contrast in texture between the background and the powerline was decreased, including by a sugarcane field, rising terrain and a tree-lined creek. In combination, these features resulted in a camouflaging effect.

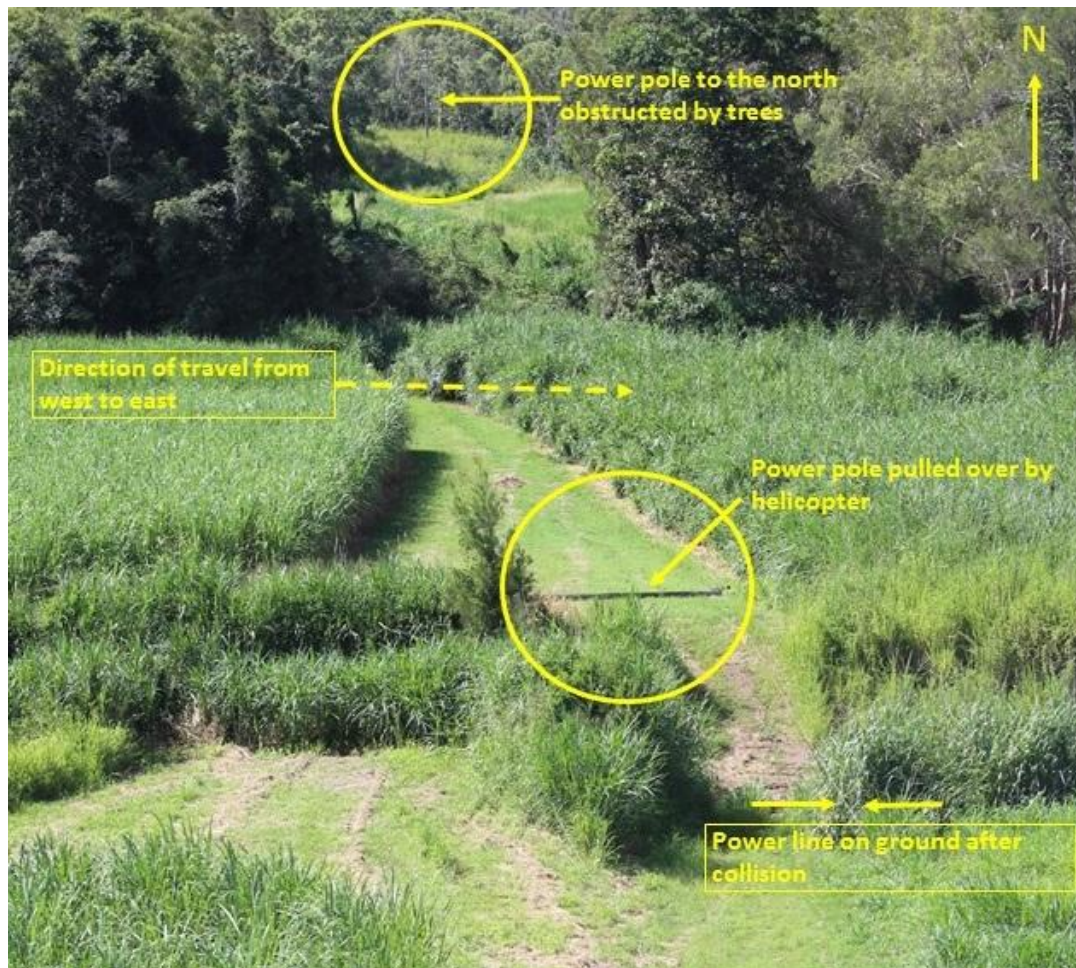
Given the approximate 8 m height of the centre pole, and the normal spraying height of the helicopter, there was the potential for the pole to have been masked by the trees and rising terrain to the east of the powerline. The powerlines were not marked with visibility devices, nor were they required to be by regulation.

**Figure 3: Terrain in the vicinity of the powerline, showing the helicopter's direction of travel and the powerline and associated poles. Note the power pole that has been pulled down as a result of the wirestrike (centre of the picture) and the tree-lined creek that tracks right to left (located towards the top of the figure)**

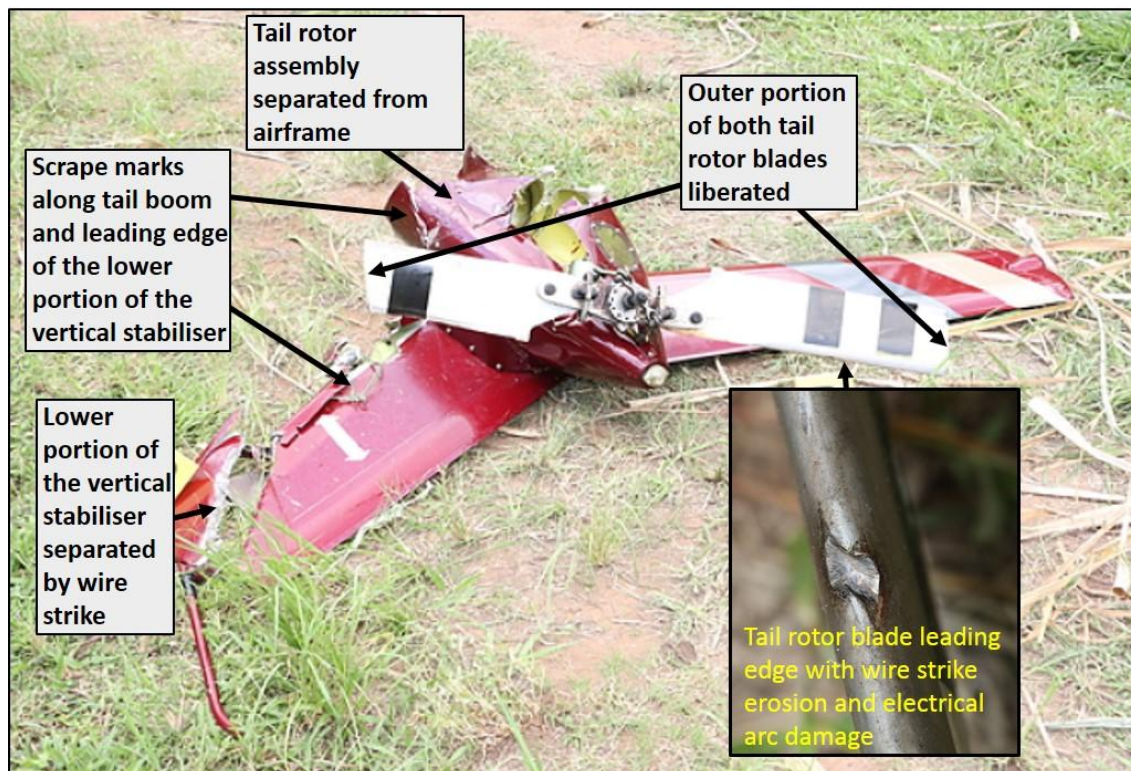
The vertical stabiliser and tail rotor assembly fractured from the boom during the accident sequence and were found about 30 m from the main helicopter wreckage. Scrape marks and gouging identified along and around the tail rotor section was consistent with colliding with a wire.

The lower portion of the vertical stabiliser displayed uneven, high-energy impact damage. The composite structure was abraded, roughened and had separated from the vertical stabiliser assembly. This was consistent with one of the powerline cables ‘pulling through’ the stabiliser during the impact sequence. The outer portions of both tail rotor blades were fractured and gouged, also consistent with colliding with one of the power line cables before separating from the tail rotor assembly (Figure 4). The liberated outer portions of the tail rotor blades were not recovered.

**Figure 4: Separated tail rotor assembly, showing the liberation of the outer portion of both tail rotor blades, electrical arcing to the leading edge of one tail rotor blade (at inset) and the separated lower portion of the vertical stabilizer**

Evidence of scraping along the tail boom, the damage to the lower vertical stabiliser and the separation of the outer portion of the tail rotor blades indicated that WHU struck the powerline in a nose-up attitude. This would be consistent with the pilot taking action to avoid a wirestrike, but likely contributed to the wire passing underneath the lower component of the helicopter's wirestrike protection system and striking the tail rotor and stabiliser assembly. The tail rotor and stabiliser assembly separated from the helicopter's tail boom, resulting in a loss of directional
