# Tail strike on takeoff involving Airbus A320, VH-VGF

Melbourne, Victoria, 11 May 2016

**ATSB Transport Safety Report**  
Aviation Occurrence Investigation  
AO-2016-046  
Final – 4 September 2017

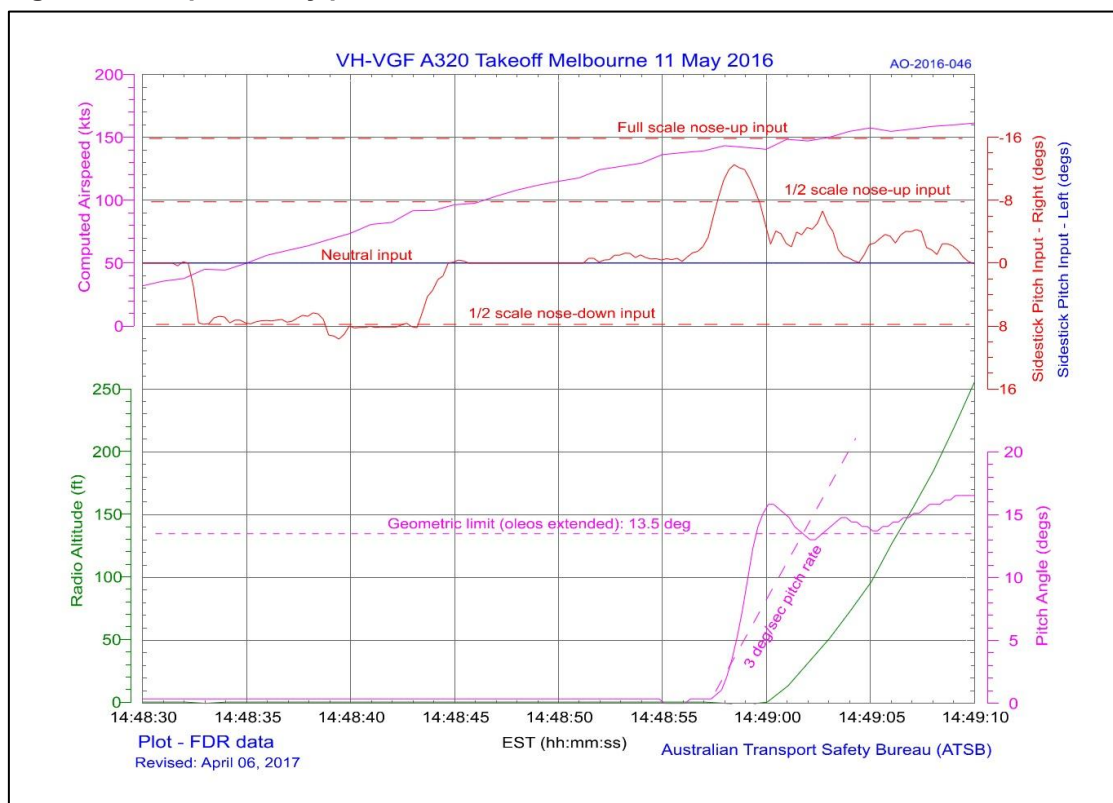
**Figure 1: FDR plot of key parameters**

The aircraft taxied onto runway 27 and the takeoff commenced at 1448. The sidestick data shows that the pilot in the right seat (cadet) was the PF. At approximately 40 kt, a nose-down sidestick input was made and this input remained until the aircraft had accelerated to 100 kt. The sidestick pitch input was then neutral until approximately 140 kt when a nose-up input commenced. The nose-up input reached a maximum value of 12.5° or 78 per cent of a full-scale input. The aircraft rotated with a pitch rate of about 9 deg/sec reaching a maximum pitch attitude of 16°. The sidestick input was then reduced and the aircraft's pitch attitude correspondingly reduced.

During rotation, the cadet pilot applied a larger than normal pitch input (3/4 backstick versus the recommended 1/2 to 2/3 of backstick travel) resulting in an excessive pitch rate during rotation (9 deg/sec versus a target of 3 deg/sec).

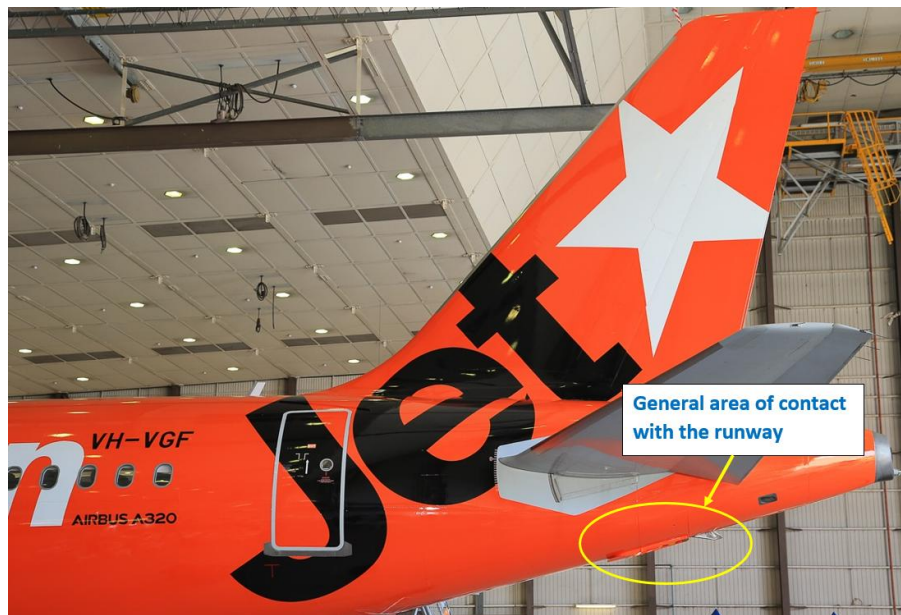
**Figure 2: General location of damage**

After landing, engineers inspected the tail of the aircraft (Figure 2). Damage to the APU diverter (air inlet) and APU drain mast was evident (Figure 3). This damage was consistent with the aircraft tail contacting the runway surface.

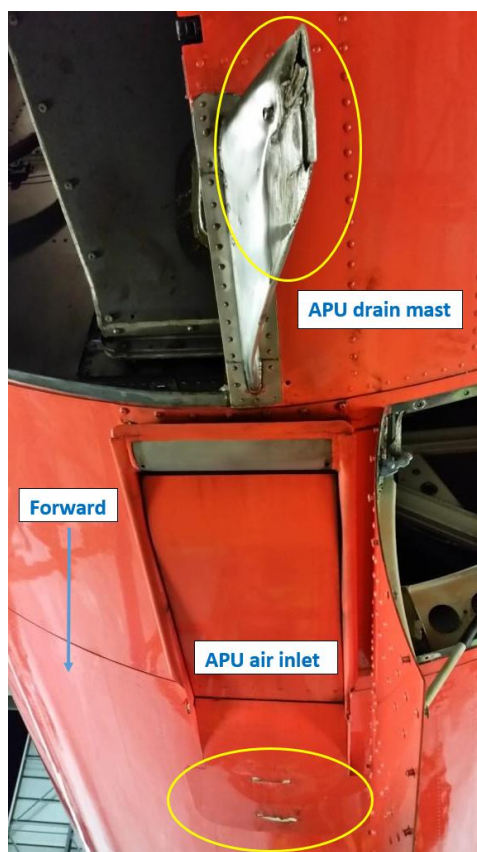
**Figure 3: Damage to aircraft tail section (circled). Note: access doors are open for inspection**

- The cadet pilot applied a larger than normal sidestick pitch input to initiate rotation. This resulted in a high rotation rate during the take-off and the aircraft's tail contacted the runway.
