# Breakaway of *Spirit of Tasmania II*

Station Pier, Port Melbourne, Victoria 13 January 2016

**ATSB Transport Safety Report**

324-MO-2016-001

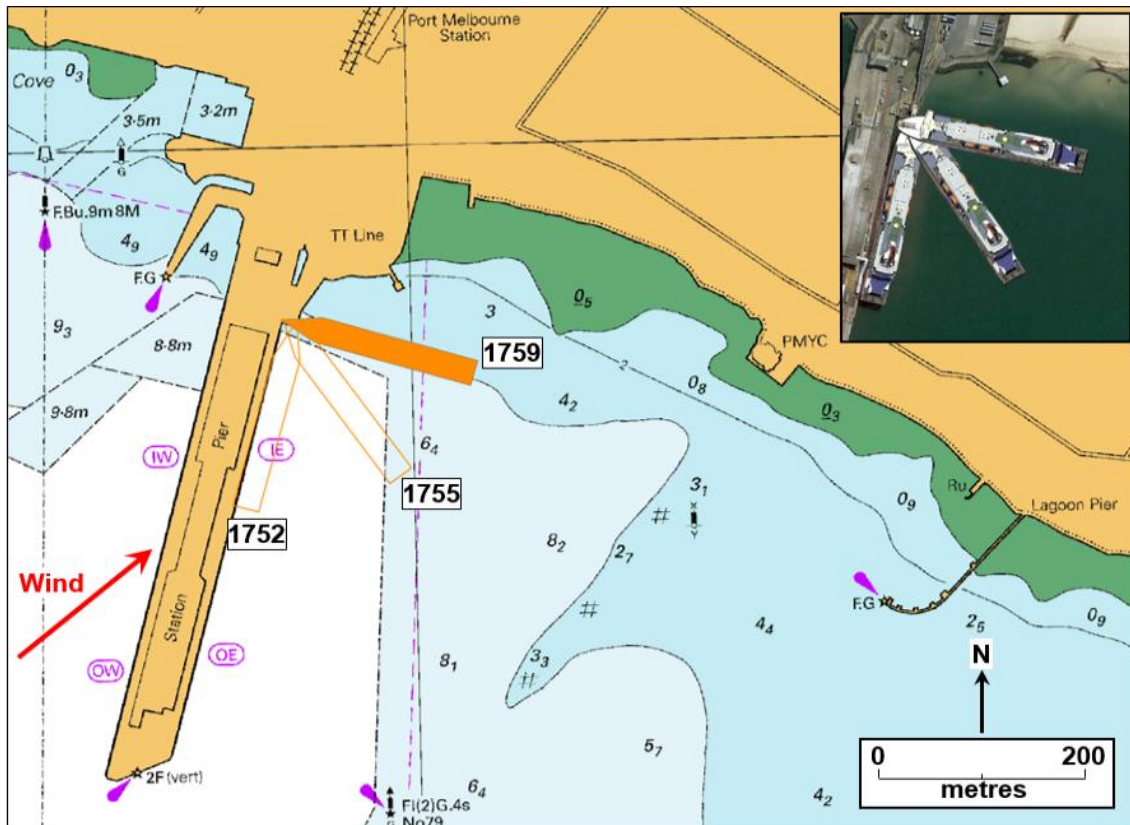
Figure 4: Section of navigational chart Aus 154 showing the ship's breakaway

With the strong winds pushing the stern away from the wharf, the ship's aft mooring lines failed in rapid succession. The ship pivoted about its bow and swung away towards the shore (Figure 4).

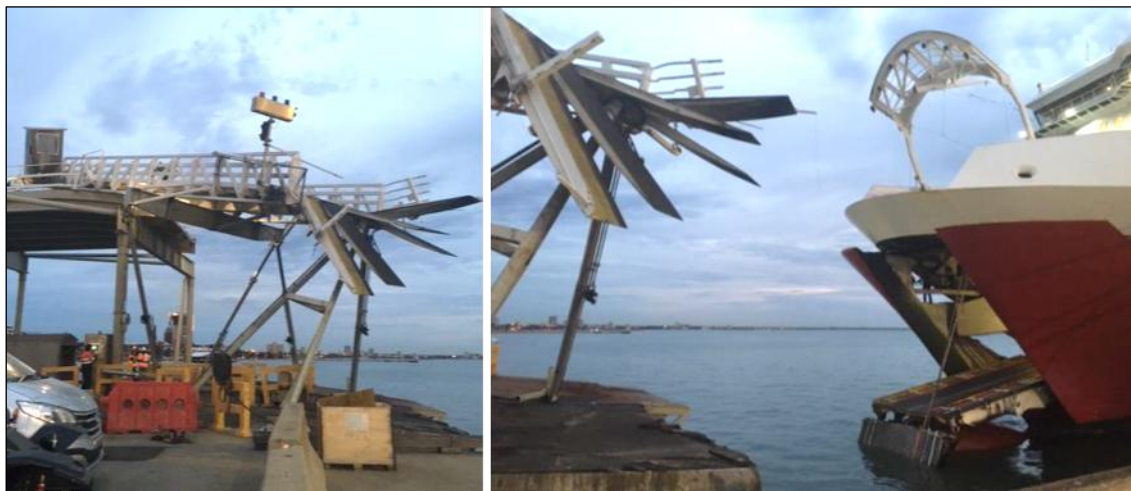
**Figure 5: *Spirit of Tasmania II*'s damaged upper bow ramp (skybridge)**

When *Spirit of Tasmania II* had turned off the wharf, its starboard bow door had come to rest against the wharf structure. Weight had then come onto it and pushed it against the lower bow ramp, resulting in damage to a number of its door operating components. The hydraulic system used to operate the doors was not damaged. As the lower bow ramp moved off and under the wharf, its end fingers were damaged as they made contact with the wharf piles. The upper vehicle ramp suffered extensive damage (Figure 5) requiring it to be removed from the wharf and taken away for repairs.

Inspections and repairs as required by the Australian Maritime Safety Authority, the ship's flag State authority, and its classification society were then undertaken. On 17 January, 4 days after the incident, *Spirit of Tasmania II* returned to service.

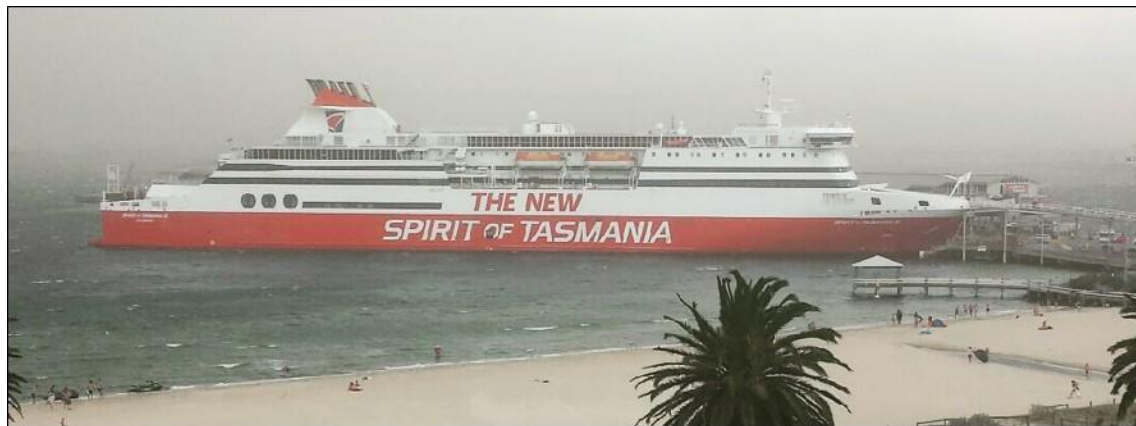
**Figure 8: *Spirit of Tasmania II* adjacent to Port Melbourne Beach**

By 1759, the ship lay at right angles to the wharf and parallel to Port Melbourne Beach (Figure 8). While waiting for tugs to assist, the ship's propulsion was used to maintain its position and prevent grounding. By 1905, the ship was back alongside Station Pier with the two tugs assisting. No one was injured and damage was limited to the ship's bow ramp and doors.

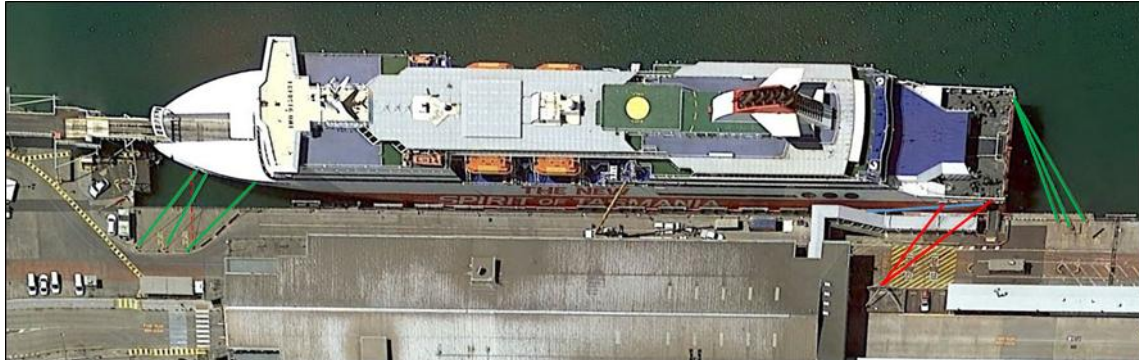
**Figure 10: *Spirit of Tasmania II*'s mooring lines as run on 13 January (lines highlighted)**

At the time of the breakaway, all stern lines were held on the winch brake. The winches holding both aft breast lines were set to self-tension. The self-tension setting was reported to have been between 80 and 100 per cent of the winches' rated pull<sup>23</sup> of 15 t.

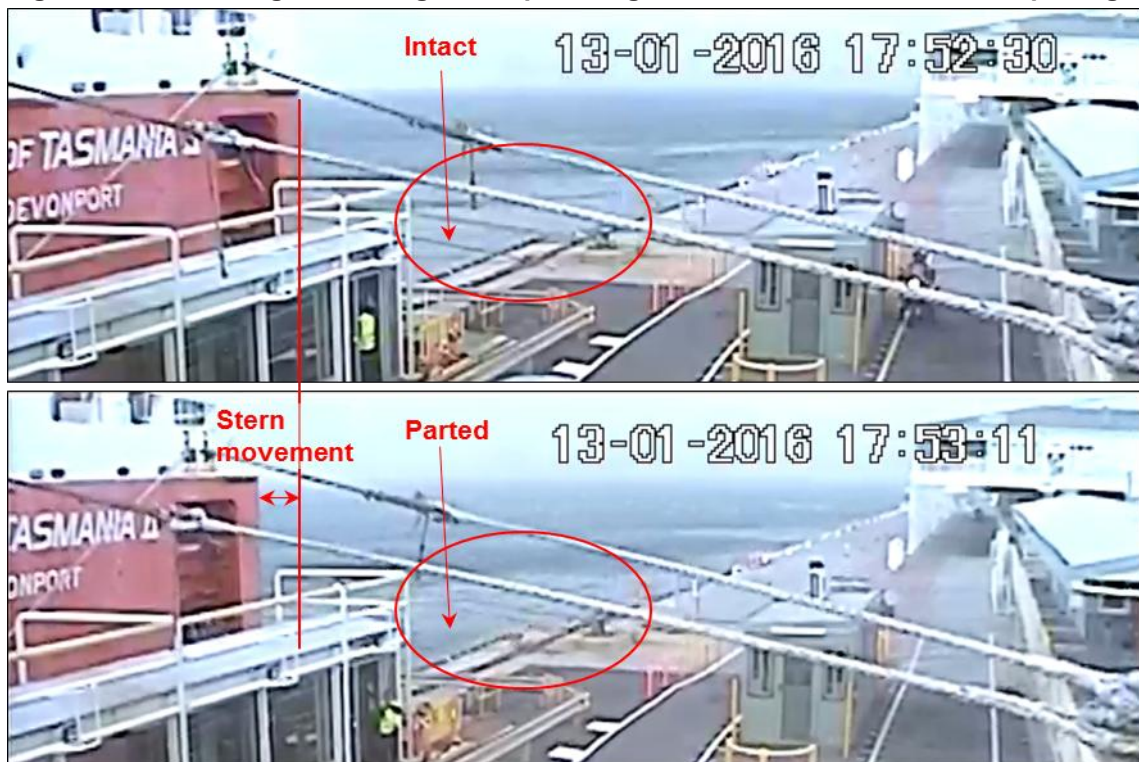
**Figure 11: CCTV images showing the ship moving off the wharf and the first line parting**

The CCTV footage from 1752 shows *Spirit of Tasmania II*'s stern moving off the wharf and its aft mooring lines stretching due to the wind loading (Figure 11). By 1753, as the wind was peaking at about 60 knots, the ship's stern was over 4 m off the wharf with the lines considerably stretched as the winch brakes held. Moments later, the shortest stern line parted when it could not stretch any further. As the load transferred to other stern lines, they parted in quick succession.

As the ship's stern was breaking away, the winches holding the breast lines payed out. However, as the ship's movement gathered speed, those lines parted. Two of the three forward head lines also parted during the breakaway.
