# **Derailment of freight train 6DA2**

Near Marla, South Australia, 31 October 2015

**ATSB Transport Safety Report**

RO-2015-020

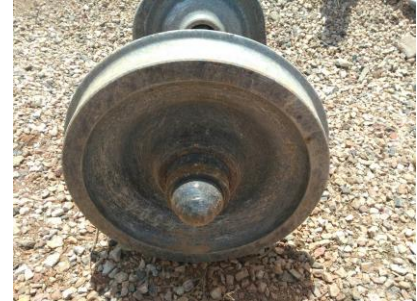
**Screwed journal**

The ATSB found that the journal and bearing on wagon FQWY 12-F had seized and lost interference fit. The loss of interference fit generated high levels of frictional heating between the bearing and the axle journal, and the subsequent torsional shearing failure of the axle (commonly referred to as a 'screwed journal'). The axle failure caused the axle and wheels to stop rotating, resulting in one wheel skidding along the railhead for approximately 50 km, before derailing.

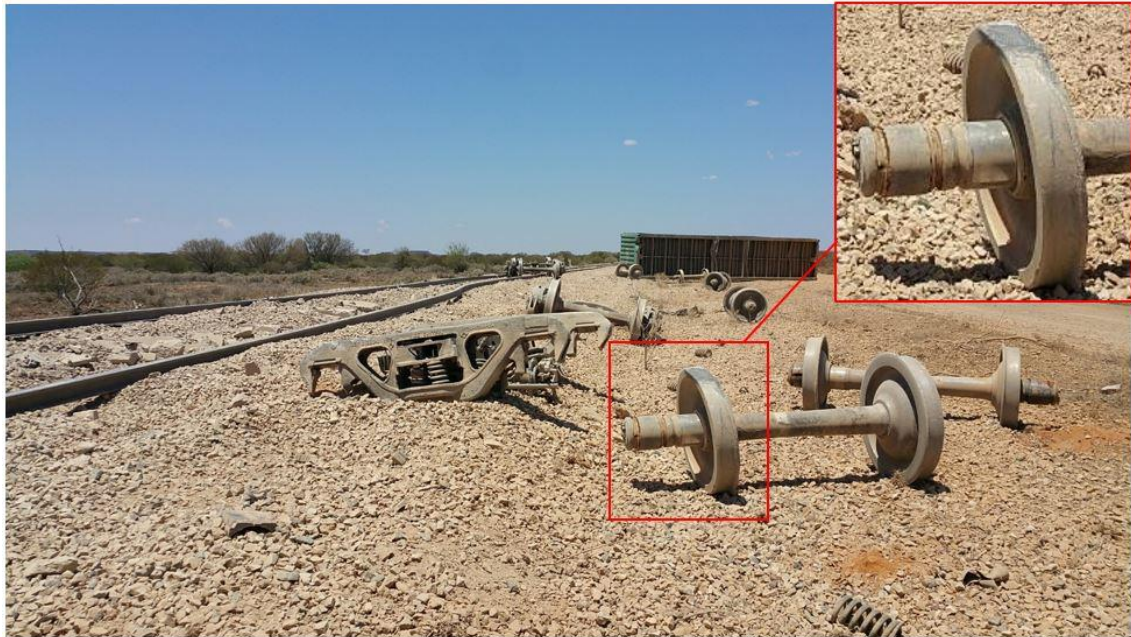
**Figure 3: Photo of derailment site with the screwed journal axle in the foreground**

The observer was tasked to go and inspect the rear of the train. As he walked towards the rear of the train, he found that the rear bogie on wagon FQWY 12-F (fourth-to-last wagon) had dislodged from the platform and was located alongside the track approximately 500m from the rear of the train (Figure 3). The remaining three 2-pack wagons remained upright with all bogies derailed, with some completely removed from their associated platforms. Several containers from the derailed wagons had broken away from the train and landed in the rail corridor. The derailment had also caused significant damage to 12 km of track resulting in mostly cracked sleepers and damage to rail fasteners. There was no spillage of any dangerous goods.

Figure 3 shows the derailment site. The axle in the foreground is the lead axle from the trailing bogie (refer to figure 2) of wagon FQWY12-F which was found to have the screwed journal. The callout box depicts the flat wheel due to the wheel jamming as a result of the screwed journal. Also pictured is the mated bearing on the journal. Obscured from view on the axle is the screwed journal. Source GWA

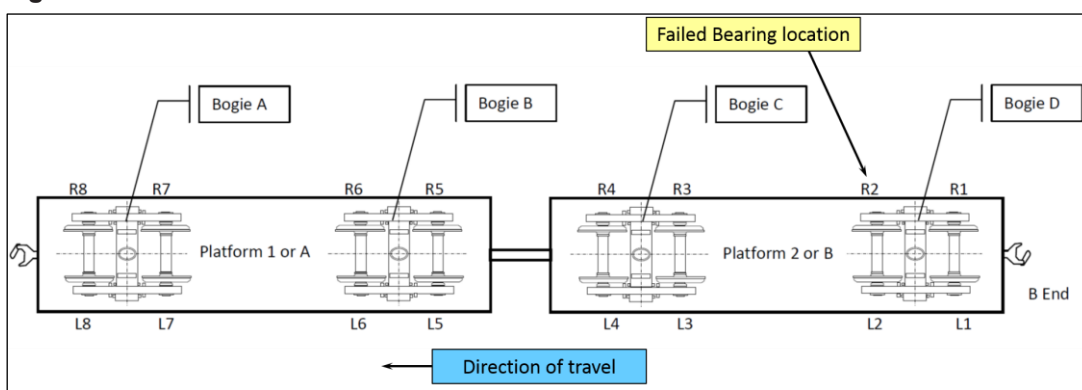
**Figure 4: Schematic of FQWY 12-F**

The R2 axle bearing on platform two bogie D failed. The wheelset was the leading axle on bogie D in the direction of travel. Source: Genesee Wyoming Australia Pty Ltd and annotated by ATSB

The failed axle was the lead axle on the rear bogie (Bogie D). At the time of the derailment the train was traveling at approximately 82 km/h. A 6.45 t container was loaded on platform A and an 11.8 t container loaded on platform B.

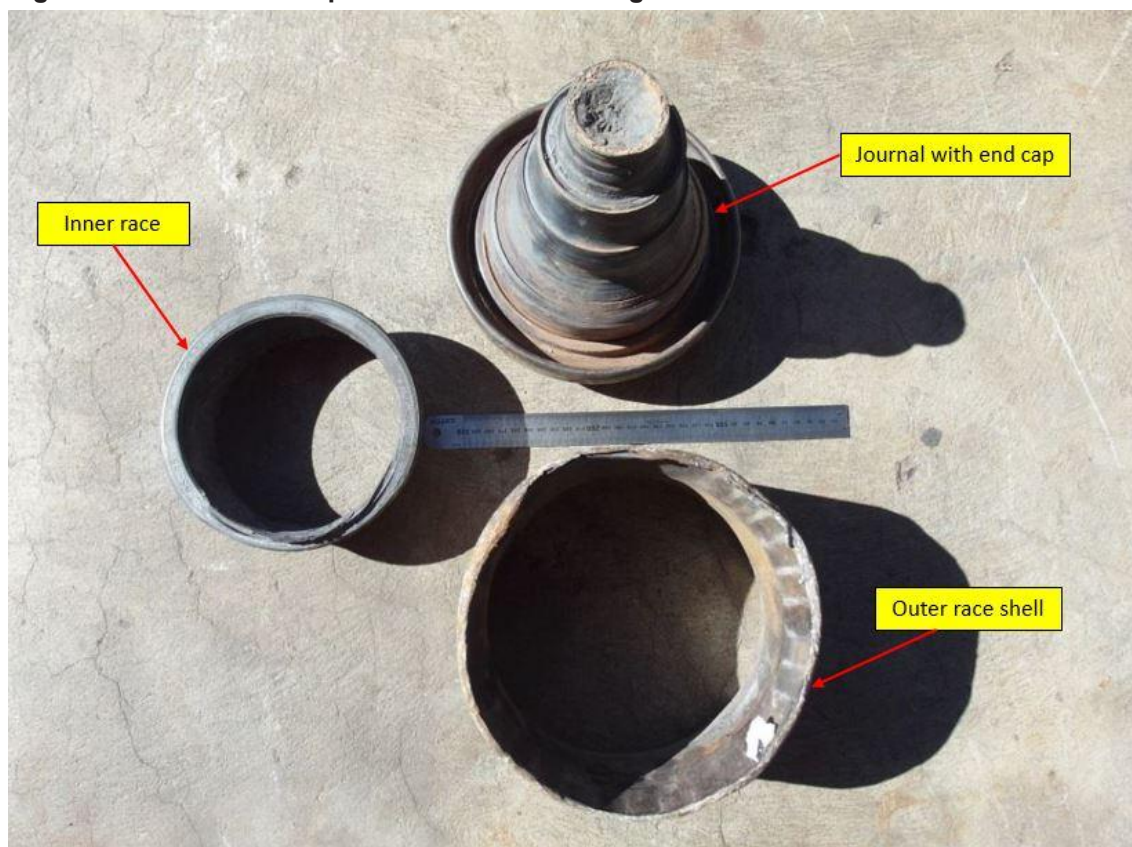
**Figure 6: Recovered components of failed bearing**

It was evident that a bearing on the wagon had failed and completely seized, causing the inner raceway to loose interference fit and spin on the axle journal. This generated and transferred sufficient heat into the journal to reduce its strength, make it 'plastic', and caused it to separate from the axle (an event commonly referred to as a *screwed journal*).

The remaining components of the failed bearing above were retrieved from site and was inspected and analysed by the Bureau Veritas Source: Genesee & Wyoming Australia and annotated by ATSB.

Examination of the inner race of the failed bearing found stamping from SKF (Sweden). There was evidence of significant heat damage and significant amount of mill scale (flaky surface, often found on hot rolled steel), suggesting a long period of exposure to high temperatures.

Examination of the outer race was unable to identify any stamping. There was significant mechanical and thermal damage to the surfaces, as well as a build-up of mill scale. Marks found around the race suggested post incident false brinelling<sup>7</sup>. An area of spalling was also noted on the rolling surface of the outer race, though this was partially obscured by post failure surface damage.

The Bureau Veritas concluded that the most likely contributor to the bearing failure was a lubrication supply issue. This may have been due to either seal failure or inadequate lubrication at the time of assembly of the bearing package. The seal was not recovered so could not be examined to determine its condition and the possibility that it may have failed prior to the derailment.

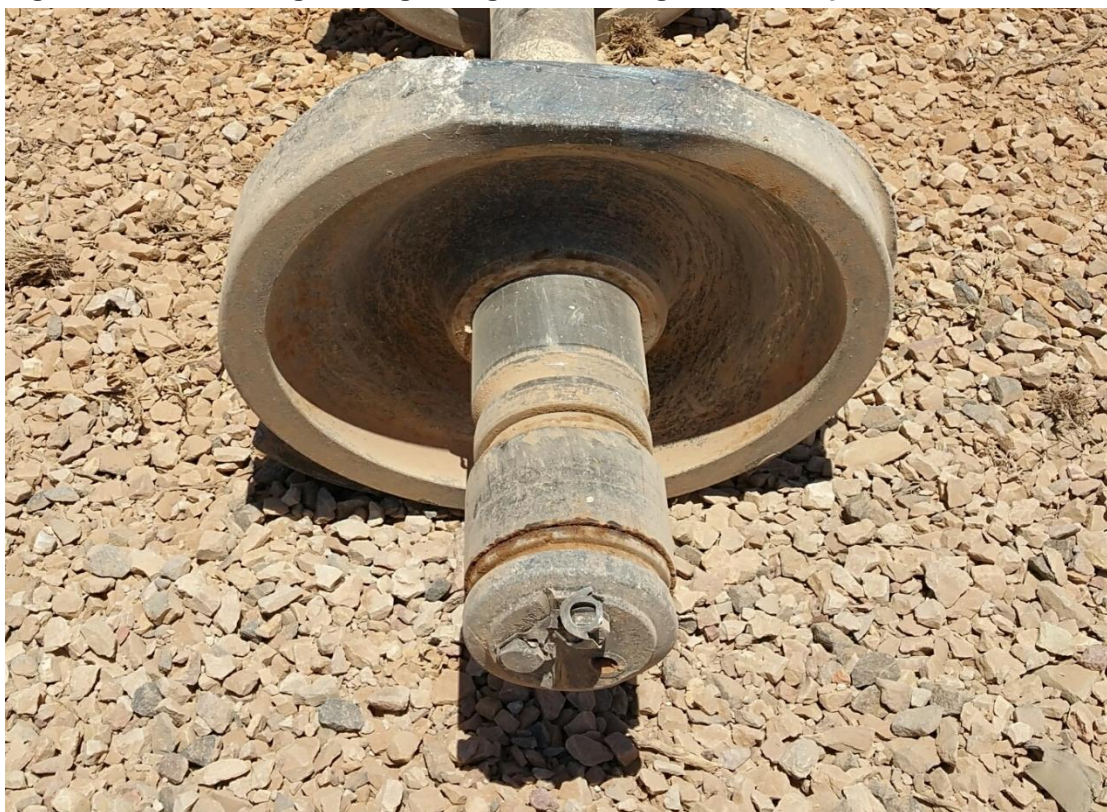
**Figure 7: Mated bearing with signs of grease leaking from end caps**

The examination also included the partner bearing from the opposite end of the axle, and found it to be in good order. The amount of grease in the mated bearing was only a light application and contained small amounts of sand. The Bureau Veritas estimated conservatively that there was less than 200 grams of grease in the bearing as supplied (approximately 50% when compared to

Both grease seals were present and intact, though post derailment observations show the end seals of the bearing appearing to be 'wet' which indicates that some grease may have been liberated during the derailment. It could not be determined how much grease was installed in the bearing. However, it is likely that some grease from the mated bearing was lost as a result of the derailment.

Figure 7 shows that the end seals of the bearing appearing to be 'wet' which indicates that some grease may have been liberated during the derailment. This also indicates that there may have been a failure in the bearing seal. Source: Genesee & Wyoming Australia
