# **Derailment of freight train 9T92**

Near Julia Creek, Queensland, 27 December 2015

**ATSB Transport Safety Report**

RO-2015-028

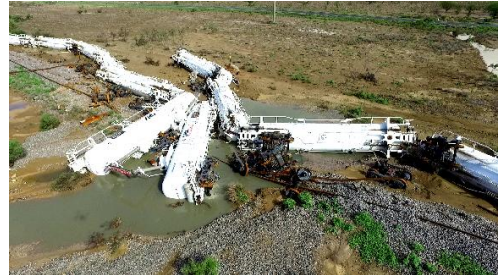
### Derailment at track washout

As these inspections were occurring, train 9T92 continued travel toward Julia Creek from the east. Shortly after passing through a section of track where floodwaters had previously overtopped the track and receded, the crew of train 9T92 encountered another area where floodwater had overtopped the track. At this location, however, the floodwater had scoured the ballast and compromised the integrity of the track.

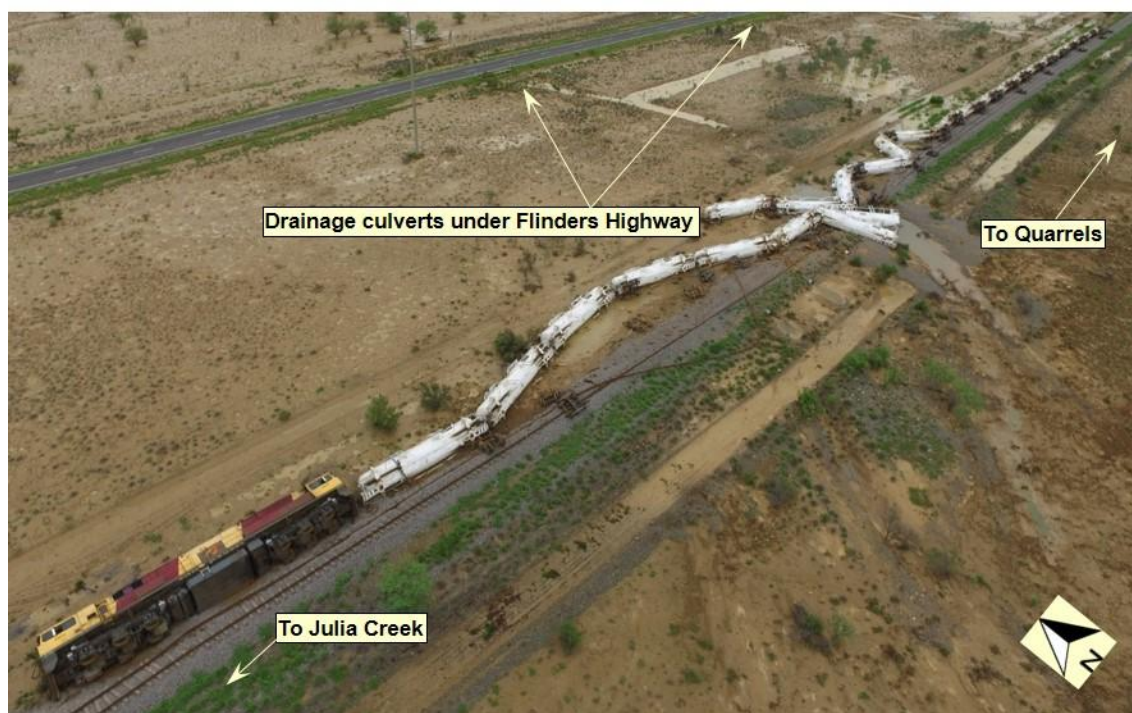
**Figure 2: Derailed train 9T92**

The derailed locomotive 2814 and 26 trailing tanker wagons of 9T92 laying to the north of the railway about 20 km east of Julia Creek. The floodwaters present at the time of derailment had receded, however pooled water is still visible in the drainage channels from culverts under the Flinders Highway leading toward the washout of the track formation. Source: Queensland Police Service

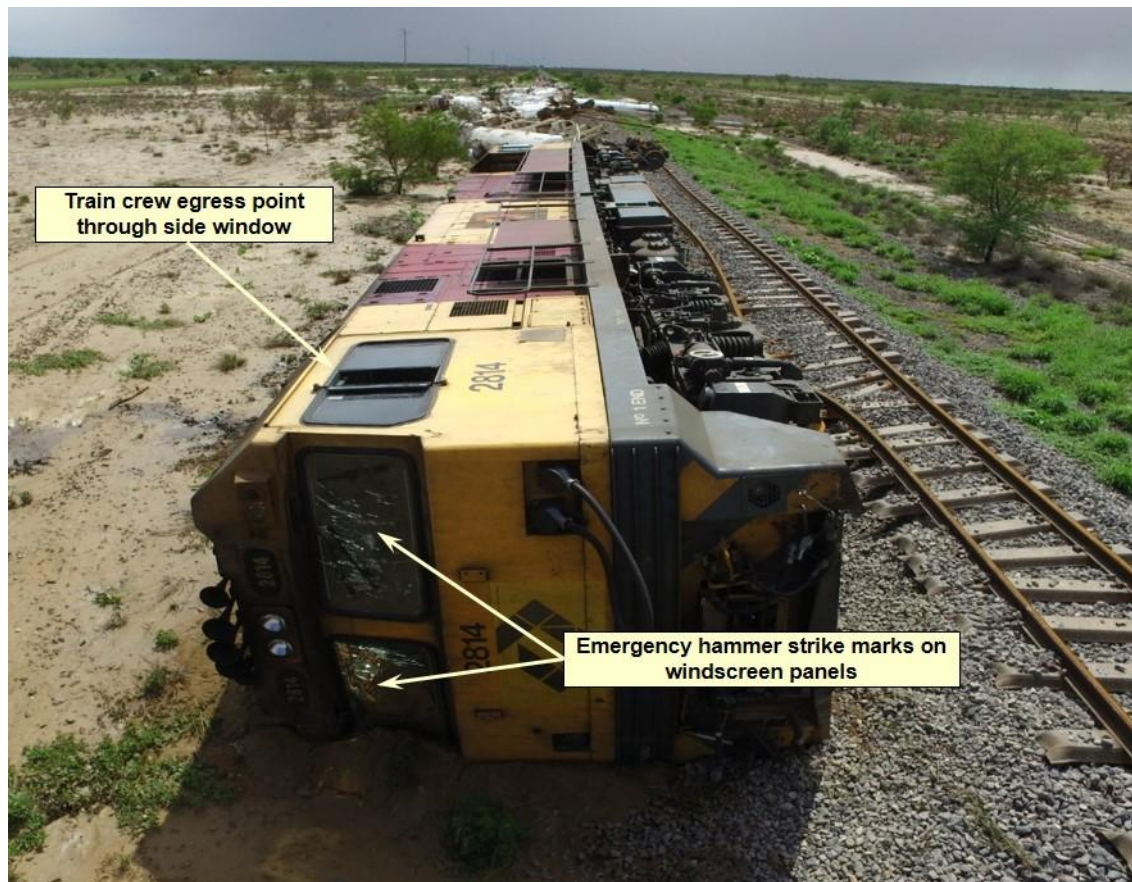
**Figure 3: Derailed locomotive 2814**

Immediately after the derailment, floodwater entered the cabin, before settling to a depth of about 600 mm. To escape the cab, the train crew attempted to break the front windscreens using the emergency hammer. After repeated strikes, they were unable to open an escape route through the windscreens, so the crew decided to climb up and out of the locomotive's side window (Figure 3).

Derailed locomotive 2814 situated on the northern side of the track. The damage to the inside surface of both windscreens was from numerous strikes using the supplied emergency hammer. The train crew were unable to break out the windscreens. The train crew escaped from the locomotive through climbing up and out the sliding side window. Source: Queensland Police Service

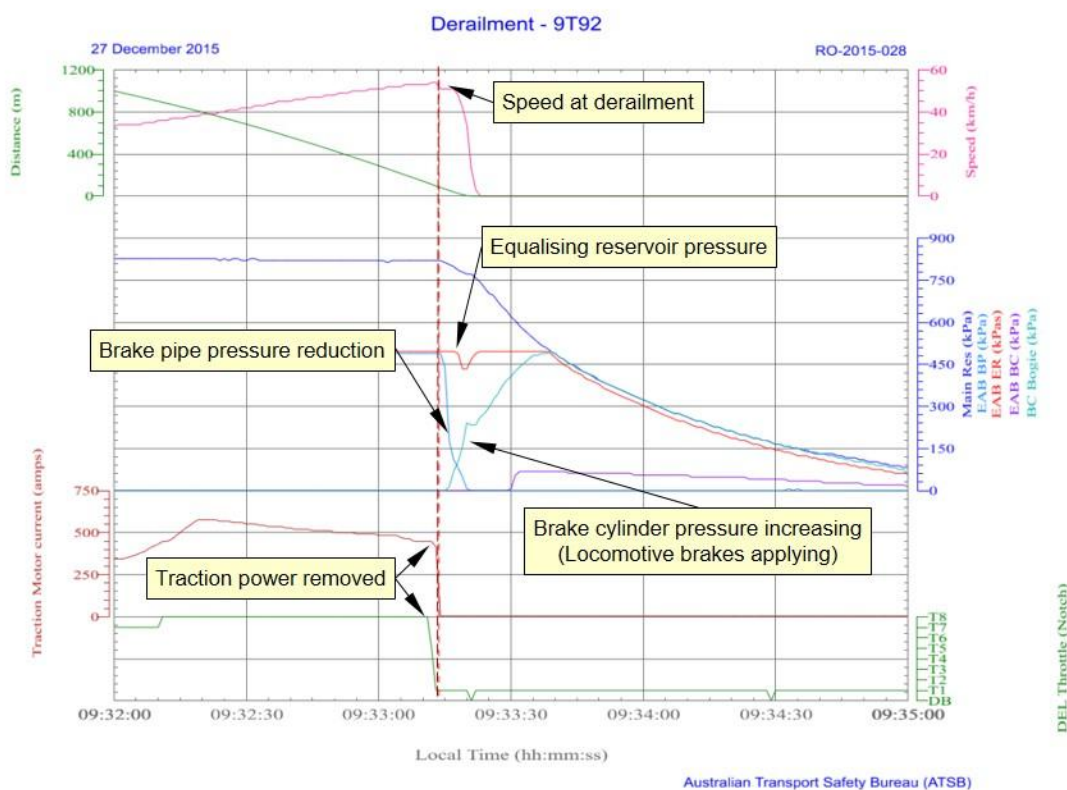
**Figure 4: Locomotive 2814 data log plot**

Plot of locomotive 2814 data log parameters. Plot illustrates driver actions in removing traction power immediately before train 9T92 enters the washed out track section. A rapid reduction in air pressure in the brake pipe occurs as train 9T92 traverses the washout and derails. Source: ATSB

Analysis of the data logger and ATP recordings by Aurizon engineering and maintenance staff showed that the reduction in brake pipe pressure did not correspond with a reduction in the equalising reservoir pressure. The movement of the brake handle by a driver toward the service or emergency position would typically cause both these pressures to reduce in unison.

The recorded events illustrate that a brake application, via the movement of the drivers brake handle to the emergency position (as recounted by the driver), did not cause the rapid reduction in brake pipe pressure. The reduction in brake pipe pressure was more likely due to a loss in brake pipe continuity during the derailment. The locomotive's automatic brake control valve sensed the reduction in brake pipe pressure and began to apply the brakes on the locomotive.

While there is variance between the driver's recollection and the data log analysis, the exact cause for brake pipe pressure reduction (brake handle or brake pipe continuity) had no material effect on the outcome of 9T92 entering the washout and derailing.

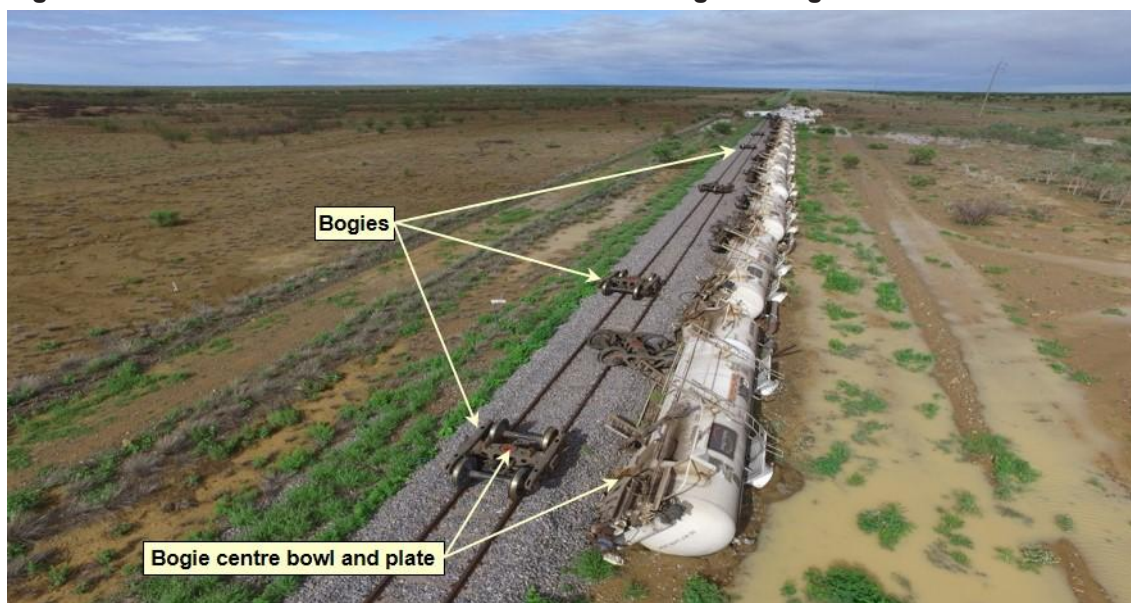
**Figure 6: Domino effect derailment of GATX tanker wagon string**

View of rear of 9T92 of the tanker wagons that derailed due to the 'domino-effect'. A number of the associated bogies remained in situ on the track adjacent to the corresponding position of the tanker unit bogie mounting point. Source: Queensland Police

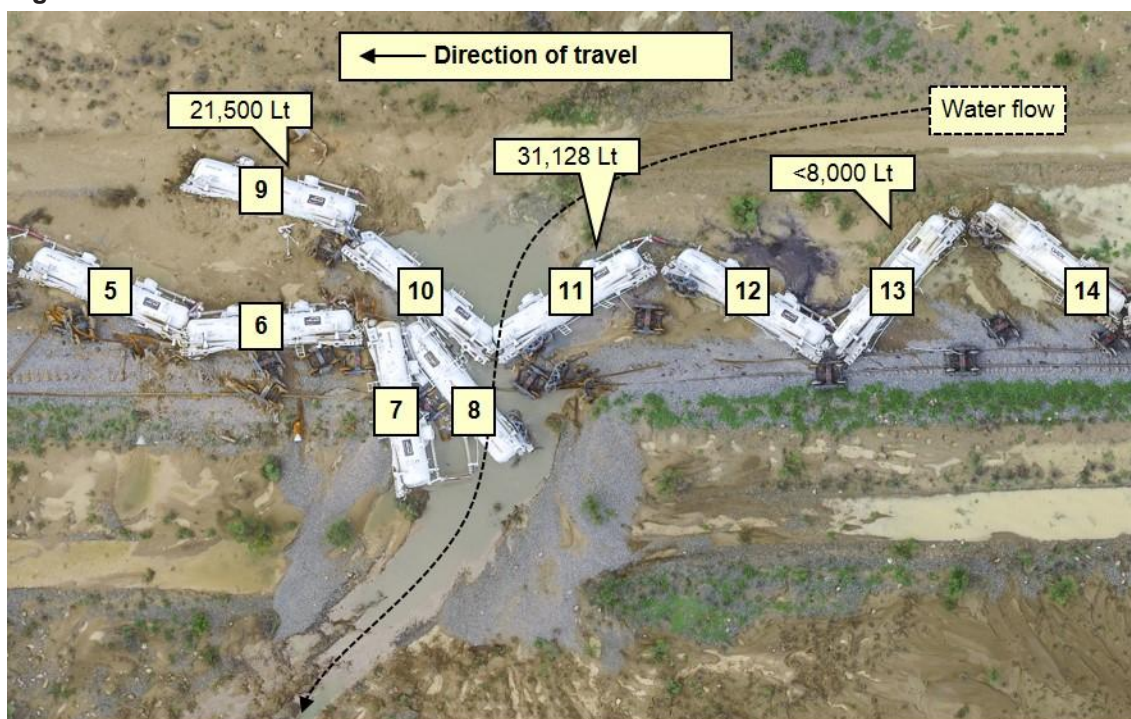
**Figure 7: Acid hot zone**

Derailment damage to tanker wagons in positions nine, eleven, and thirteen of the train caused sulphuric acid to escape (21,500 litres, 31,218 litres, and slightly less than 8,000 litres, respectively). The acid, 98 per cent pure, mixed with the surrounding floodwater and began to etch the damaged external surface of the tanker vessels within the acid pool hot zone<sup>7</sup> (Figure 7).

This image identifies the wagons that leaked product before restoration. Wagon 9 leaked 21,500 litres, wagon 11 leaked 31,218 litres (all contents), and wagon 13 leaked less than 8,000 litres. Source: Queensland Police Service. Annotated by ATSB

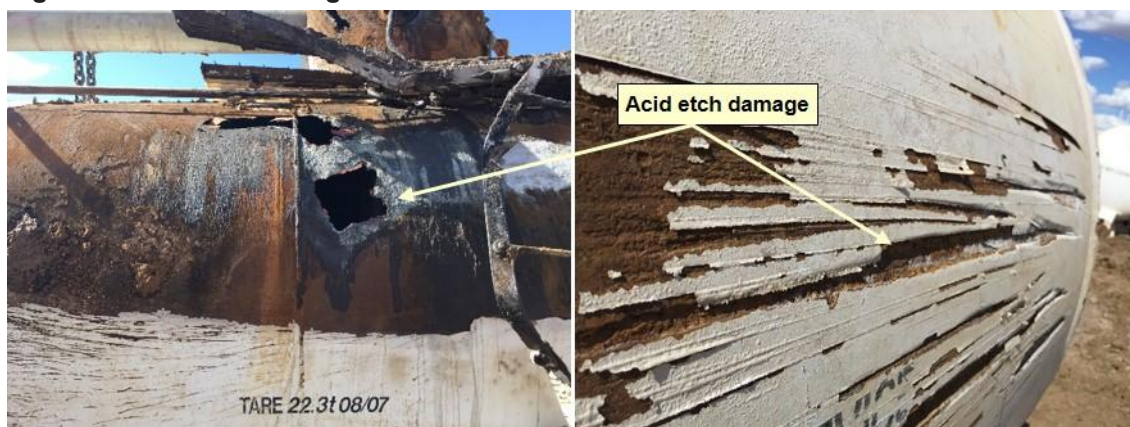
**Figure 8: Acid etch damage to GATX tanker vessel**

The etching resulted in further leakage of product, exacerbating the acid etching of the already damaged surfaces (Figure 8).

Images of acid etching to external surface of tanker vessel of GATX tanker wagon OZSY 44688. This tanker wagon was in position 11 of the train. Following the derailment, this tanker wagon was within the acid hot zone and lost all contents. Source: Incitec Pivot. Annotation by ATSB

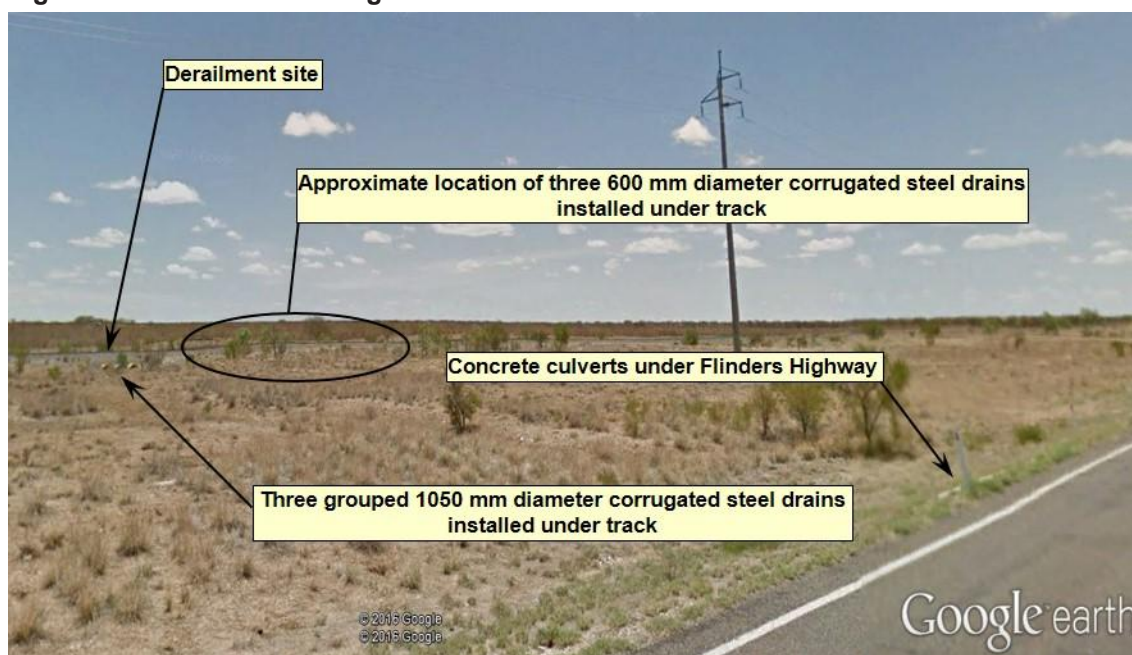
**Figure 9: Under-track drainage at the derailment site**

Location of the derailment as it appeared before the event - viewed in a south-westerly direction from the Flinders Highway. Rainwater runoff flows from the catchment to the north, passes through a series of concrete culverts under the highway and toward the railway formation. A series of circular corrugated steel pipes installed under the track formation allows water to then flow into the watercourses located to the south of the railway. Source: Google Earth, annotated by ATSB

Queensland Rail (QR) advised that the group of three 1050 mm corrugated steel pipes were installed during the re-construction of the Mount Isa line completed in the early 1960s. In the 1980s a flood occurred that resulted in scouring of the formation adjacent the three existing pipes. This event resulted in the addition of the three 600 mm corrugated steel pipes to the west.

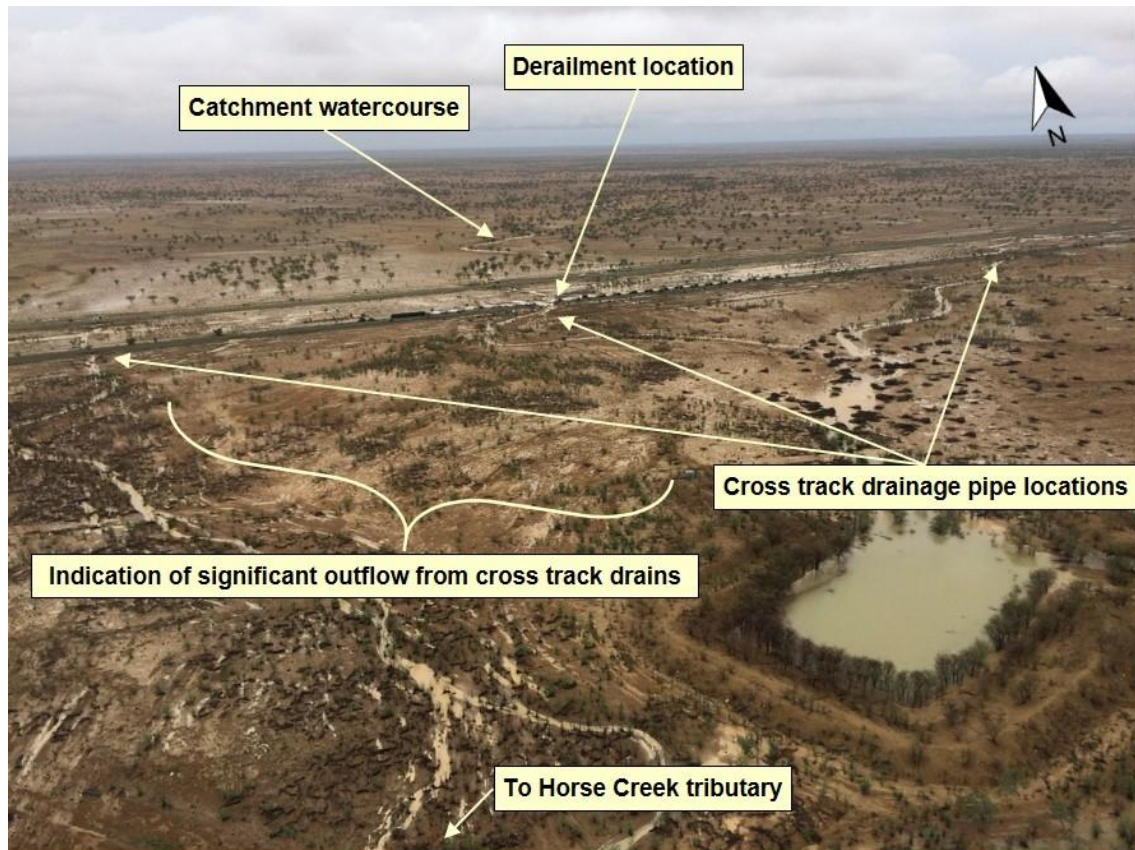
**Figure 12: Northward view of catchment area and watercourses**

Northward view of the catchment area and associated water courses that cross the Flinders Highway and the Mount Isa railway. The view shows the path of floodwater outflow from the cross track drains adjacent the derailment site. Source: Queensland Police

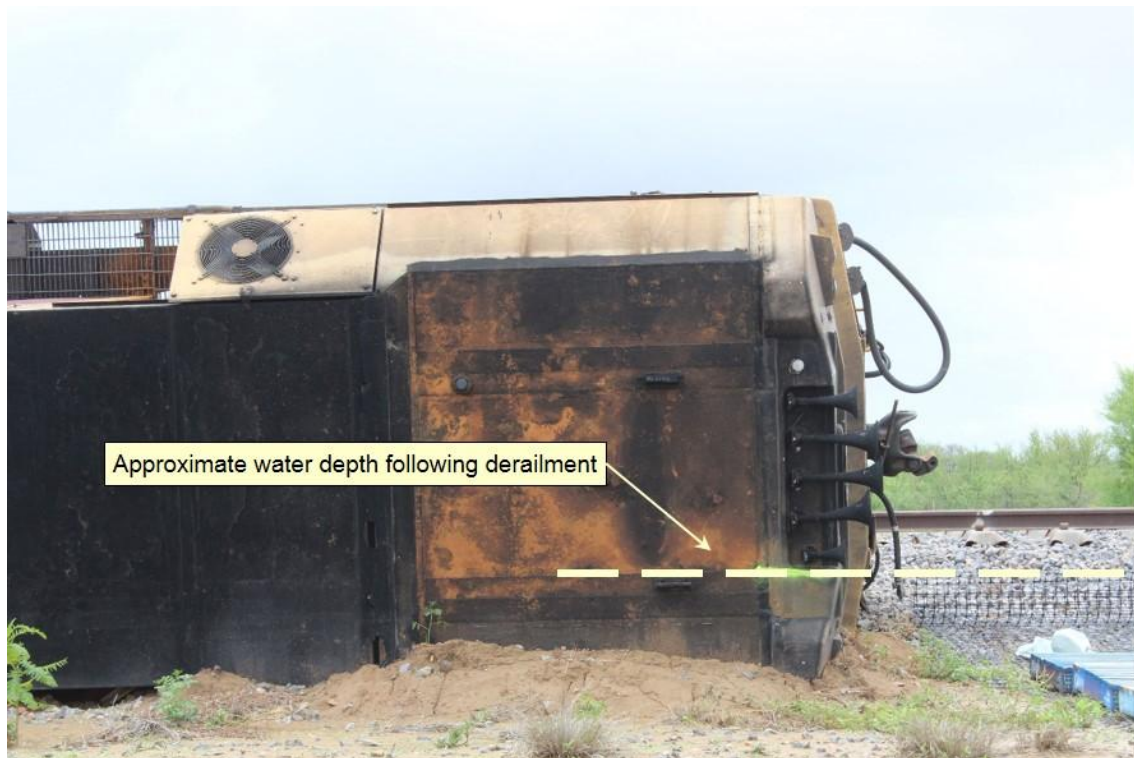
**Figure 13: Approximate water depth following derailment**

Watermark on the locomotive indicating the depth of the floodwater. Source: Queensland Rail

Based on the observed depth of water following the derailment, and evidence of sediment and scouring south of the track from water outflow (from under track drains and the washout), it was likely the level of floodwater that damaged the track formation was higher than was present at the time of the derailment. It is likely that water had banked up against the track formation, and the water level receded once the formation had washed away.

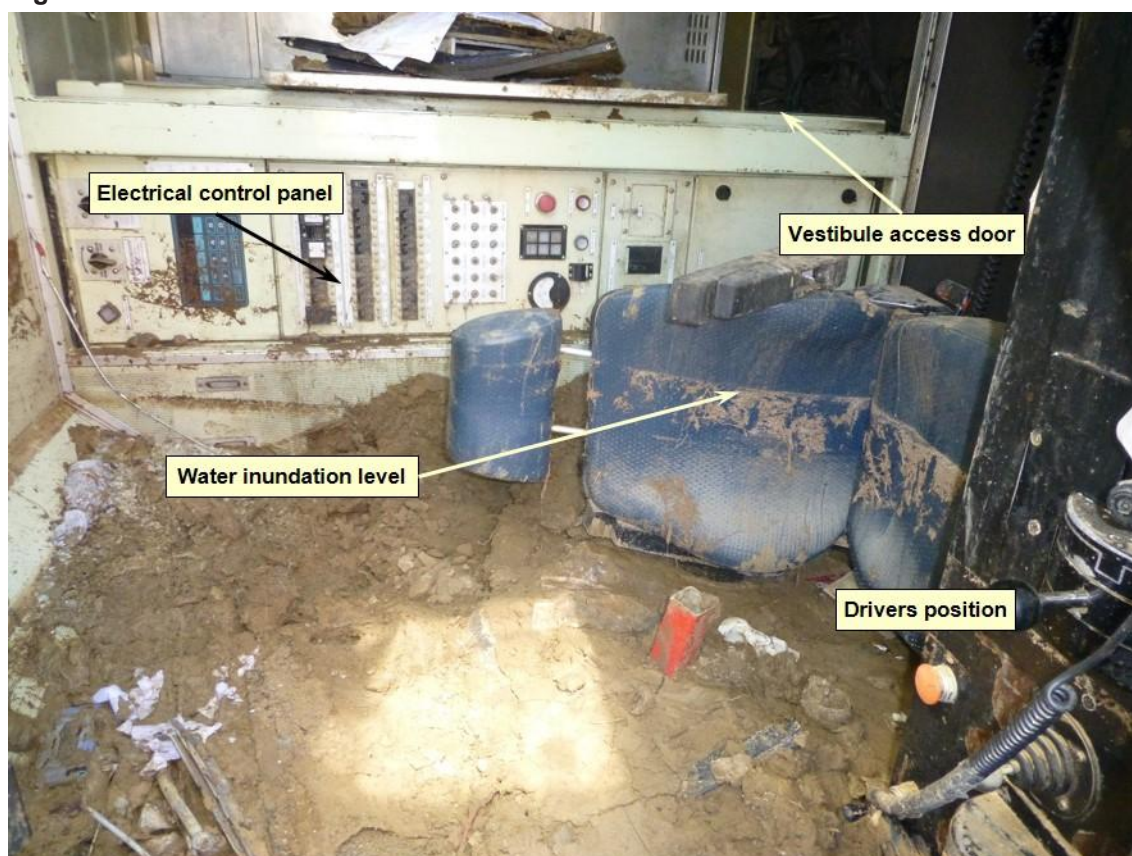
**Figure 26: Locomotive 2814 cab**

Image showing drivers side seating position and vestibule access door at the rear of the cab post derailment. Floodwaters and sediment entered the locomotive cab to a depth of 600 mm inundating communications and electrical systems. Debris in vestibule door was placed in vestibule during recovery operations. Source: ATSB

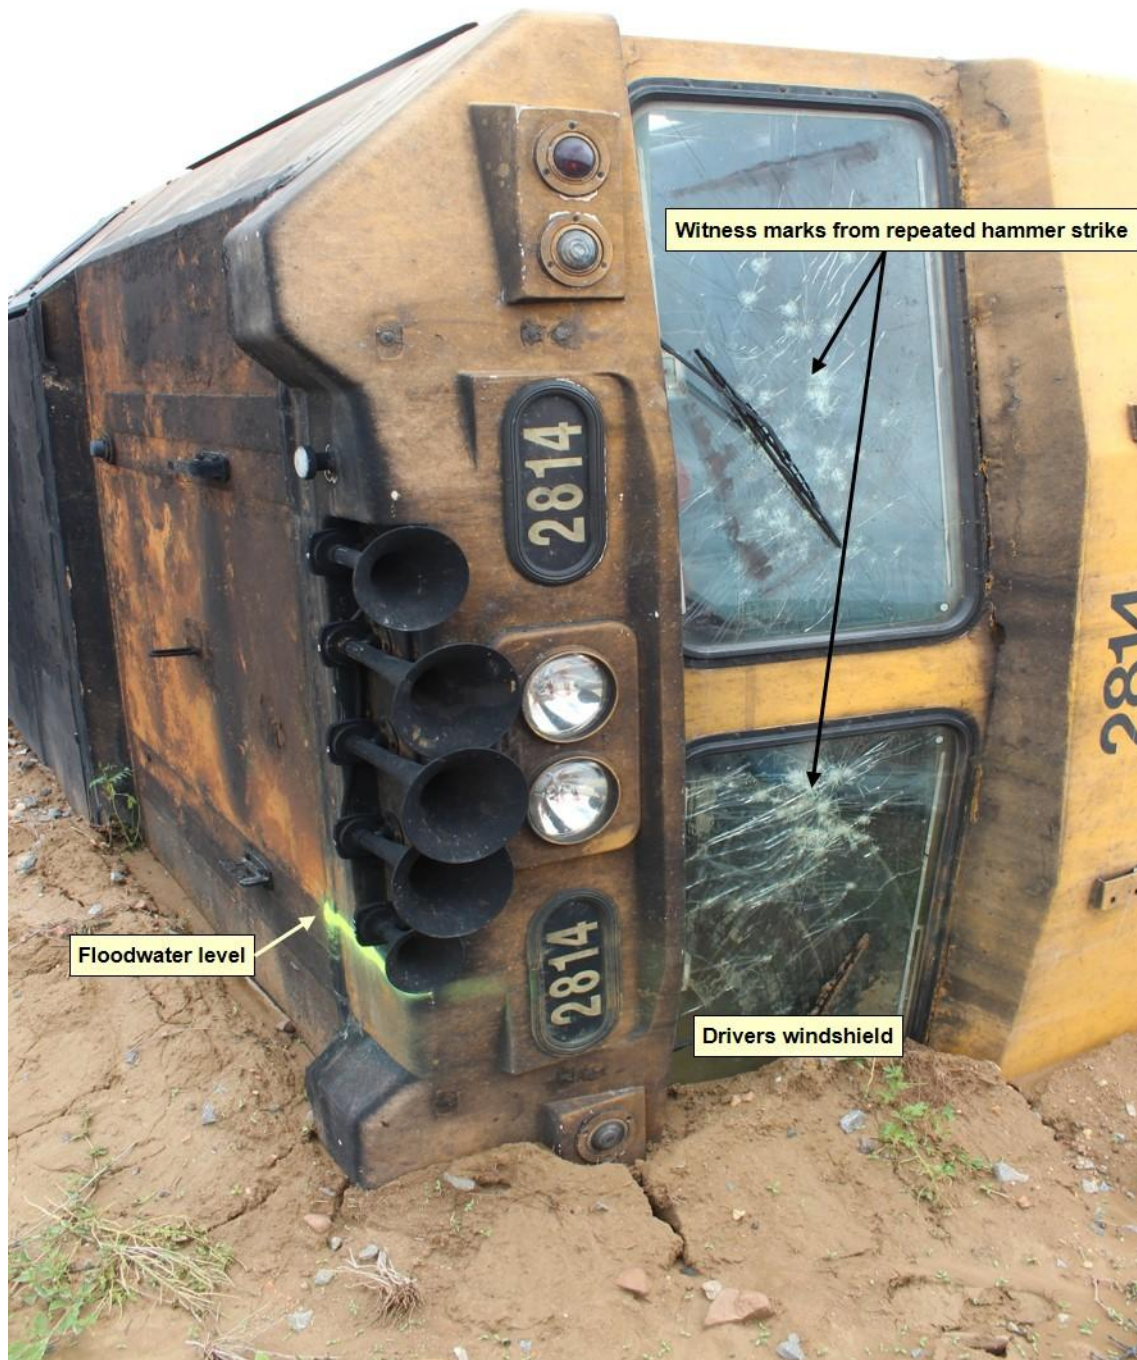
**Figure 27: Damage to windscreens of locomotive 2814**

Image of leading locomotive 2814 in its final resting place and indicative water level. The image displays repeated attempt by train crew to smash out the windcreens with the emergency hammer. Source: Queensland Rail
