# **Derailment of train 3MP5**

Rawlinna, Western Australia, on 21 April 2016

**ATSB Transport Safety Report**

RO-2016-005

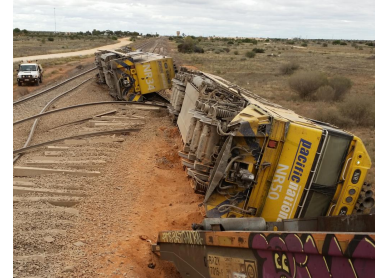
### Derailed locomotives

On 21 April 2016, at about 1115<sup>1</sup>, train 3MP5 (travelling from Melbourne to Perth) derailed while traversing the eastern points at Rawlinna. The points failed to restore to the normal position after the last train departed the loop line, leaving the points in an unsafe open position. The colour light point indicator system worked as designed by displaying a red indication when the points were unable to be detected and locked in a safe position.

There were minor injuries sustained by the crew. About 200 m of track infrastructure was damaged, and the main line between Adelaide and Perth was blocked until 1351 on 25 April 2016.

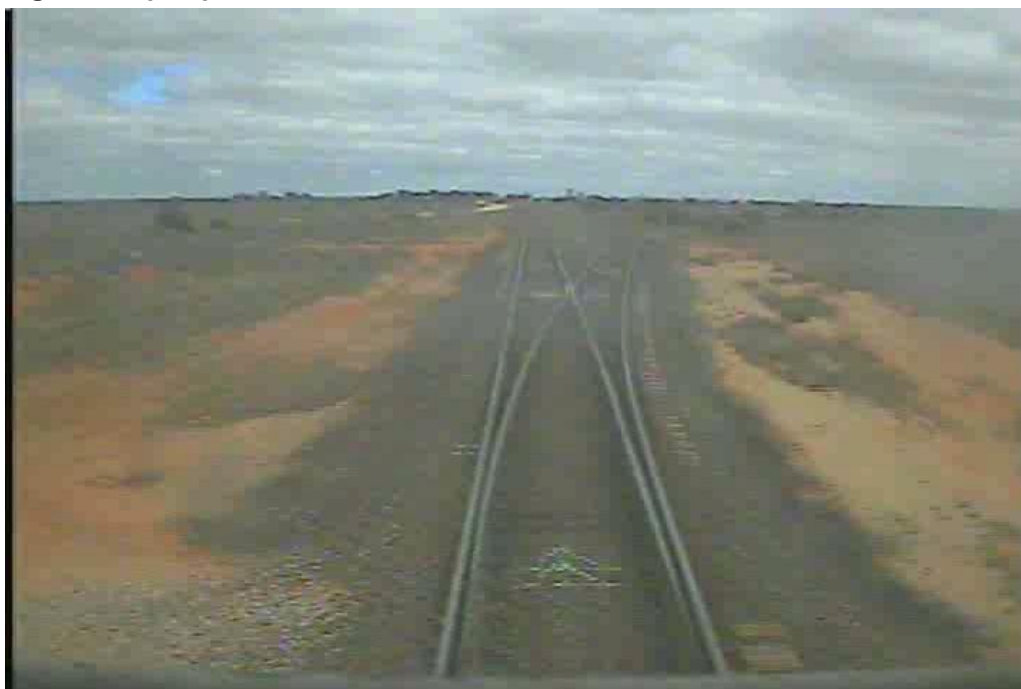
**Figure 2: Open points at Rawlinna – as seen from 3MP5.**

Train 3MP5 was unable to stop and, at 1114:56, it travelled over the points (Figure 2) at 90 km/h and derailed. The train continued to travel derailed for a further 160 m, coming to rest between the main and loop lines. Both locomotives and the crew van tipped onto their sides. The following six wagons, totalling 389 tonnes and 450 m in length, all derailed. Most of the wagons jack-knifed into an area about 140 m in length (Figure 3).

Graphic derived from the General Electric LocoCAM showing the Rawlinna eastern points in an open condition. That is, the points are not closed for either the main line (straight through) or the loop line (diverging to the right). Source: Pacific National

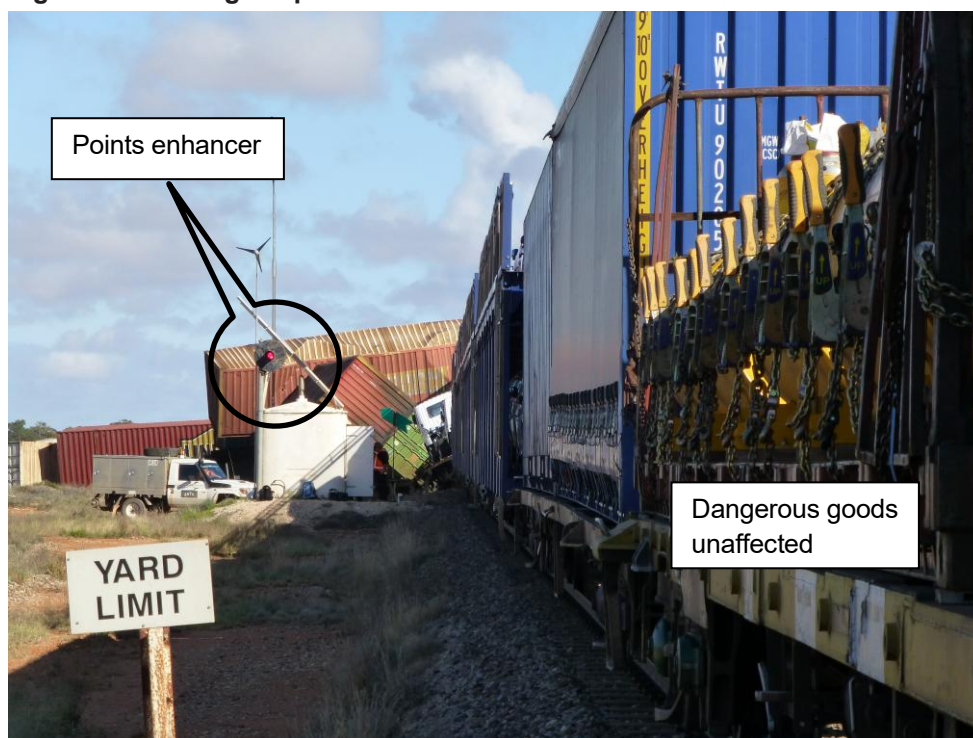
**Figure 3: Wreckage at points**

About 200 m of track was damaged, including the points. The ARTC built a track deviation to the south around the wreckage in order to allow rail traffic pass while recovery works were undertaken. The deviation was completed and the track, main line only, was reopened to allow rail traffic to pass at 1351 on 25 April 2016.

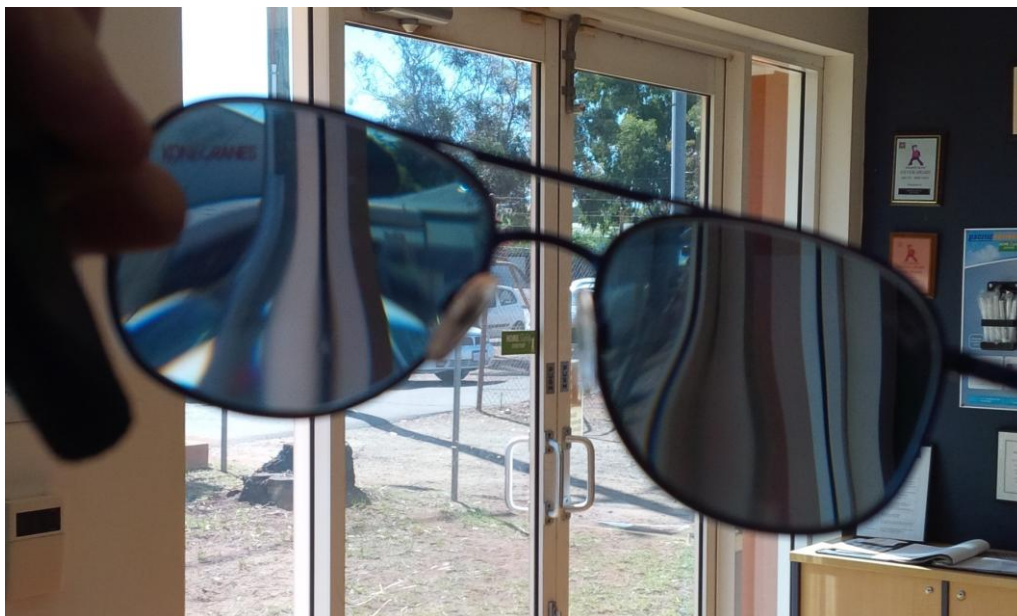
**Figure 6: Prescribed tinted sunglasses**

The driver stated that on this occasion, he was wearing prescribed sunglasses supplied by an ophthalmic retailer through Pacific National. The lenses were tinted grey and not polarised, Figure 6.

Given the driver's fitness for duty and no evidence of colour interference from a grey tint, it is likely that the prescription sunglasses worn by the driver did not affect the colour transmission of the red indicator. It is plausible that other factors such as distance, heat haze, and expectation may affect the interpretation of a red indicator.

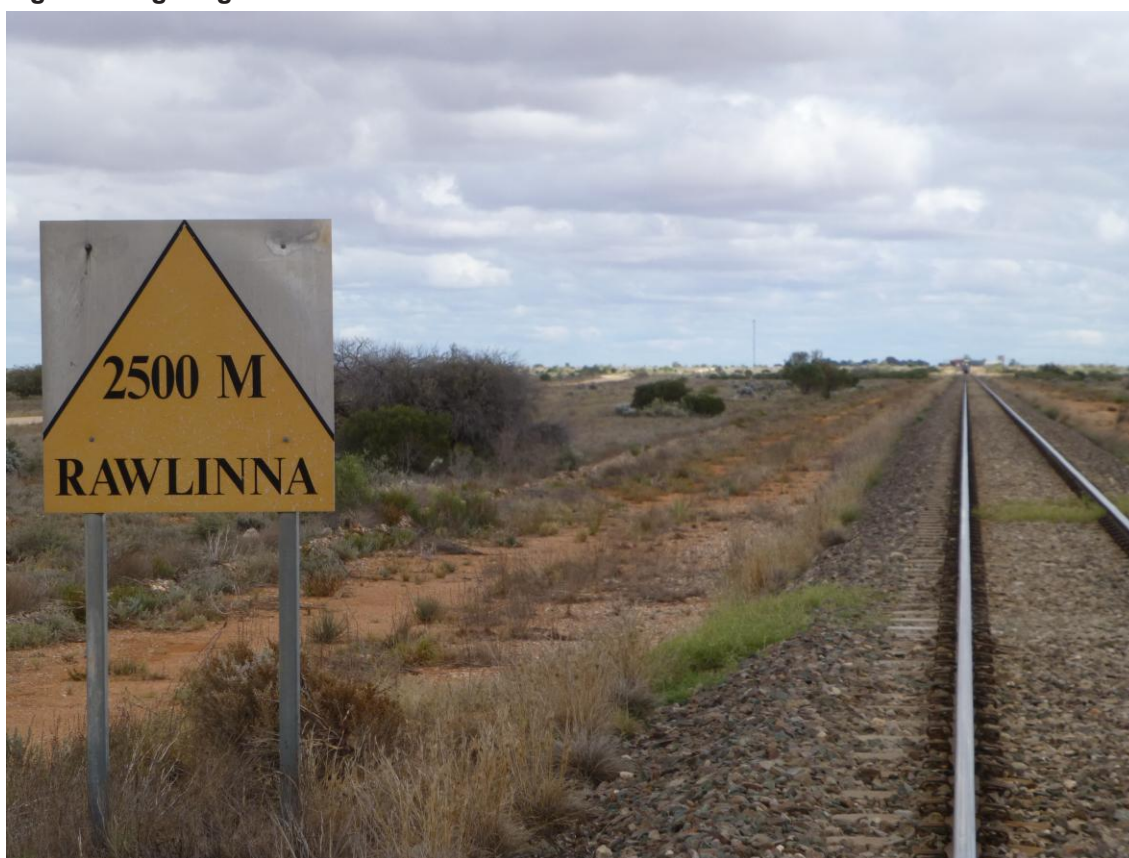
**Figure 7: Sighting from Rawlinna location board**

Train crew vigilance and effective indicator sighting distance are critical. The enhancer lights at Rawlinna consisted of an incandescent long distance (K3) search light. Depending on lens system, lamp, and ambient conditions, the K3 signal can attain a range of up to 2500 m in clean air. Any form of beam spread applied to a signal reduces its range. Based on the recollections of train crews (including 3MP5), the effective sighting distance of the eastern enhancer light is about 1000 m. ATSB investigators onsite measured about 1200 m sighting of the eastern enhancer light from ground level. This is dependent on time of day, weather, heat haze, direction of sun, and other environmental conditions.

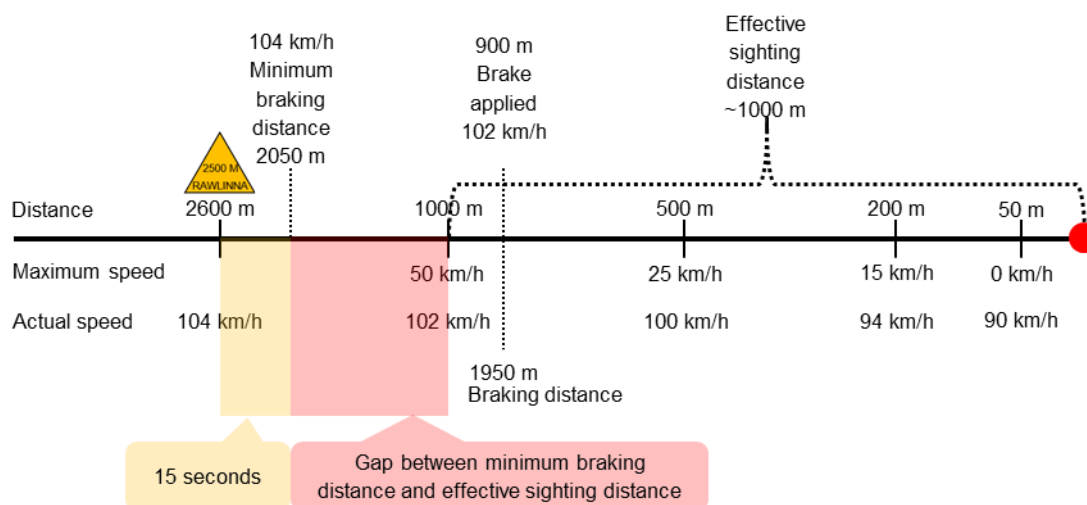
**Figure 8: Sighting and braking distances**

Figure 8 illustrates a gap of about 1050 m between the minimum full service braking distance and effective sighting distance. In order for trains to approach at a speed at which they can stop, a brake application is required near the location board. Following this, it is inevitable that a train travelling at about 100 km/h at a sighting distance of 1000 m would not stop in time. Train 3MP5 was travelling at 102 km/h when the co driver called a red enhancer and the brakes were applied. This equates to a full service braking distance of about 1950 m on level track, considerably more than the 900 m available in this case.

When considering Pacific National's train handling guidelines and safety critical zones, Pacific National trains should be braking at the location board in order to reduce speed to 50 km/h at the 1000 m point. This would allow trains greater time to slow or stop as required or until the condition of the points could be positively confirmed.

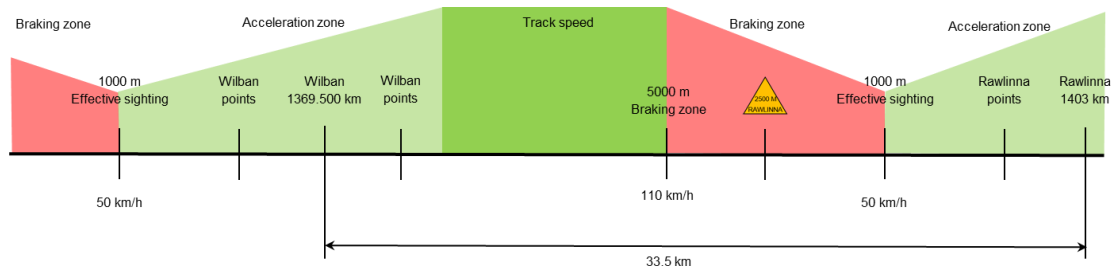
**Figure 9: Section time analysis**

The analysis concluded that the section running time allowed for train 3MP5 between Wilban and Rawlinna was likely adequate for normal running. The section running time did not include extra time for adverse weather or other conditions that might affect train-running speeds.

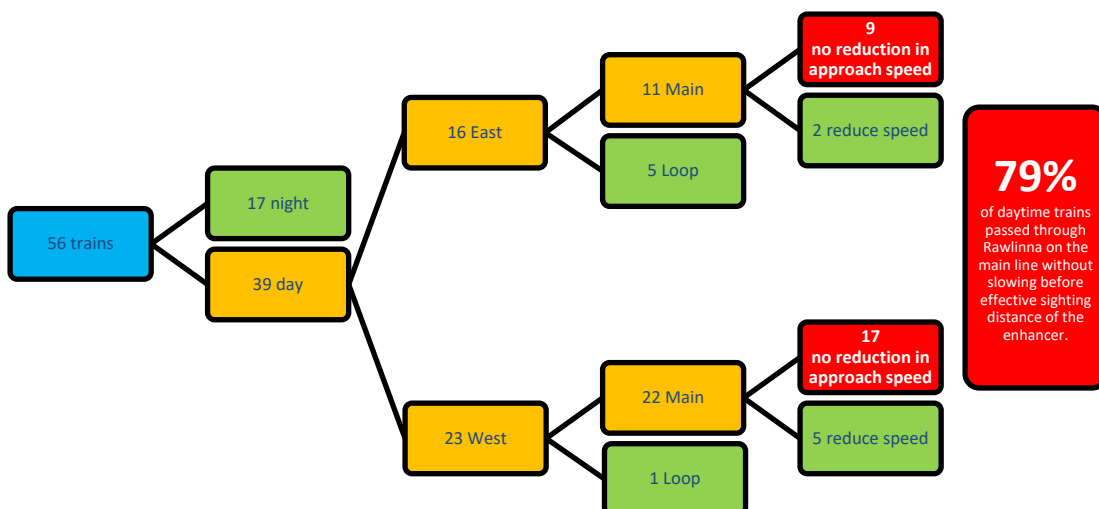
**Figure 10: Approach speed analysis results**

The results indicate that 79 percent of daytime trains (passing through Rawlinna) do not slow down before the effective sighting of the enhancer, both east and west. This meant that trains

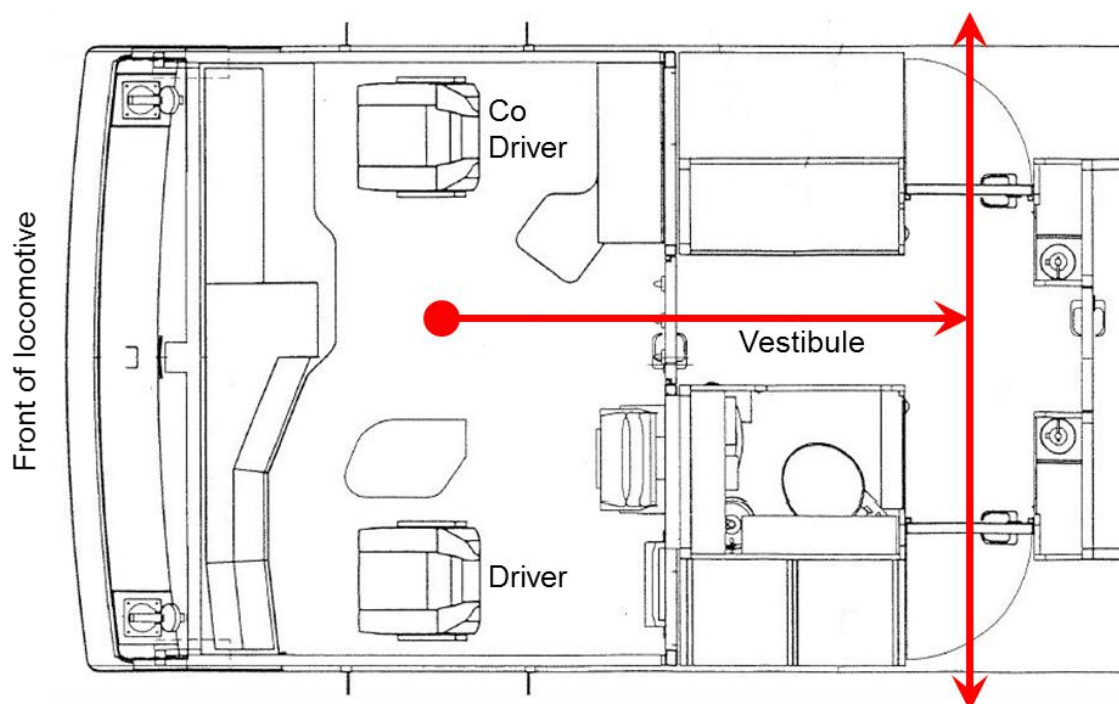
**Figure 11: NR class locomotive cab access/egress schematic**

The NR class locomotive has an enclosed cab. Access and egress to the cab was via a single door to a central vestibule, and two doors to the outside of the locomotive (Figure 11). This access was also the primary emergency escape path. Although the construction of the NR class locomotive (NR34) occurred prior to the publication of the RISSB Standard AS 7522, Pacific National had included the identification of an alternate escape path through the locomotive cab side windows. The alternate escape path was available after sliding open the side windows.

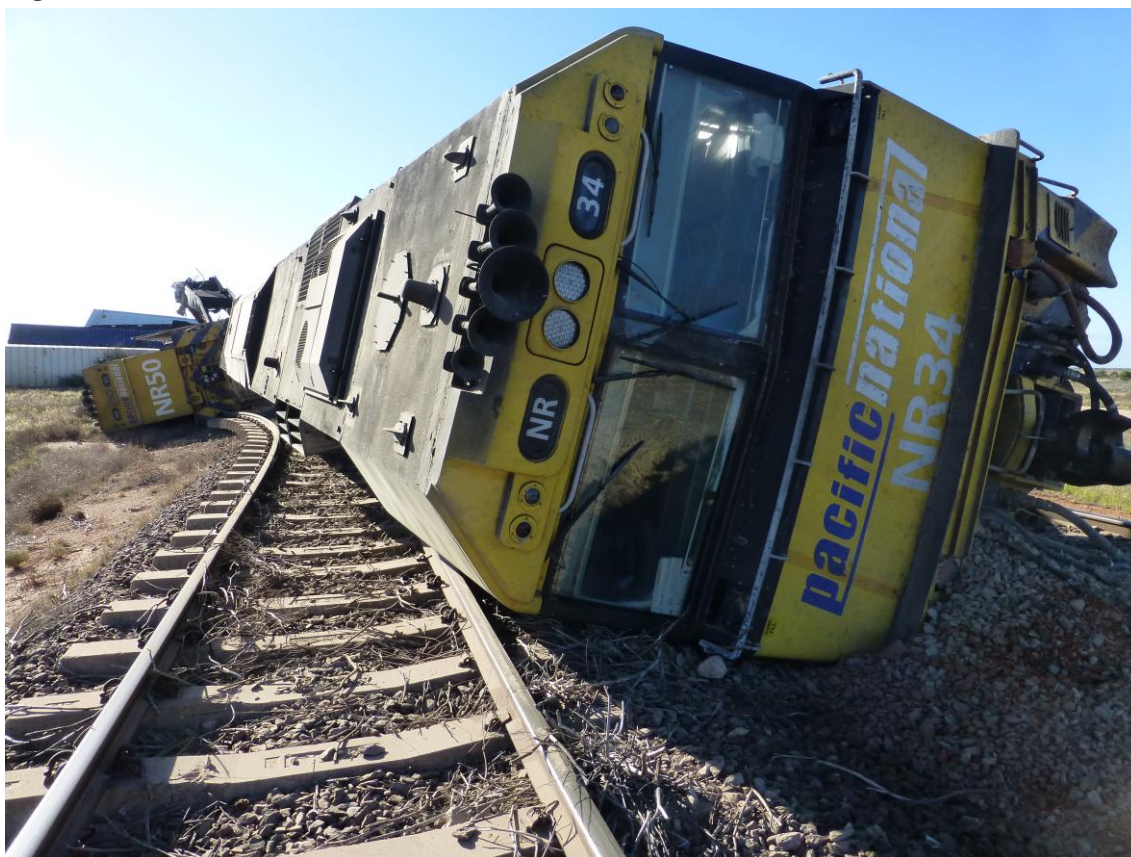
**Figure 12: Locomotive NR34 cab**

Following the derailment on 21 April 2016, locomotive NR34 came to rest on the co-driver's side (right side in direction of travel). Both drivers were thrown into the side of the cab (Figure 12).

In the derailment of train 3MP5, both identified escape paths necessitated the crew climbing on internal structures to facilitate egress. The minor injuries sustained by the drivers did not overly affect their escape in climbing up through the cab and out of the side window (now on top).

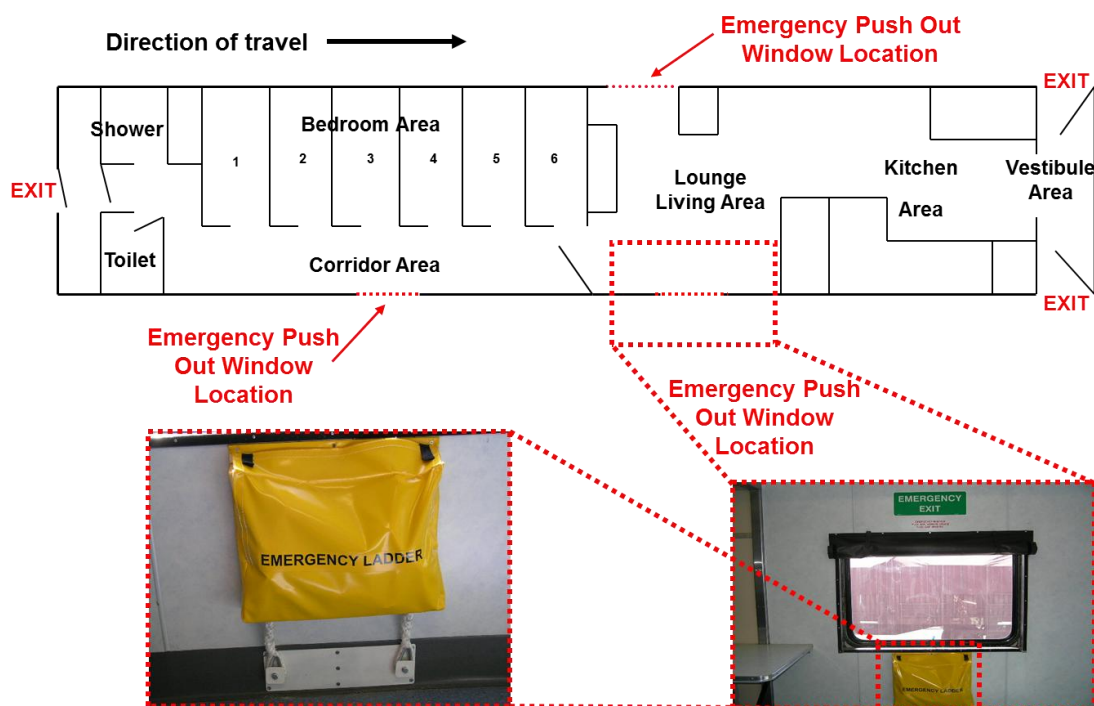
**Figure 13: FAM crew van layout and exits**

The crew van is a steel-framed car, has a stainless steel body and rides on all-steel two-axle bogies. Metal-framed rectangular windows are evenly spaced down the sides of the carriage. Vehicle access is via two external side doors into a central vestibule, and a vehicle end door (Figure 13). The external doors were also the primary emergency escape paths. A supplemental escape path through side windows was available after removing the window, and lowering an emergency ladder out of the window.

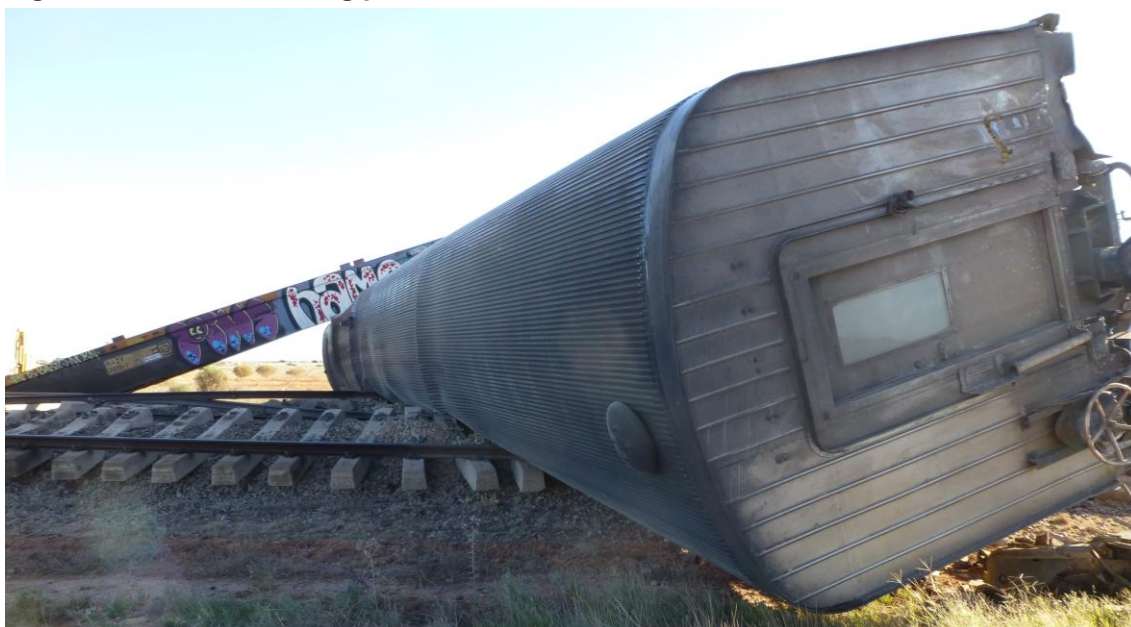
**Figure 14: Crew van resting position**

Following the derailment, the crew van came to rest on its left side in direction of travel. The resting driver was thrown around inside of the van (Figure 14) and received facial lacerations from a lunch box.

The driver in the crew van could not access the primary escape paths. Similarly, since the vehicle was on its side, the driver could not reach the emergency push-out window, so remained trapped. Both drivers (from the locomotive) tried to assist the driver in the crew van. Initially, the emergency window accessing the dining area was smashed and the emergency ladder deployed (Figure 15).

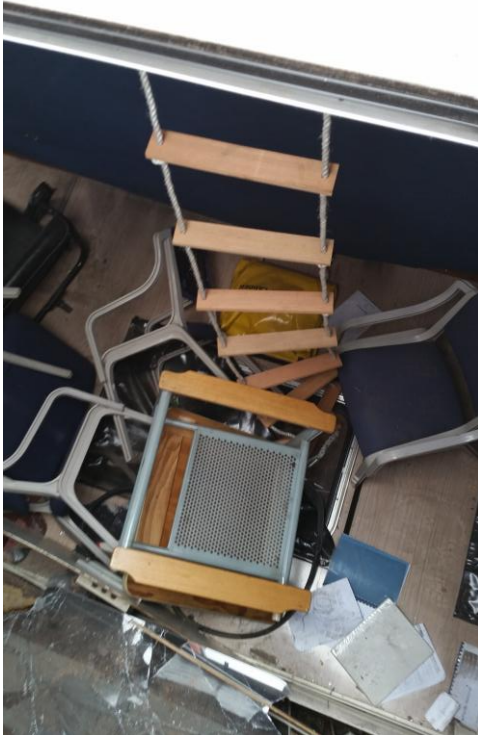
**Figure 15: Crew van emergency ladder**

Unfortunately, the ladder was only designed to be deployed to the ground outside the window, providing effective egress from a wagon in an upright position. In this case, the wagon was on its side and the mounting position of the ladder made it ineffective as a method to allow escape. Consequently, the resting driver remained trapped in the crew van until an ARTC worker (who attended the incident site) could provide a standard step ladder (Figure 16).

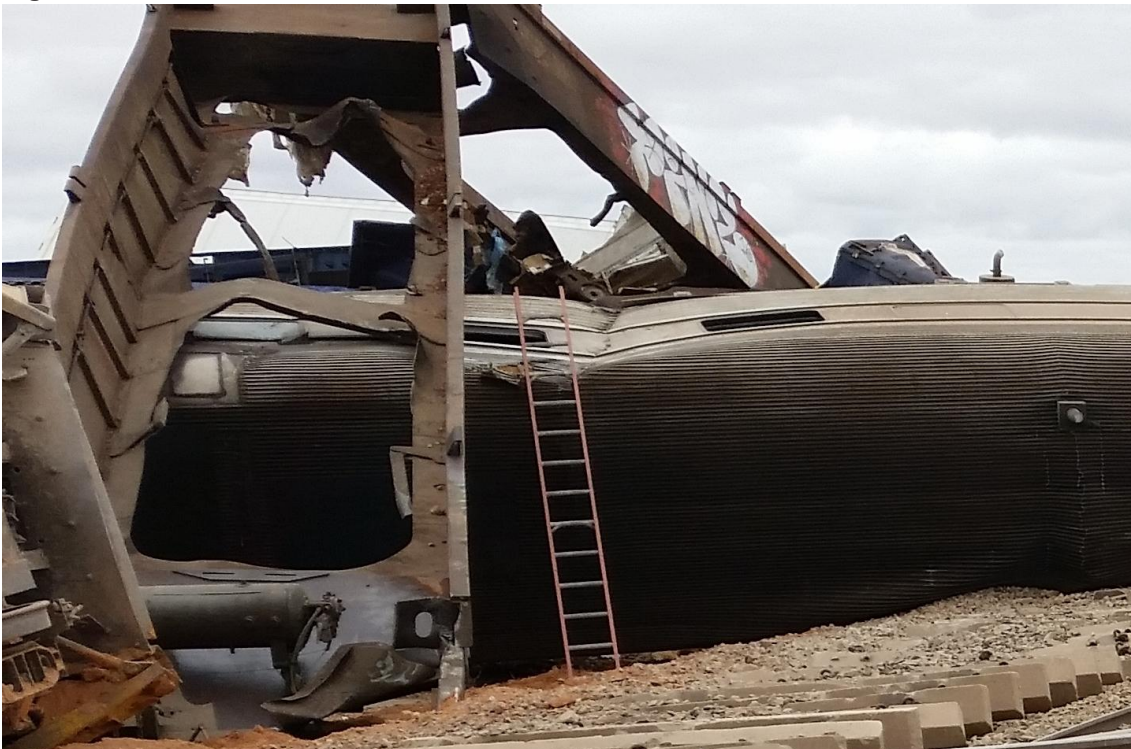
**Figure 16: Crew van evacuation**

It is evident that, in this case, the crew van did not meet the requirements of AS 7522 since the driver could not access any escape paths without assistance and additional equipment.
