# Derailment of freight train 9305

Katunga, Victoria 30 May 2016

**ATSB Transport Safety Report**

RO-2016-007

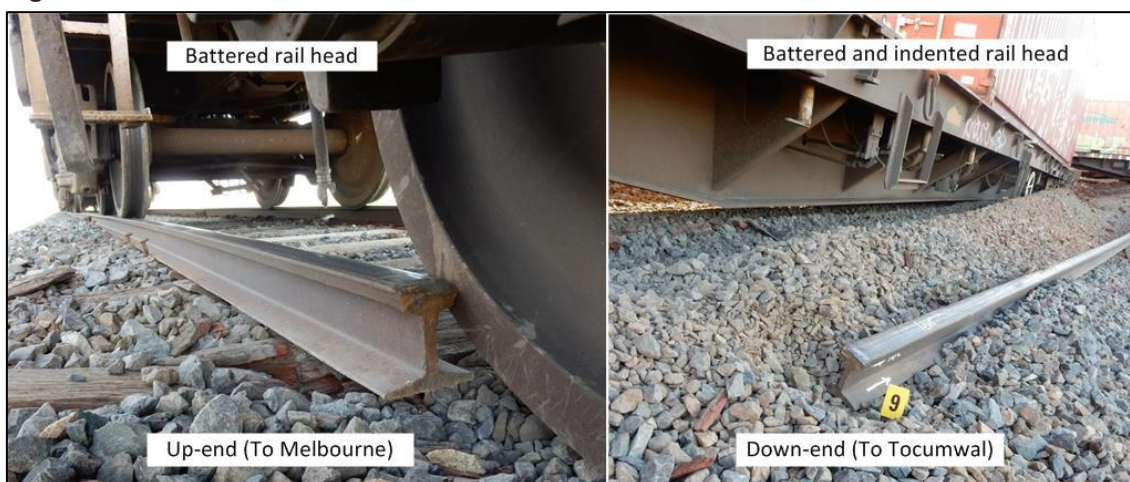
**Figure 2: Fractured rail**

The train had derailed at a fractured flash butt welded rail joint in the east rail at about the 227.8 km mark (Figure 2).

The passage of train 9305 over the fractured rail had disturbed the joint sufficiently to laterally misalign the rail ends, such that a wheel flange impacted with the rail head on the Down-end. This resulted in further disarrangement of the rail and a loss of guidance for the following wagons. It is probable that the trailing axle of the leading bogie of wagon six was the first to derail.

The derailment occurred as a result of a fracture at a flash butt welded rail joint. The condition of the fracture surfaces indicated that the fracture had occurred prior to the passage of train 9305. Battering of the fractured rail indicated bi-directional traffic across the fracture, and corrosion and fracture surface damage suggested the fracture had been present for several days.

The battering of rail head ends indicated that vertical displacement of the rail had been possible in the period following the fracture. In addition, dog spikes on the Up-side of the fracture had been lifted and were loose suggesting that the passage of trains had resulted in the deterioration of rail fixings around the fracture. This deterioration was sufficient to allow the development of a lateral discontinuity at the fracture during the passage of train 9305 resulting in the derailment of the train.

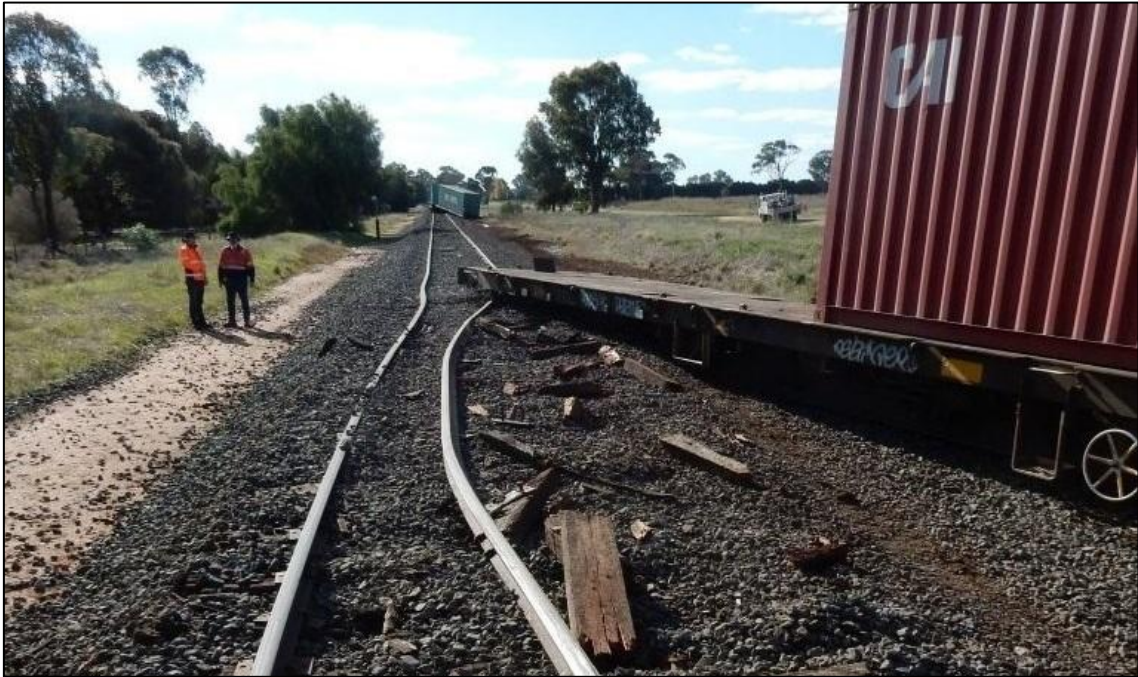
**Figure 3: Separated section of train and track damage, looking towards Tocumwal**

Of the twelve wagons that derailed, wagon six, seven and eight stayed upright and generally followed the track alignment, while the rear bogie of wagon nine veered to the east of the track. The tenth wagon and the following eight wagons veered to the east of the line causing a separation between the ninth and tenth wagons. The separation caused the loss of brake pipe pressure and the subsequent application of the train brakes. The locomotive and the first nine wagons travelled about 137 m from the separated section of the train (Figure 3).

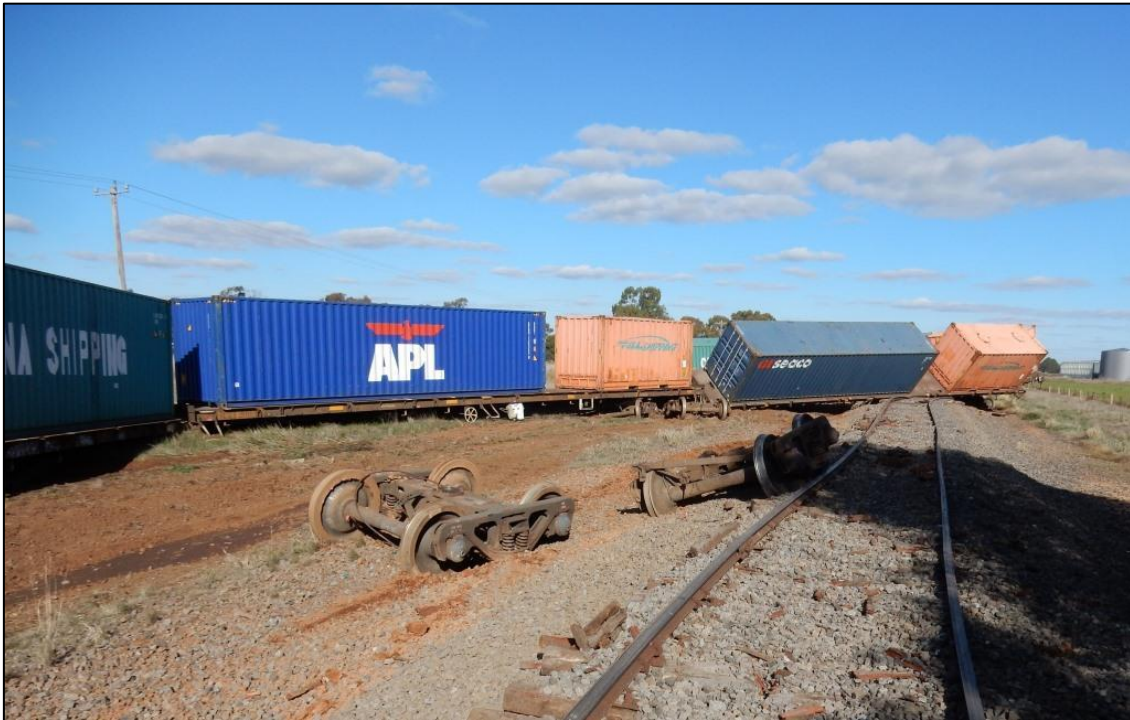
**Figure 4: Disarranged wagons separated bogies and damaged track**

Wagons 10 to 17 ended in various states of disarrangement (Figure 4). The leading end of wagon 18 had lifted off the bogie centre bowl while the last nineteen wagons remained on the track. The derailment resulted in about 350 m of track damage.

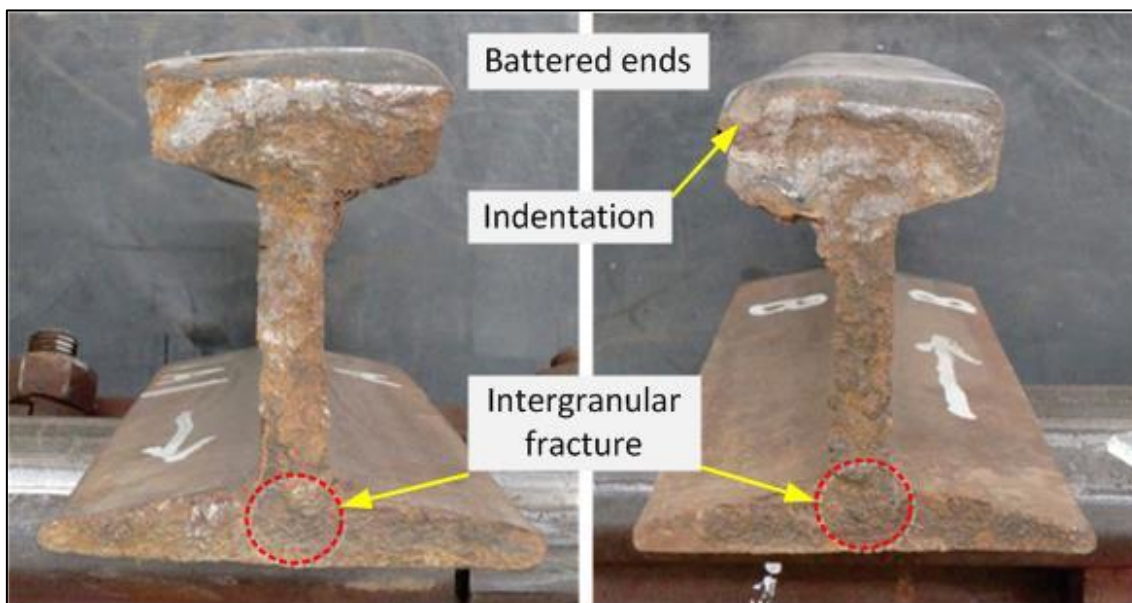
The rail head at the fractured weld had been battered on both sides of the break. Both ends were battered to a depth of about 10 mm. Mechanical damage to this depth indicated the passage of bi-directional rail traffic over the broken joint after fracture. There was also significant mechanical damage to the fracture surfaces and corrosion. At the intersection of the web and the foot, the fracture surface exhibited a region of predominantly intergranular fracture where significant grain boundary oxidation was observed (Figure 6).

**Figure 6: Fractured weld ends, the Up-side rail is on the left and the Down-side rail on the right. The area of intergranular fracture is identified.**

The damage to the fracture surfaces had destroyed a significant amount of the fracture detail. The undamaged fracture surfaces of the rail head and web exhibited a coarse dimpled appearance consistent with instantaneous overload fracture. These features were indicative of ductile-fast fracture.

Metallographic examination of the fracture exhibited a mixed mode (transgranular and intergranular) cracking mechanism. The fracture surface at the foot-web intersection of the fractured weld exhibited a predominantly intergranular brittle fracture mode (Figures 6 and 9).

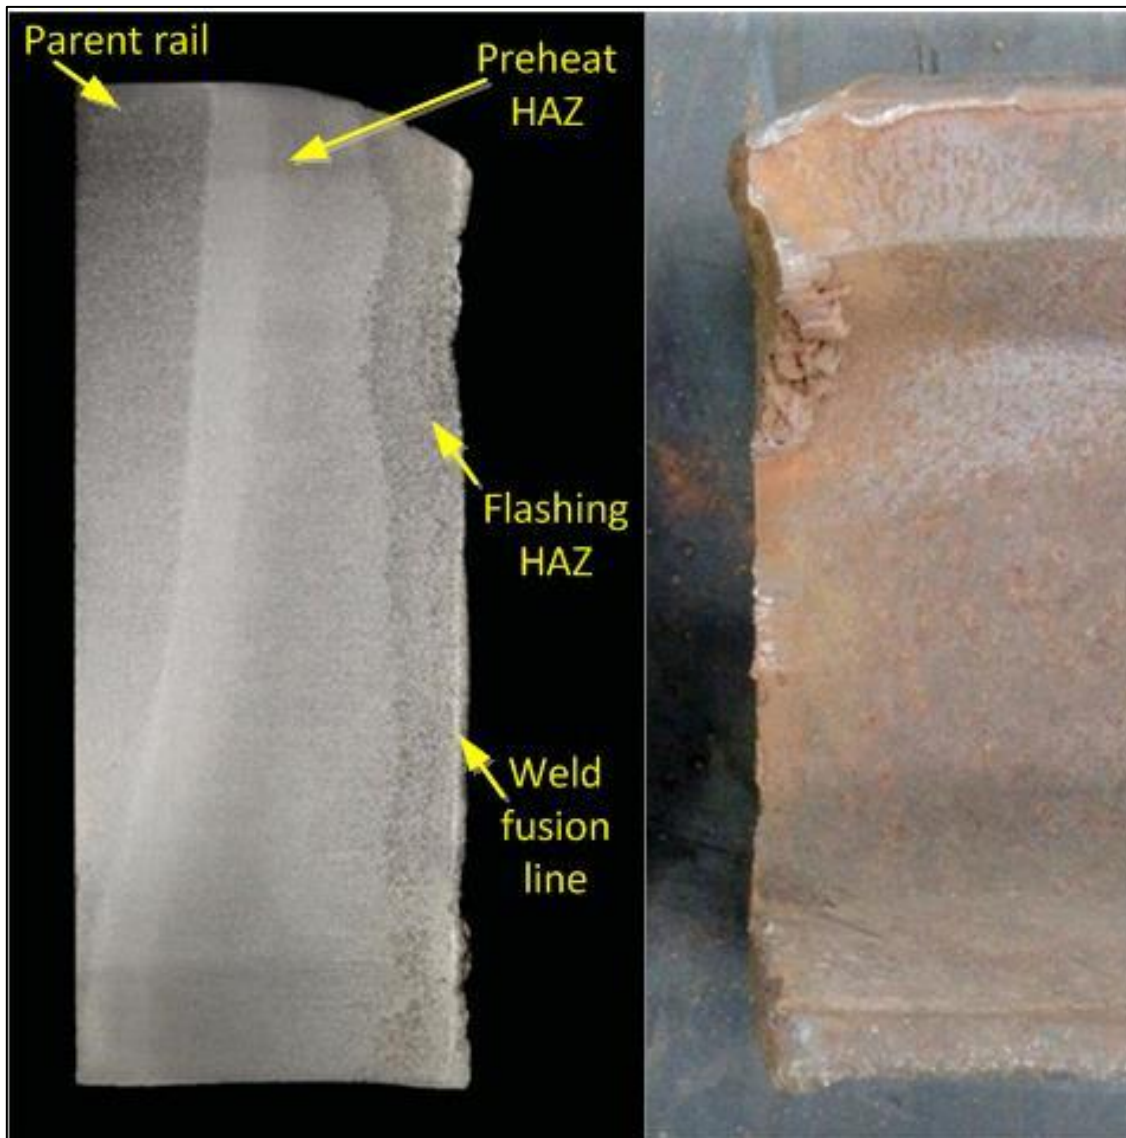
In addition to the parent material, the evaluation revealed three distinct areas; a weld fusion line, a weld flash Heat Affected Zone (HAZ) and a HAZ produced during pre-heating prior to welding (Figure 7). The two Heat Affected Zones are consistent with in-plant flash butt welding processes. The fusion line hardness of the subject rail was consistent with the parent-rail material hardness. The peak HAZ hardness was 264HV (Vickers), 2.5 mm from the break and is not excessive for the application.

**Figure 7: Macro etched longitudinal section of rail on the left showing that the fracture had occurred predominantly in the HAZ adjacent to the weld fusion line. The rail prior to sectioning is shown on the right.**

The fracture occurred predominantly in the Heat Affected Zone adjacent to the weld fusion line and fracture surfaces were consistent with instantaneous overload fracture.

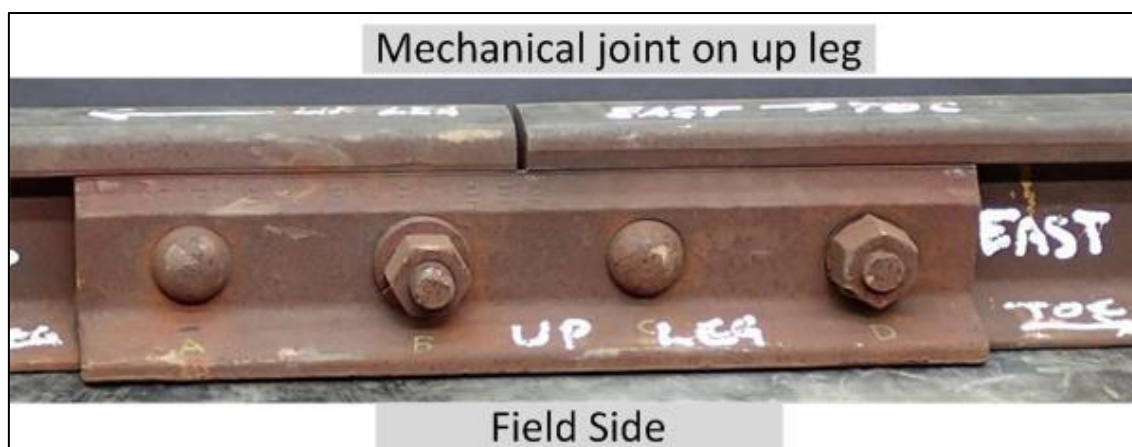
**Figure 8: Mechanical joint adjacent to fractured weld on the East rail**

A mechanical joint adjacent to the fractured weld on the east rail was visually and mechanically examined (Figure 8). Based on bolt torques and wear on the fishing surfaces, the examination concluded that the rail had been expanding and contracting at the mechanical joint.

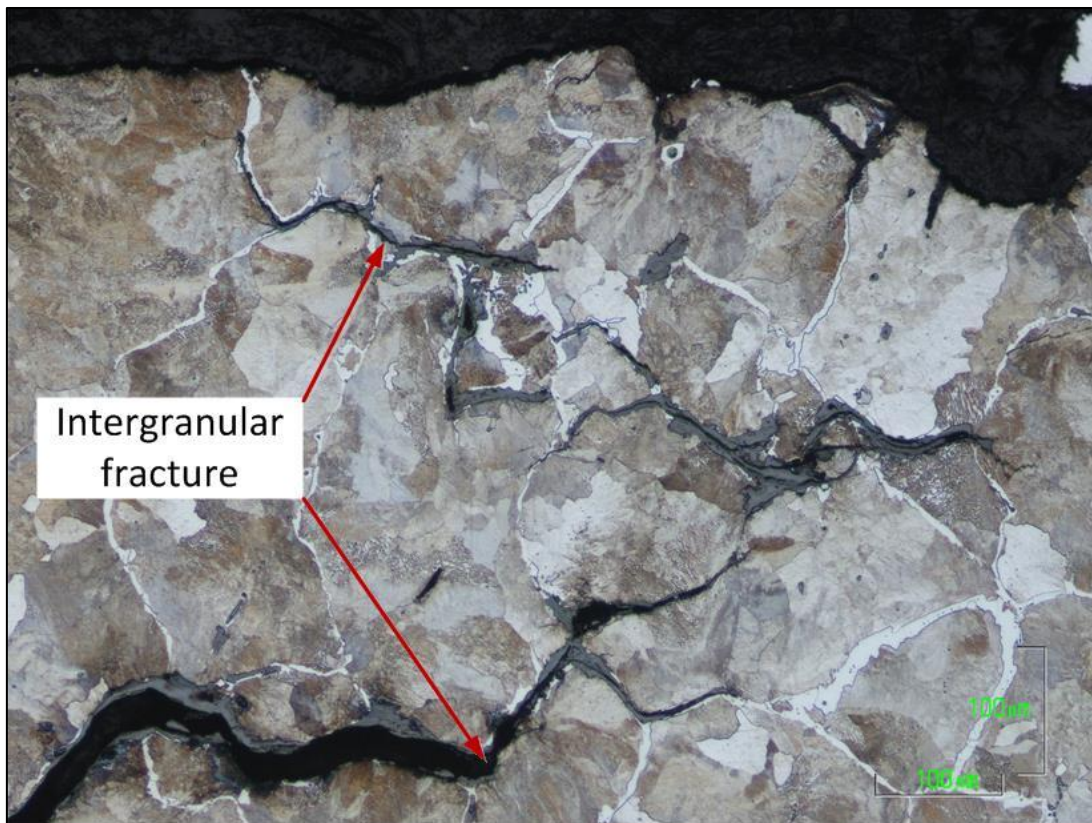
**Figure 9: Photomicrograph of the etched microstructure of the rail fracture surface. The foot-web intersection of fractured weld exhibited an intergranular fracture mode.**

Intergranular brittle fracture occurs by separation at or adjacent to the grain boundaries (where significant oxidation was observed). This type of fracture is indicative of improper material processing during flash butt welding.

It is unlikely that the defects found within the weld would be detected by ultrasonic testing used in an automated RFD vehicle or currently available train borne monitoring equipment. The defects that were located on grain boundaries within the crystalline material structure were small and discontinuous and would produce specular multi-directional ultrasonic responses. These responses would produce a multi peak indication similar to lower level 'noise' signals and would be expected to be below the threshold that would cause a defect alarm. The microscopic defects observed would need to propagate by fatigue to produce a macroscopic planar defect before a detectable ultrasonic return signal could be produced. While some microscopic fatigue was observed, it had not progressed to macroscopic levels in this case.
