# TAWS alert involving ATR-GIE Avions de Transport Regional ATR72-212A, VH-FVR

Moranbah Airport, Queensland | 15 May 2013

**ATSB Transport Safety Report**  
Aviation Occurrence Investigation  
AO-2013-085  
Final – 12 March 2015

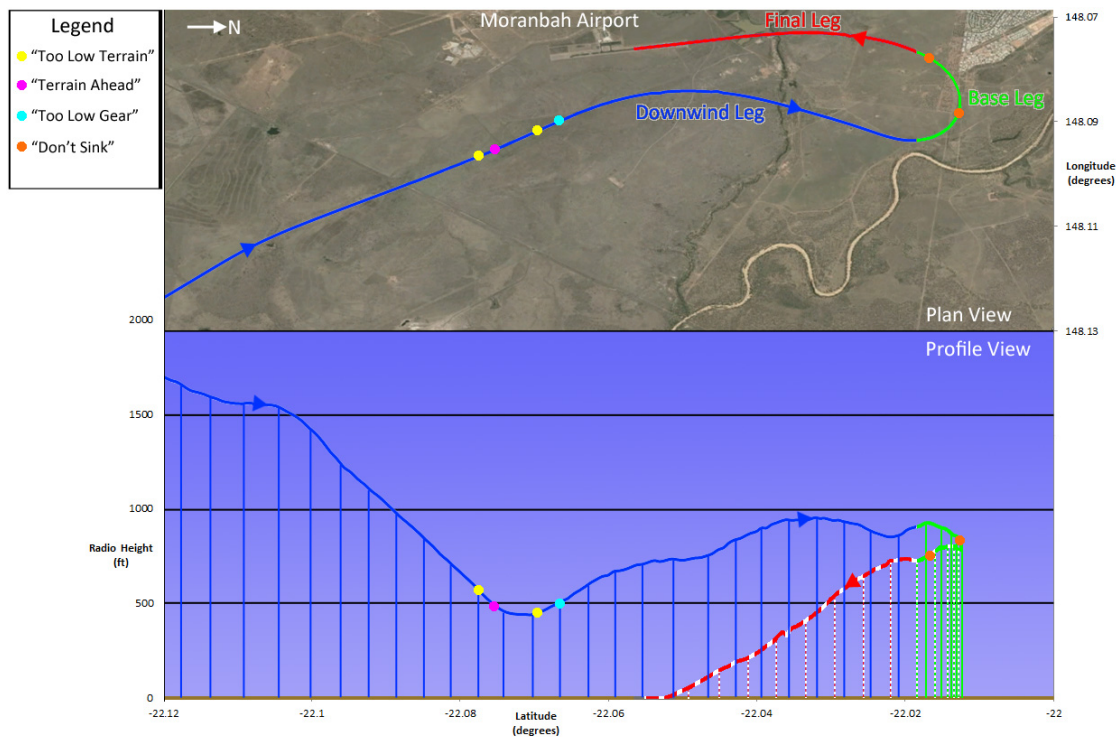
**Figure 1: Flight path and descent with TAWS alerts indicated (see legend)**

Consistent with the recorded vertical speed, the FO indicated that, soon after descending from the intended circuit height, they observed the aircraft's vertical speed at about 700 ft/min in descent. About 30 seconds later, while passing 562 ft AGL, the aircraft's terrain awareness warning system (TAWS) ground proximity warning system activated (Figure 1), sounding an aural 'Too Low Terrain' alert together with a visual 'caution' annunciation on the glareshield. This alerted the crew of the aircraft's proximity to terrain and was followed shortly after by a 'Terrain Ahead' alert, another 'Too Low Terrain' alert and then a 'Too Low Gear' alert. All occurred within 12 seconds of the aircraft being levelled at about 440 ft AGL.

The recorded average vertical speed during the descent from circuit height to 440 ft AGL, the lowest recorded height before the crew initiated a climb, was 1,750 ft/min.

The lower level of the cloud base was reported by the crew as being about 500 ft AGL. The crew indicated that as they were 'visual', clear of the cloud, had the ground/runway in sight, were aware that no obstacles existed along the downwind leg of the circuit and that they knew why the TAWS alert activated, they could acknowledge the alerts and continue the approach.

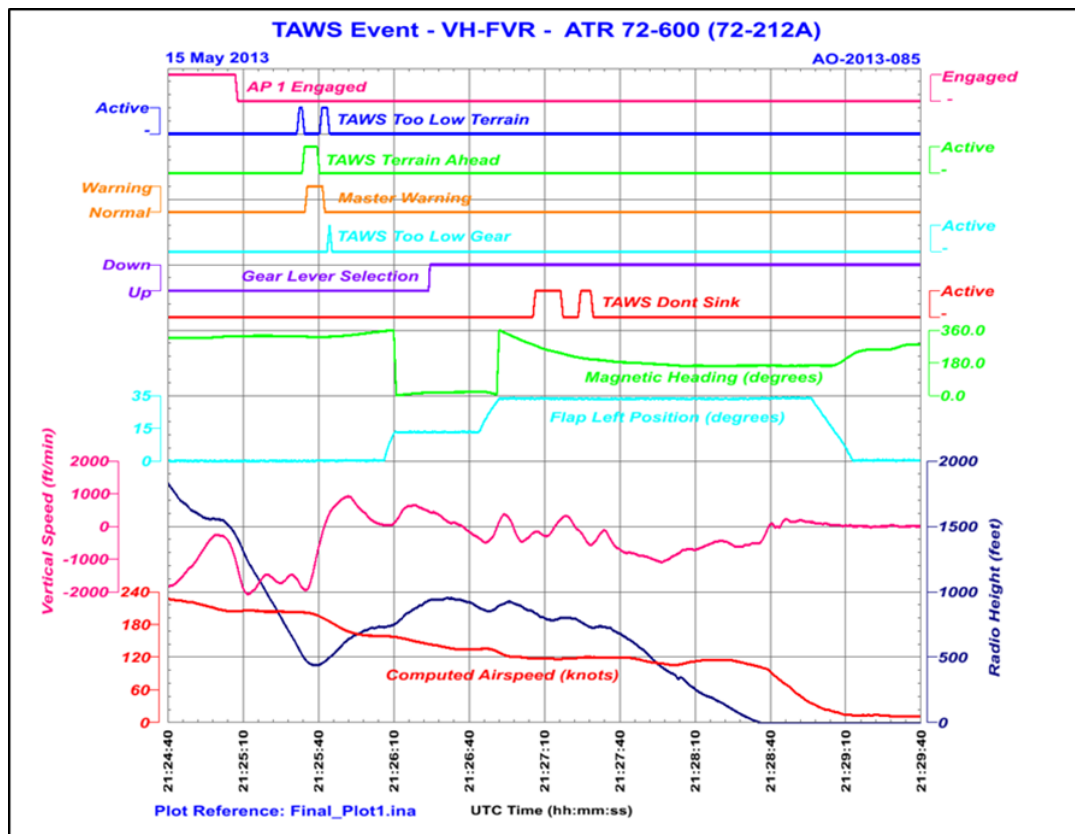
Figure 2: Recorded aircraft flight parameters with TAWS alerts indicated

The following TAWS alerts were activated after the crew descended from the intended circuit height of 1,500 ft AGL (Figure 2):

In this case, the TAWS Mode 3 functionality was armed when the crew initiated the climb from 440 ft AGL when in a clean configuration. The ‘Don’t Sink’ alert activated when the crew commenced their descent for landing without first reaching 1,500 ft AGL (as measured by the radio altimeter).
