46 km north-east of Tenterfield, New South Wales, on 13 March 2026

# Investigation summary

At 0834 Australian Eastern Standard Time on 13 March 2026, a Robinson R44 II helicopter, registered VH-TCF, departed from Gold Coast, Queensland, for a private flight to Mudgee, New South Wales (NSW), with an intermediate stop at Armidale, NSW, to refuel.

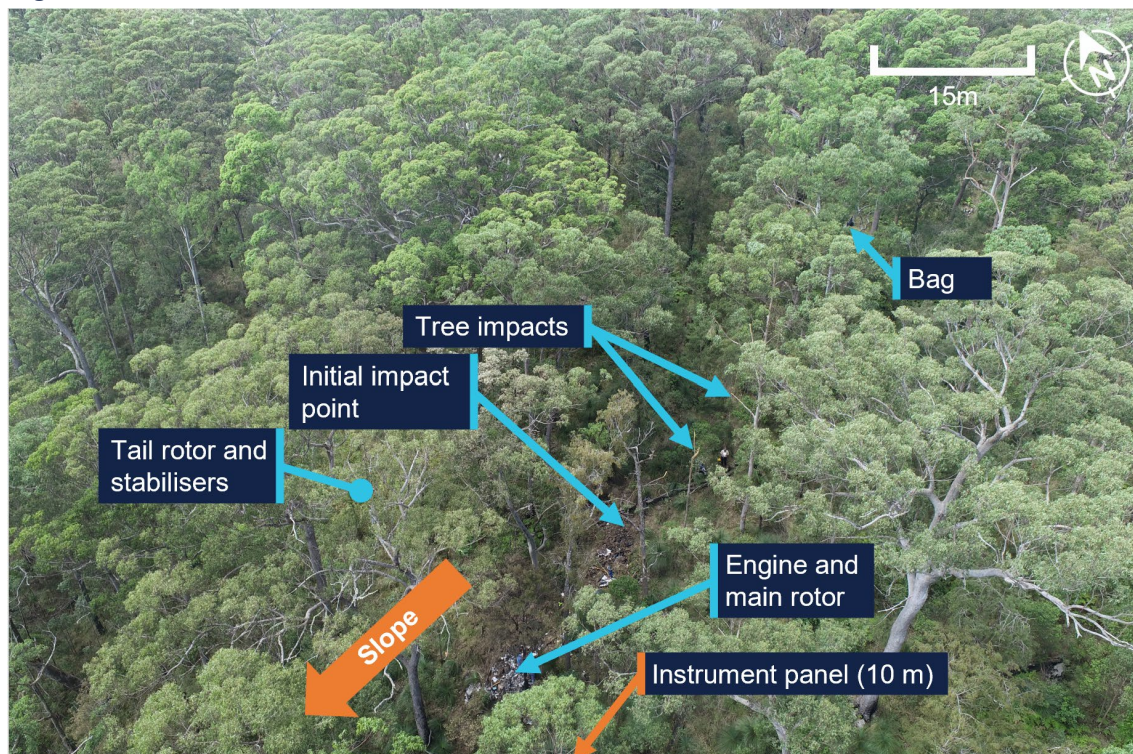
**Figure 4: Accident site**

The wreckage trail was approximately 12 m long in a westerly direction (Figure 4). It consisted of an initial impact point, followed by a trail of debris down the slope leading to the fuselage, engine and main rotor, much of which were consumed by a post-impact fire. Damage was evident on 2 trees located near the initial impact point, indicating the helicopter had struck these trees in a near vertical descent.

The aft section of the tailcone assembly, including the tail rotor and stabilisers, had separated from the fuselage and was located approximately 20 m from the fuselage across the slope through dense vegetation (Figure 4). A large, soft shell travel bag was located in the tree canopy (Figure 4), around 12 m upslope from the initial impact with the trees. Various other items from within the helicopter, such as a headset, were located between the bag and the initial impact site, indicating they had been liberated from the helicopter above the tree line, prior to the initial impact point.

The main instrument panel was located a further 10 m down the slope away from the fuselage.

- all major components were identified at the site
- damage to the cooling fan was indicative of the engine rotating at the time of impact
- damage to, and location of, the instrument panel (Figure 4) was consistent with a high energy liberation event, possibly from a main rotor strike.

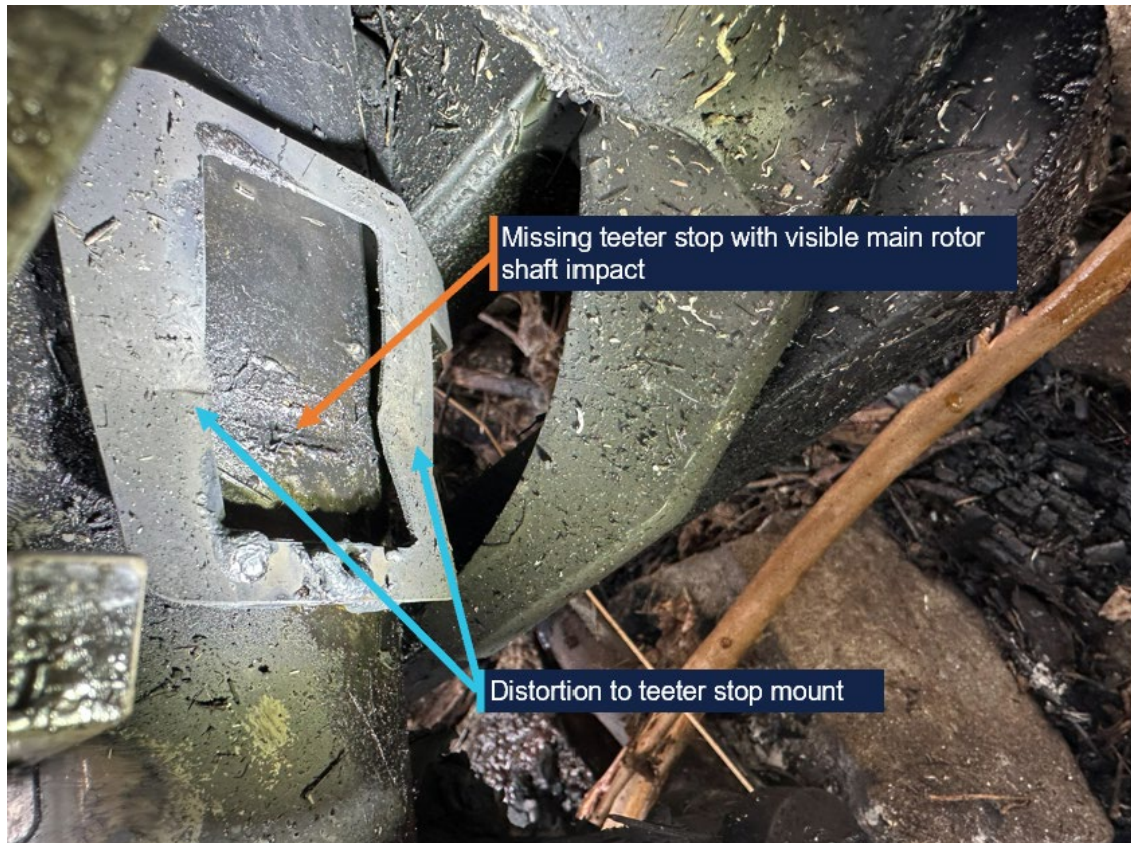
**Figure 5: Example of damage to teeter stop and main rotor shaft on one side**

- one teeter stop had fractured in the centre due to severe impact forces from the spindle, with the upper half liberated
- the other teeter stop was not present (Figure 5)
- both teeter stop stainless steel mounts exhibited distortion from spindle impact (Figure 5)
- impact damage to the main rotor shaft at both teeter stop locations (Figure 5).

Consistent with this, the wreckage examination identified signatures of the main rotor assembly being subject to excessive teeter and mast bumping that resulted in both pitch links failing. Following this, the main rotor blades were free to rotate through various pitch angles, and the helicopter was no longer controllable.

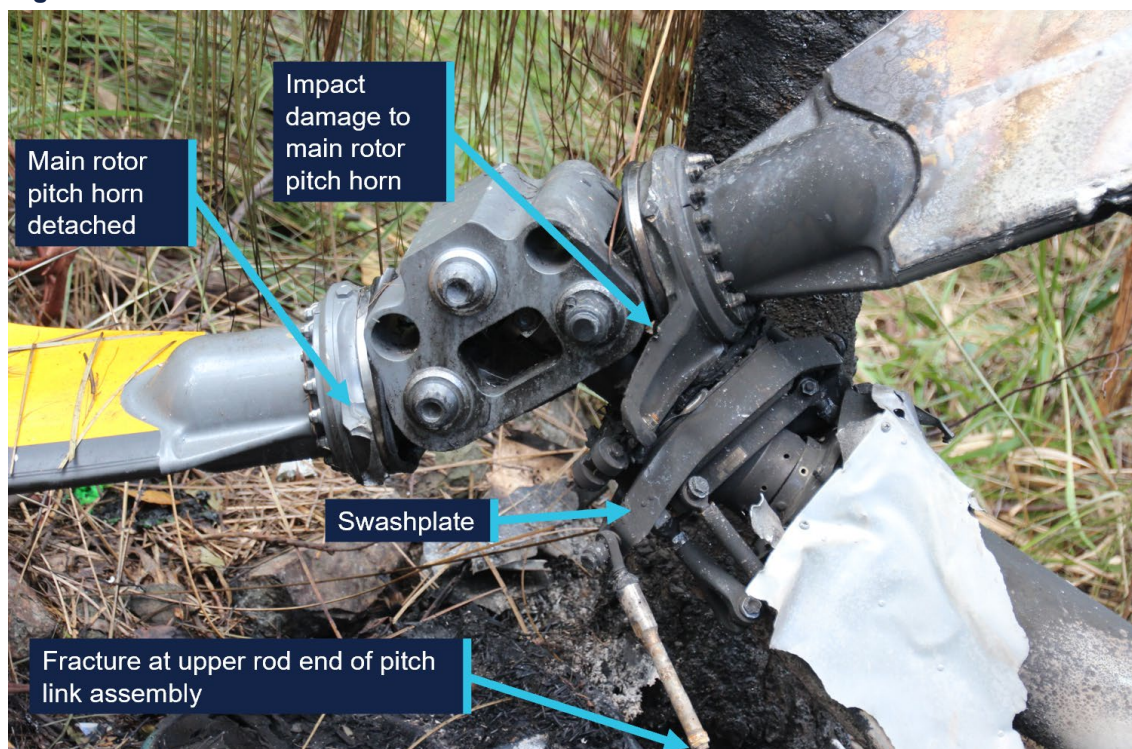
**Figure 6: Main rotor hub**

- both main rotor pitch change links had fractured in overstress, at the upper rod end thread (Figure 6)
- one pitch horn had detached, with the fracture surface consistent with overstress (Figure 6)
- the other pitch horn was secured to the spindle and exhibited damage consistent with contact with the main rotor hub (Figure 6).

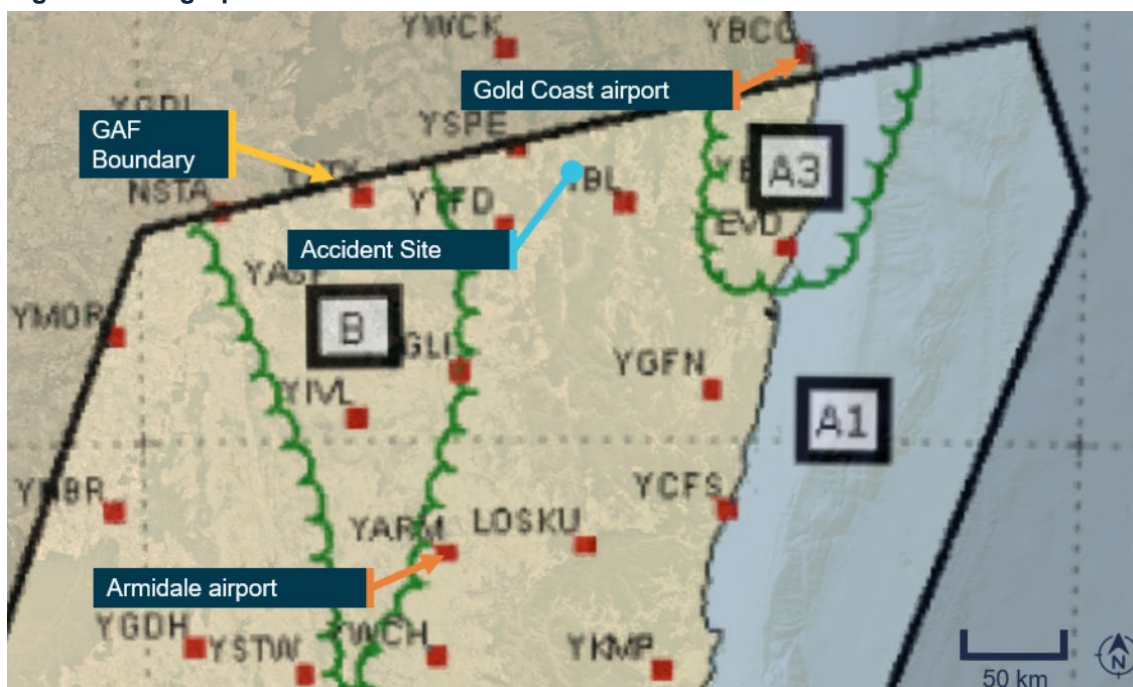
**Figure 7: Geographical area forecast**

The BoM graphical area forecast (GAF),<sup>12</sup> issued at 0809 AEST on 13 March 2026 for the area encompassing the flight path south of Gold Coast to the accident site (Figure 7) included:

- visibility greater than 10 km with broken stratus with bases at 1,500 ft and tops at 2,000 ft and broken stratocumulus with bases at 2,000 ft and tops to 9,000 ft
- visibility 4,000 m in isolated<sup>13</sup> showers of rain with broken stratus with bases at 1,000 ft and tops at 2,000 ft, and broken cumulus/stratocumulus with bases at 2,000 ft and tops to 9,000 ft

- visibility 3,000 m in isolated drizzle with broken stratus with bases at 800 ft and tops at 2,000 ft, and overcast stratocumulus with bases at 2,000 ft and tops to 9,000 ft
- in a small coastal area just south of Gold Coast, isolated thunderstorms and rain were forecast, reducing visibility to 2,000 m with associated cumulonimbus with bases at 2,000 ft and tops above 10,000 ft, broken stratus with bases at 500 ft and tops at 2,000 ft, and broken cumulus/stratocumulus with bases at 2,000 ft and tops above 10,000 ft.

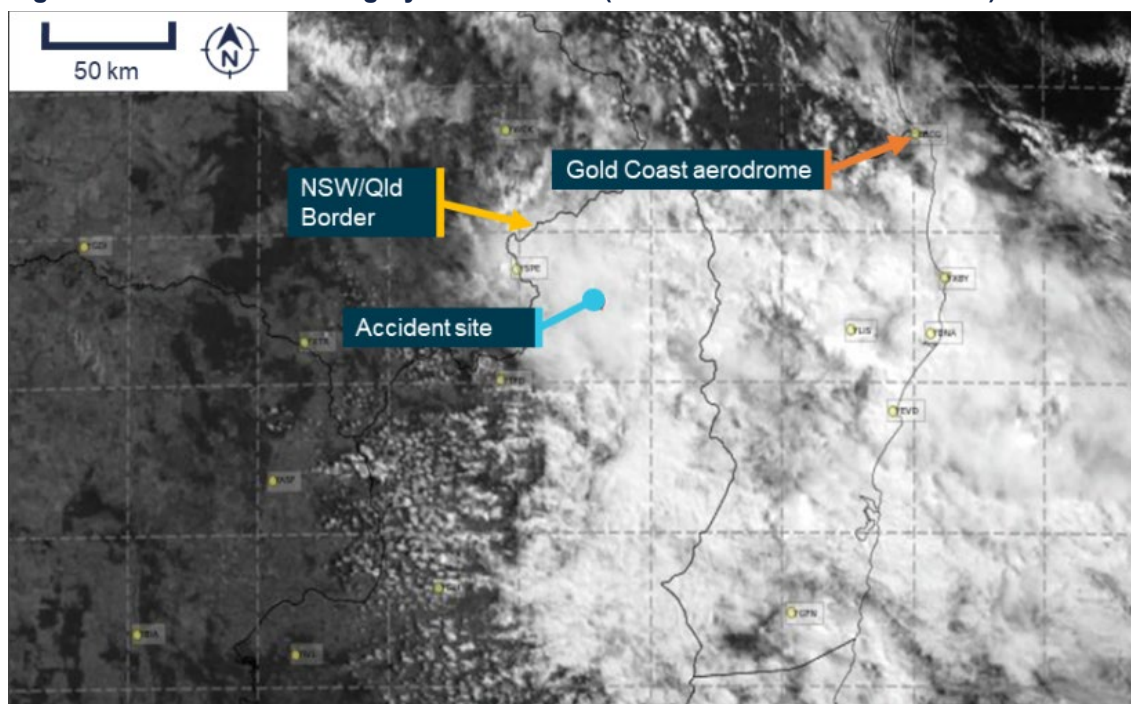
**Figure 8: Satellite cloud imagery at 1040 AEST (6 minutes before the accident)**

High resolution visible satellite imagery showed extensive cloud extending inland to the NSW/Queensland border, including at the accident site (Figure 8).

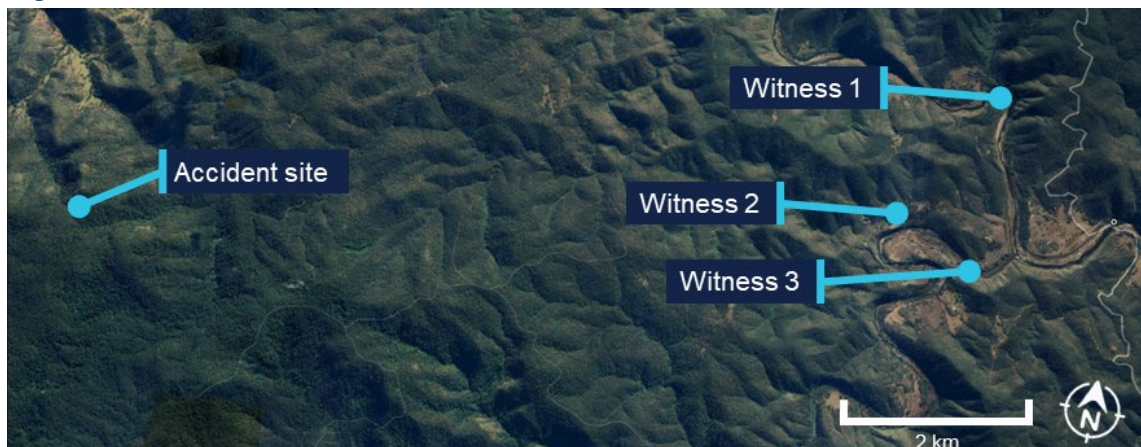
**Figure 9: Witness locations**

Several witnesses located near the accident site (Figure 9) reported very low cloud and drizzle on the morning of the accident. They stated that they observed a helicopter flying

In addition, one witness stated that the helicopter seemed to be stuck below cloud and remarked to their partner that it 'looks like it's trying to find a way out'. Another witness recalled waving at the helicopter and stated that it passed them twice before heading west.
