# **Air traffic control procedural error and serious runway incursion involving Bombardier DHC-8, VH-QOC, and Boeing 737-800, VH-XZG**

Sydney Airport, New South Wales, on 27 July 2026

**ATSB Transport Safety Report**  
Aviation Occurrence Investigation  
AO-2026-086  
Preliminary – 30 September 2026

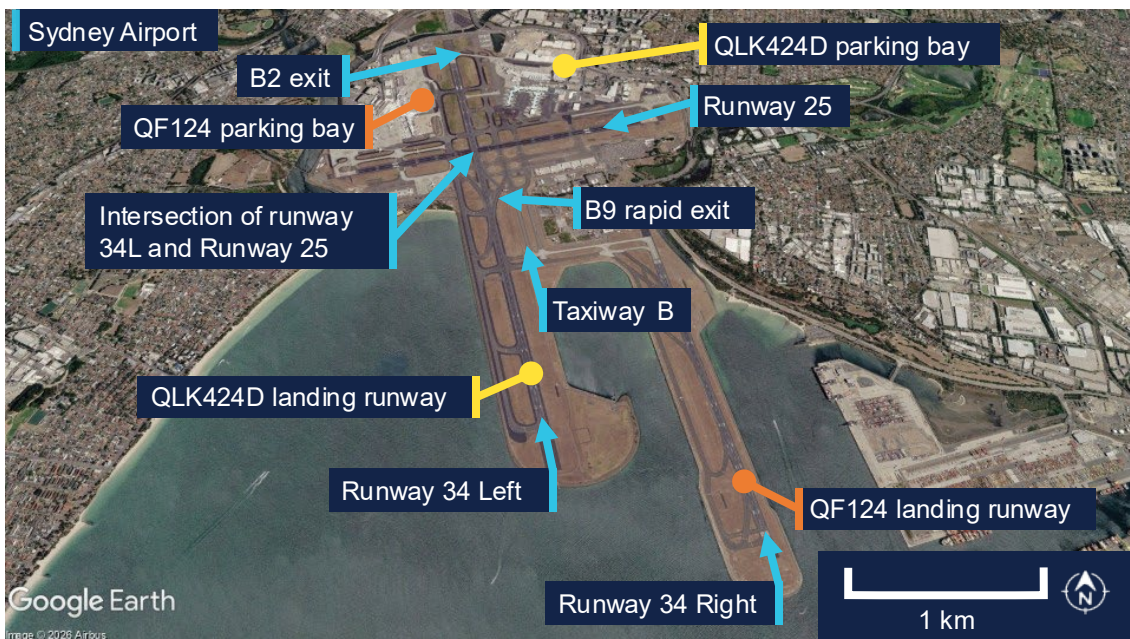
**Figure 1: Sydney Airport with aircraft landing positions and final parking positions**

On the morning of 27 July 2026, a Qantas Boeing 737-800 aircraft, registered VH-XZG, was being operated as flight QF124 from Queenstown, New Zealand, to Sydney, New South Wales, with 2 flight crew, 5 cabin crew and 147 passengers on board. At about 0810 local time (Figure 2, A), the aircraft landed on runway 34 right (R)<sup>1</sup> at Sydney Airport. The flight crew vacated the runway with the intention of taxiing the aircraft to parking bay 11 at the international terminal. The surface movement controller (SMC) east on radio frequency 121.7, who was the air traffic controller responsible for ground movements in that part of the airport, provided the flight crew with initial taxi instructions to follow taxiway Bravo (B) and hold short<sup>2</sup> of runway 25 (Figure 1).

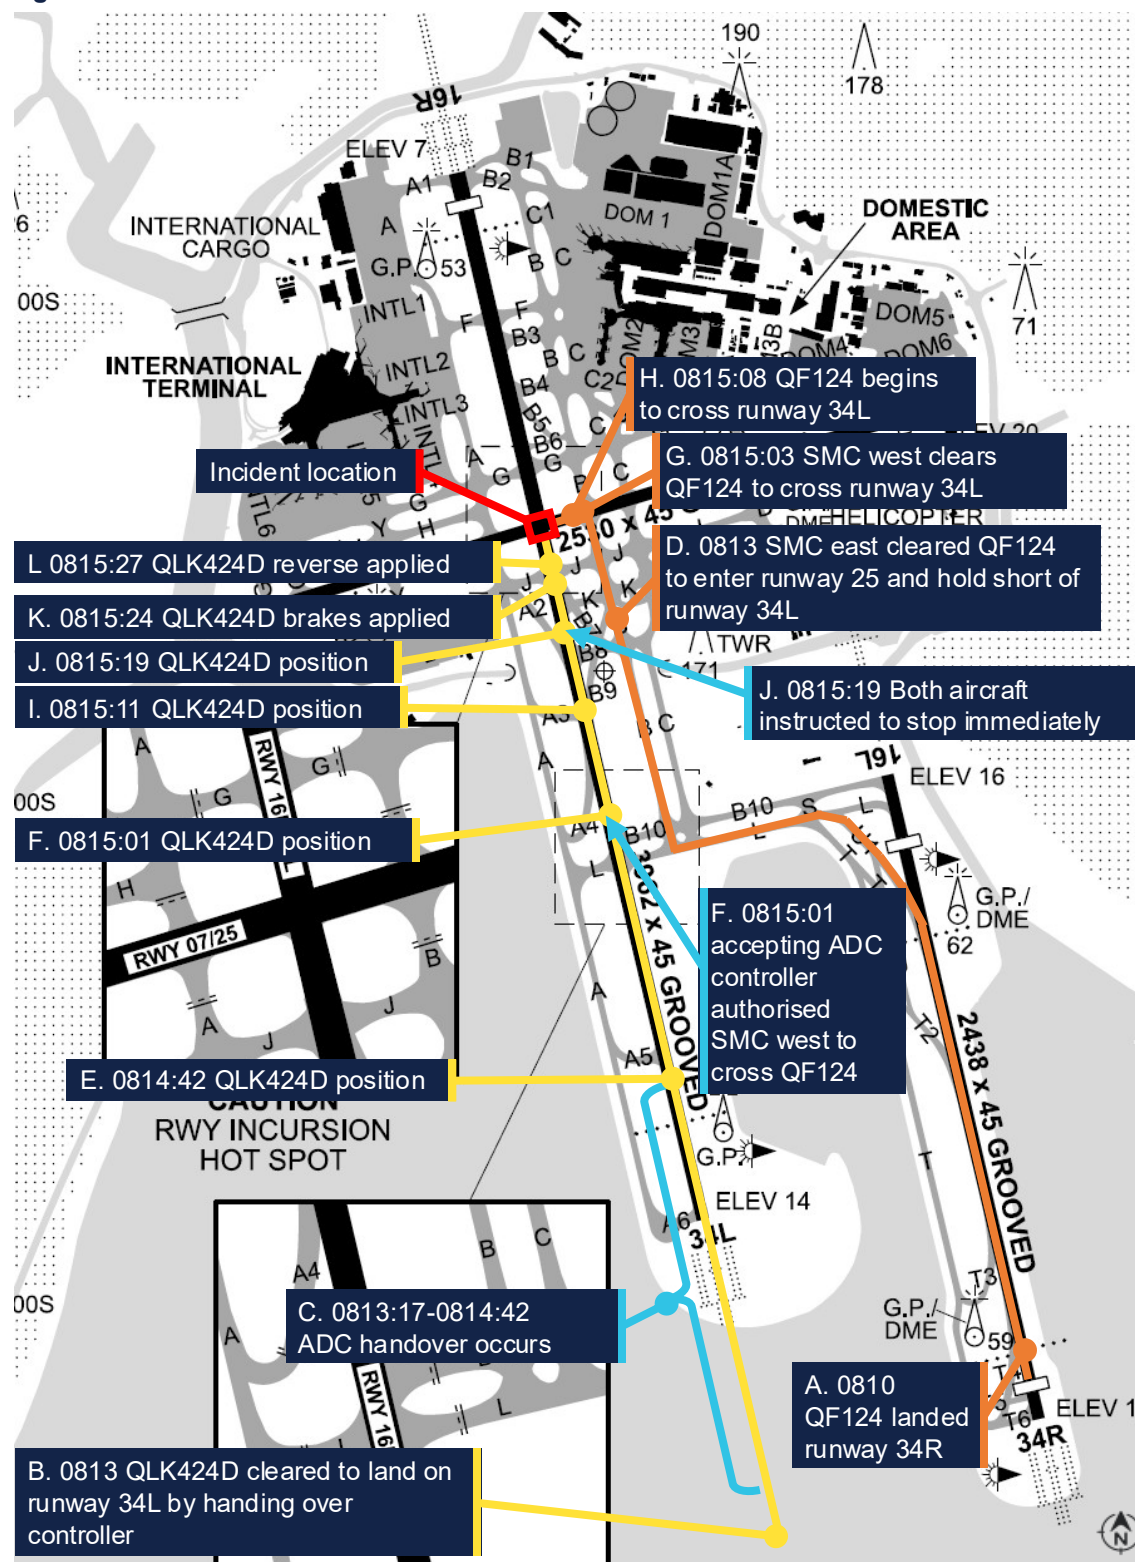
Figure 2: Positions of both aircraft at the times of notable events

At about 0813 (Figure 2, B), a QantasLink Bombardier DHC-8-400 aircraft, registered VH-QOC, operating as flight QLK424D from Canberra, Australian Capital Territory, to Sydney, New South Wales, was on approach to runway 34 left (L) with 2 flight crew,

At the same time (Figure 2, D), QF124 was cleared to enter runway 25, hold short of runway 34L and change radio frequencies from SMC east (frequency 121.7) to SMC west (frequency 126.5). At about 0814, the flight crew of QF124 contacted SMC west and reported their position on runway 25, holding short of runway 34L.

In 25 seconds, between 0814:17 and 0814:42 (Figure 2, C), the outgoing ADC west provided a handover brief to the controller taking over the position. This handover included:

The controller now in charge of ADC west observed QLK424D slowing down and assumed the aircraft would take the rapid exit at B9, which was the expected exit for DHC-8 aircraft if not cleared otherwise. Through internal communications recorded at 0815:01 (Figure 2, F), the ADC west instructed the SMC west to cross QF124 from their current position on runway 25. The SMC west acknowledged that they were clear to make the cross on 25 (Figure 2, G). ADC west extinguished the stop bars<sup>5</sup> and the SMC

west provided clearance to the flight crew of QF124 to cross runway 34L. At approximately 0815:08 (Figure 2, H), the aircraft began moving forward.

At 0815:11 (Figure 2, I), QLK424D passed the B9 rapid exit at an indicated airspeed of approximately 88 kts. While the flight crew of QF124 was reading back their crossing clearance, the SMC west transmitted over that readback to cancel their crossing clearance and instructed them to hold short on runway 34L.

At 0815:19 (Figure 2, J), both the SMC west and ADC west transmitted on their respective frequencies instructing both aircraft to stop immediately.

The captain of QLK424D reported to the ATSB that, at the time of the stop instruction, they were already slowing the aircraft. Flight data from QLK424D showed that brake pressure was applied at 0815:24 (Figure 2, K) and reverse thrust was selected at 0815:27 (Figure 2, L).

QF124 had stopped before reaching the intersection of runway 34L and runway 25 but was within the runway surface area past the runway stop bars resulting in a runway incursion.<sup>6</sup> QLK424D came to a stop prior to the runway 34L and 25 runway intersection. When both aircraft came to a stop, they were approximately 120 m apart.

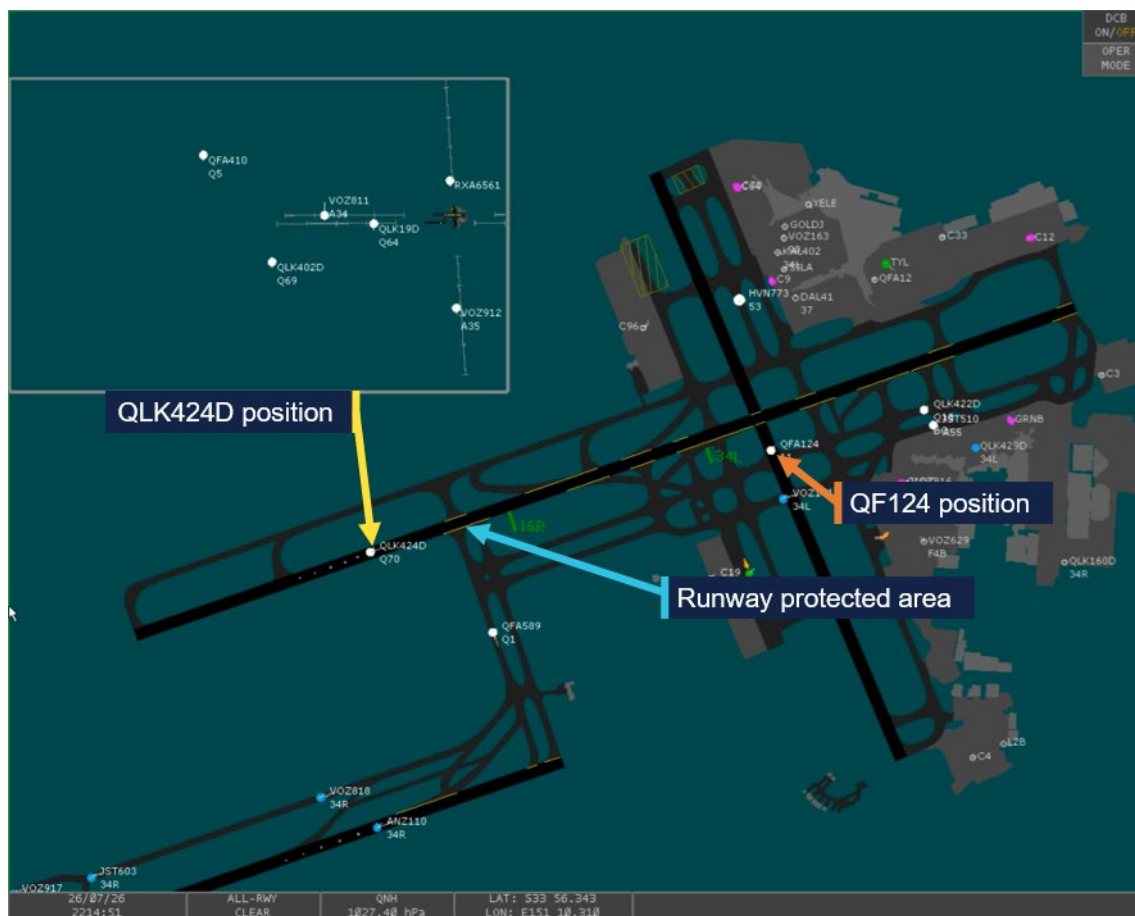
**Figure 4: The advanced surface movement guidance and control system display showing QF124 and QLK424D**

Both the ADC and SMC also had an advanced surface movement guidance and control system (A-SMGCS) display. This system uses many distributed radio frequency sensors and surface movement radar to detect vehicles and aircraft on the airport surface. Aircraft and ground vehicles are fitted with a transponder, which transmits a signal to a receiver at the airport. Used at major airports, the A-SMGCS showed the position of aircraft and ground vehicles on a screen in front of the controller in the tower. When an aircraft met the parameters to occupy the runway, the display would show the runway as protected by displaying yellow lines across the taxiways that intersected that runway (Figure 4). If the safety logic parameters were met, an alert would be generated and provided to controllers. The yellow runway safety lines (Figure 4) were independent of the stop bars.

The controllers reported to the ATSB that an alarm would be triggered if an aircraft crossed the yellow line while the runway was protected. In this occurrence, QF124 had not passed the yellow line, and therefore no alarm was activated.

Airservices provided a recording from the A-SMGCS (Figure 4).

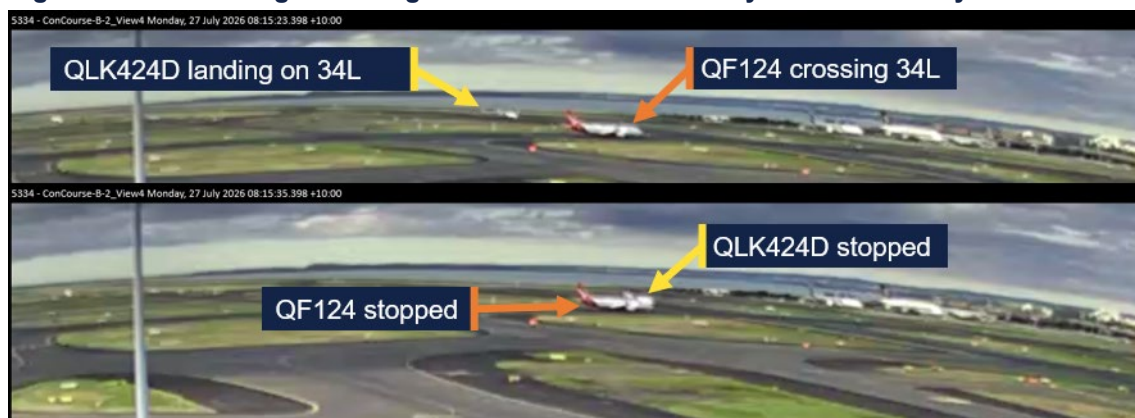
**Figure 5: Video footage showing the intersection of runway 34L and runway 25**

Closed-circuit television (CCTV) footage was provided by Sydney Airport directed towards the intersection of runway 34L and 25. The footage shows the proximity of QLK424D landing on runway 34L and QF124 moving to cross that runway (Figure 5).
