# **Taxiing proximity event involving Airbus A320, VH-VQJ, and Boeing 777, A7-BEU**

Sydney Airport, New South Wales, on 9 August 2026

**ATSB Transport Safety Report**

AO-2026-087

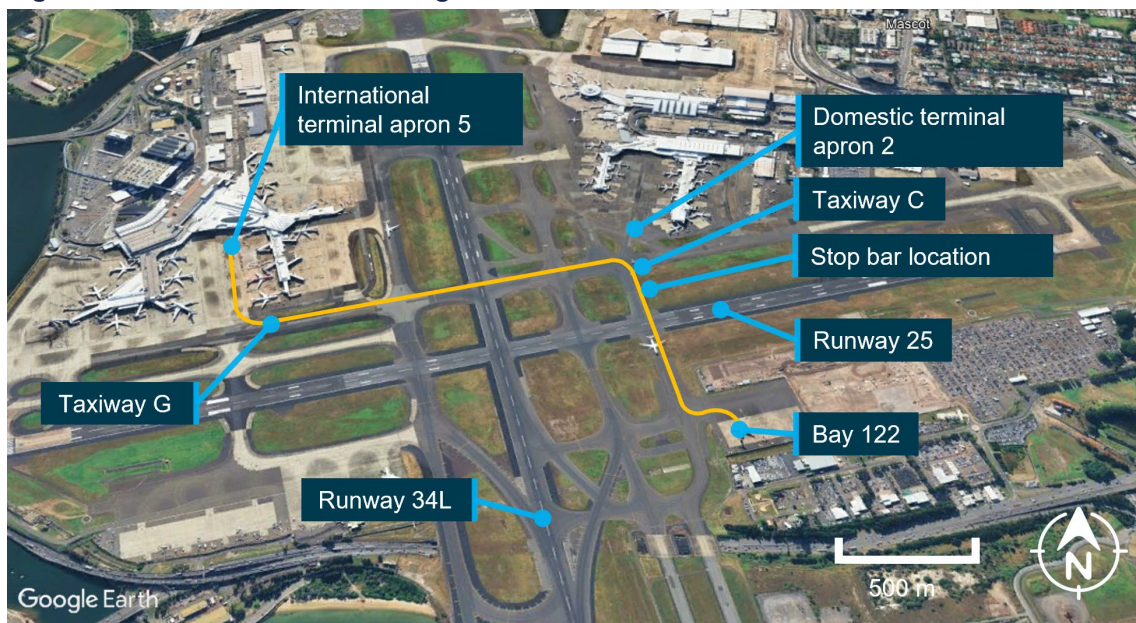
**Figure 1: Planned taxi route for tug in tow with B777**

On 9 August 2026, at 0716:36 local time, a Menzies Aviation Bliss-Fox F1-500-D ground support tractor (tug), callsign 'Silver Victor', began ground towing operations of a Qatar Airways Boeing 777-300ER (B777) aircraft, registered A7-BEU, from the international terminal 5, bay 32 at Sydney Airport, New South Wales, to remote bay 122 for daily storage (Figure 1, Figure 2, A). On board the B777 was an engineer (in the cockpit) and 5 cabin service agents (cleaners), while the tug had the driver and a head-setter<sup>1</sup> monitoring the tow.

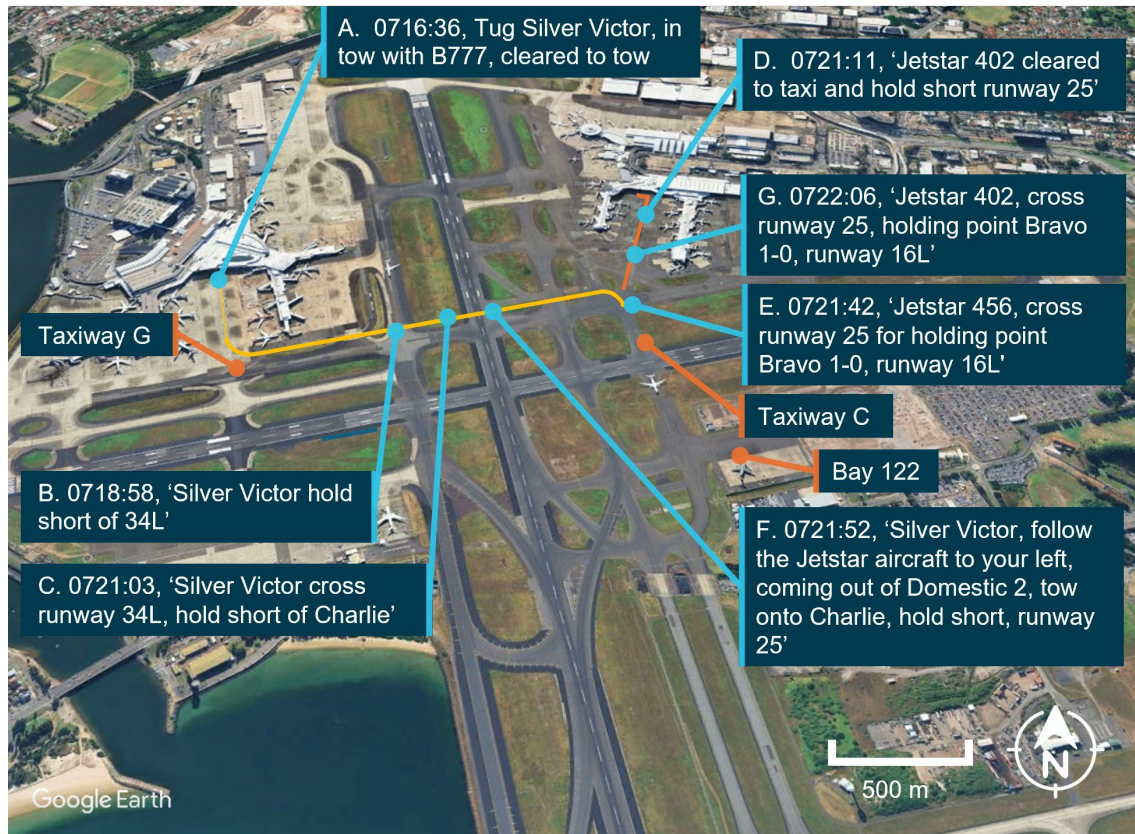
**Figure 2: Aircraft and tow vehicle movements and clearances at Sydney Airport**

heading east on taxiway G, with an instruction to hold short of taxiway Charlie (C) (Figure 2, C).

Three seconds later, a Jetstar Airways Airbus A320-232 (A320) aircraft, registered VH-VQJ (callsign Jetstar 402), with 180 passengers and 6 crew on board, was cleared by the SMC to taxi from domestic terminal apron 2 for a passenger transport flight to the Gold Coast, Queensland. The instructions given to the flight crew were to taxi via taxiway C, follow a preceding Jetstar Airways A320 (callsign Jetstar 456) and hold short of runway 25 (Figure 2, D). At 0721:30, Jetstar 402 began to move.

At 0721:42, the SMC cleared Jetstar 456 to cross runway 25 (Figure 2, E). Six seconds after that transmission, before finishing crossing runway 34L with the B777 in tow, Silver Victor was cleared to follow a 'Jetstar aircraft' to their left coming out of domestic apron 2, 'tow onto taxiway Charlie and hold short of runway 25' (Figure 2, F). The tow driver responded that they would 'follow the Jetstar, tow onto Charlie and hold short of runway 25'.

As Jetstar 456 approached the holding point to begin its cross of runway 25, Jetstar 402 departed the domestic terminal apron and tracked towards taxiway C. At 0722:06, Jetstar 402 was given clearance by the SMC to cross runway 25 (Figure 2, G). The captain, who was the pilot flying,<sup>4</sup> recalled proceeding along taxiway C towards the runway at about 15 kt.

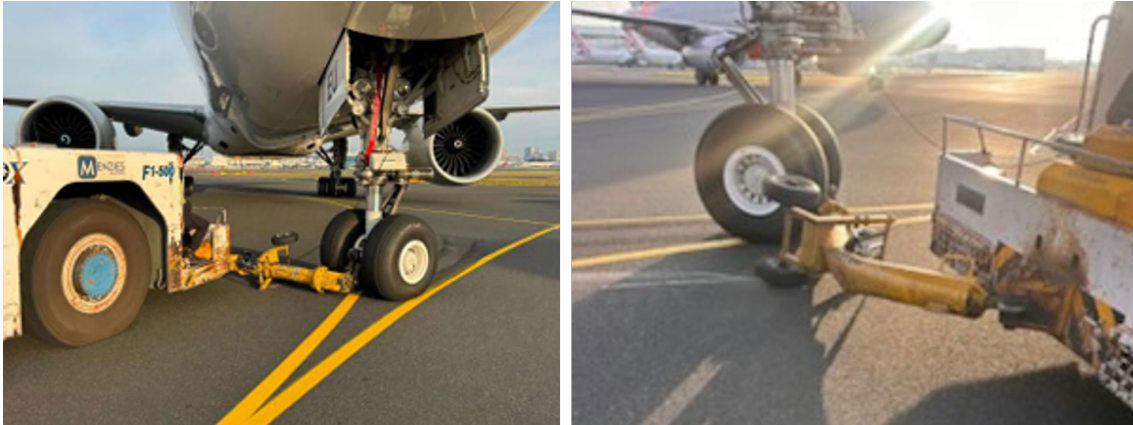
**Figure 3: Damage to the aircraft tow bar**

However, during the initial emergency stop performed by the tug driver, the tow bar, compressed under the heavy braking pressure and aircraft momentum, deformed and obstructed the B777 nosewheels, which prevented further rotation and caused minor damage (Figure 3). There were no injuries to those on the tug or in the B777.

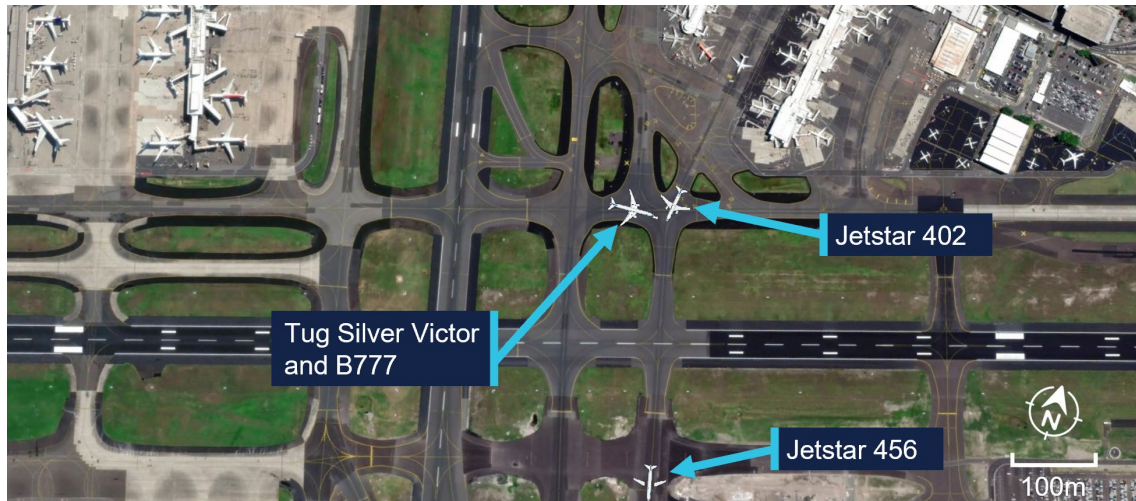
**Figure 4: Proximity of tug and aircraft post-event**

The tug in tow with the B777 and Jetstar 402 came to a stop with less than 30 m separation (Figure 4). Further manoeuvring by the tug vehicle was not possible due to the failure of the tow bar.

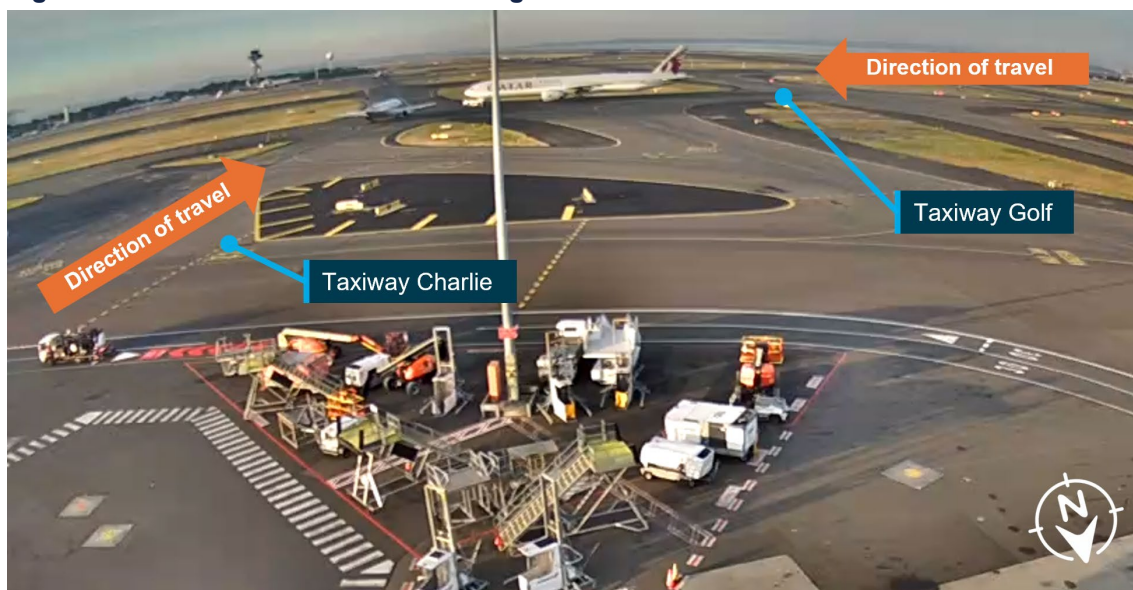
**Figure 6: Closed-circuit television footage of intersection**

Closed-circuit television footage was provided by Sydney Airport directed towards the intersection of taxiway C and G. The footage shows the approach of both the B777 under tow on taxiway G and Jetstar 402 during taxi on C (Figure 6).
