# Air traffic control procedural error and runway incursion involving Boeing 737-8SA, VH-IJQ, and Boeing 737-838, VH-XZH

Sydney Airport, New South Wales, on 9 August 2026

AO-2026-090

Preliminary – 30 September 2026

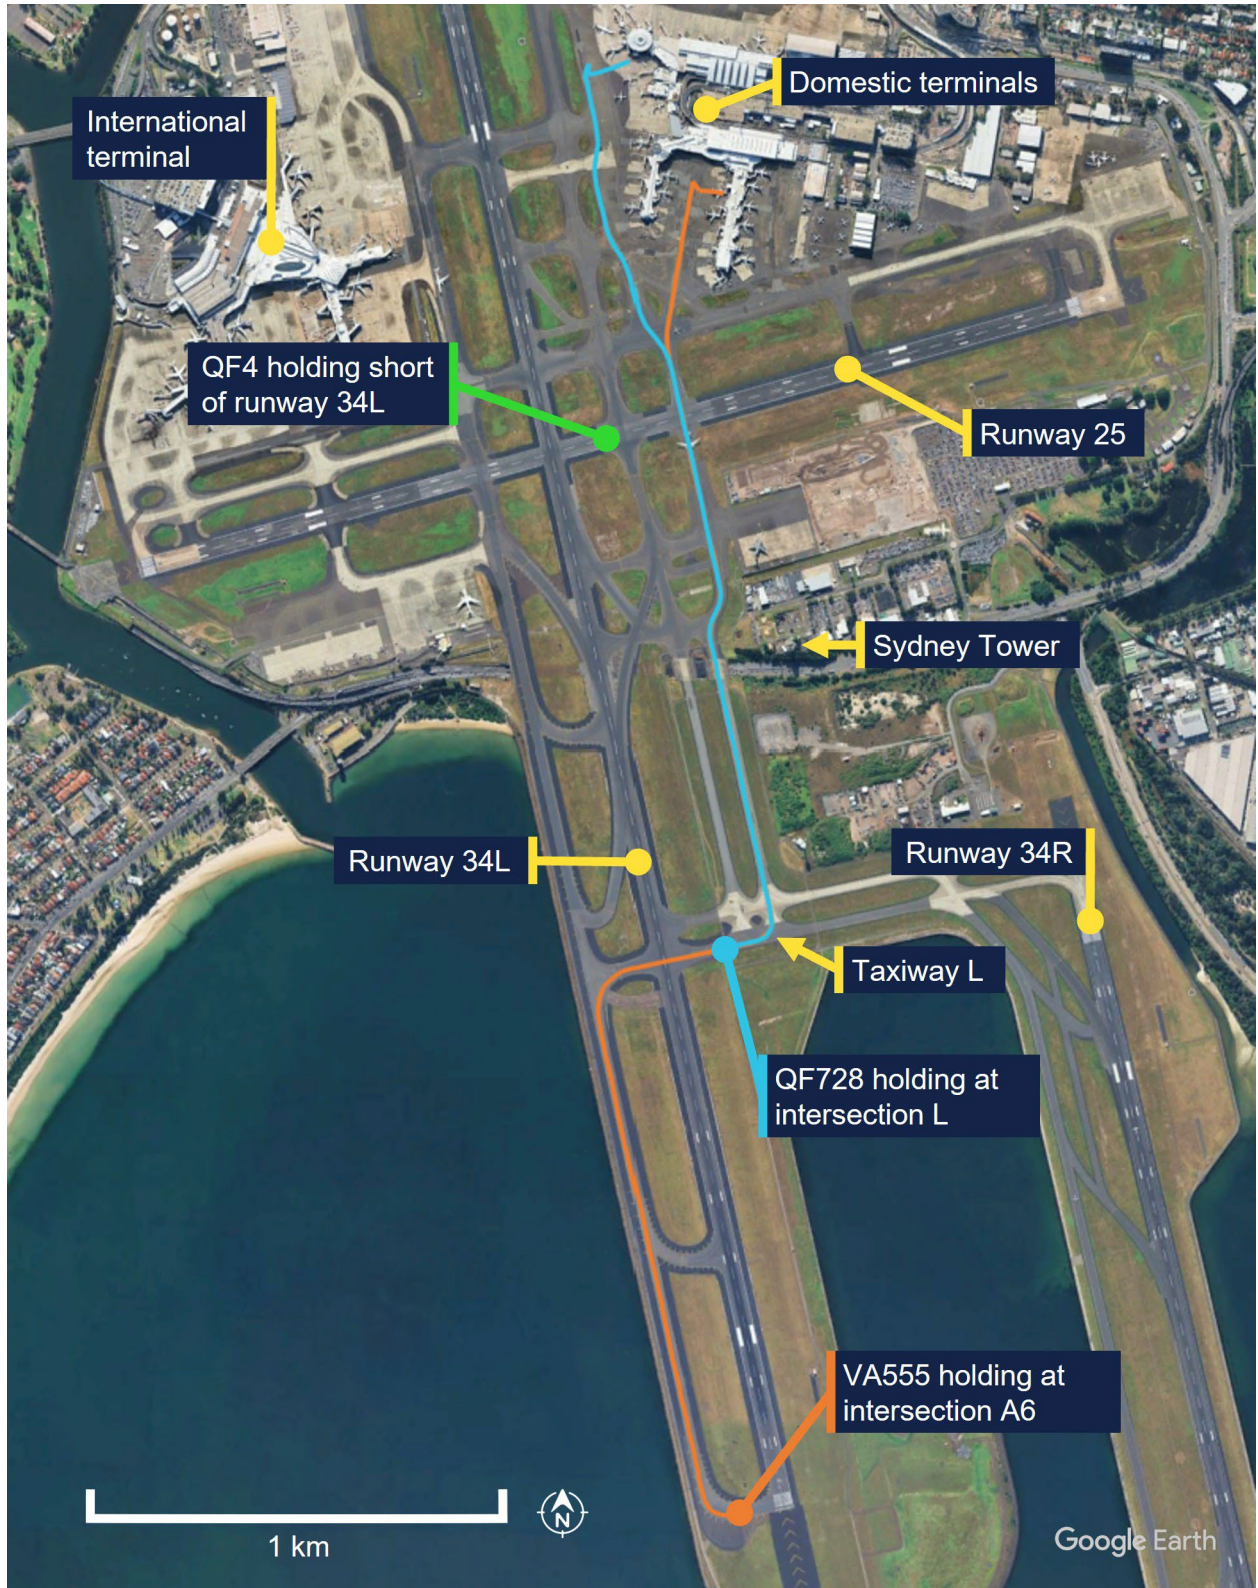
Figure 1: VA555 and QF728 taxi route and positions at 1003:48

Both aircraft had departed from Sydney's domestic terminal and the taxi routing from the terminal to runway 34L required all aircraft to cross the runway to facilitate a full-length departure. VA555 had departed the domestic terminal 7 minutes ahead of QF728 and was next in line to take off from intersection A6 on runway 34L. QF728 had followed the same routing and had been instructed to hold at the intersection of runway 34L and taxiway L (Figure 1). At the same time, QF4, a Boeing 787 that had recently landed on runway 34R was taxiing to the international terminal. QF4 was taxiing on the cross-runway (runway 25) and holding at the intersection with runway 34L awaiting a clearance to cross from the SMCW.

At 1003:45, the ADCW coordinated<sup>2</sup> with the SMCW, advising the SMCW to allow QF728 to cross runway 34L on taxiway L behind a landing aircraft. The ADCW later recalled that they also intended to coordinate with the SMCW to allow QF4 to cross runway 34L behind the same landing aircraft.

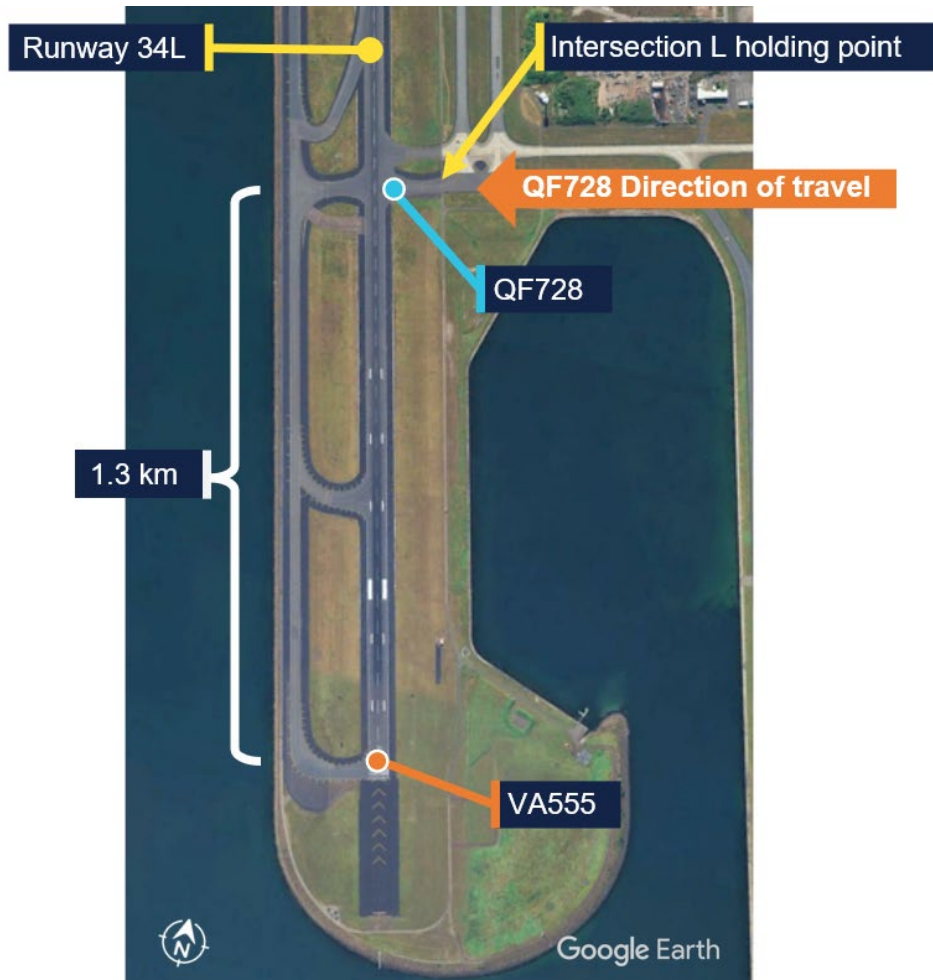
**Figure 2: QF728 and VA555 positions at 1004:48**

At 1004:48, the ADCW issued a take-off clearance to VA555, which the FO immediately acknowledged. At this time QF728 was occupying the runway protected area<sup>6</sup> 1.3 km ahead of VA555 (Figure 2).

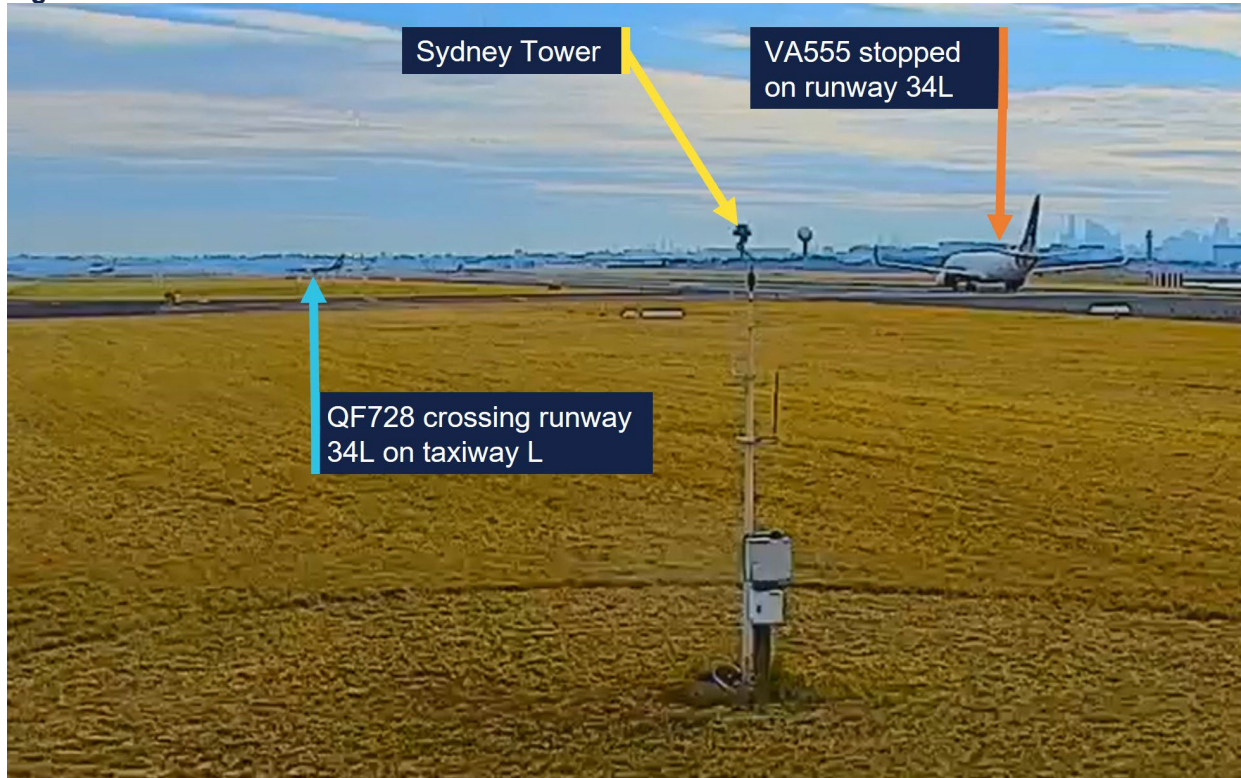
**Figure 3: VA555 and QF728 at about 1004:56**

At 1004:56, the ADCW issued VA555 with a take-off clearance cancellation, which was acknowledged by the FO. At about the same time, the captain of VA555, having observed QF728 enter the runway at taxiway L, retarded the thrust levers as both engine N1<sup>7</sup> indications reached 33% and brought the aircraft to a stop (Figure 3). Meanwhile, QF728 continued to taxi across runway 34L on taxiway L and exited the runway protected area at 1005:11.
