# Taxiing conflict involving Airbus A321, VH-OGA, and Boeing 737, VH-VXL

Sydney Airport, New South Wales, on 18 August 2026

AO-2026-091

Preliminary – 30 September 2026

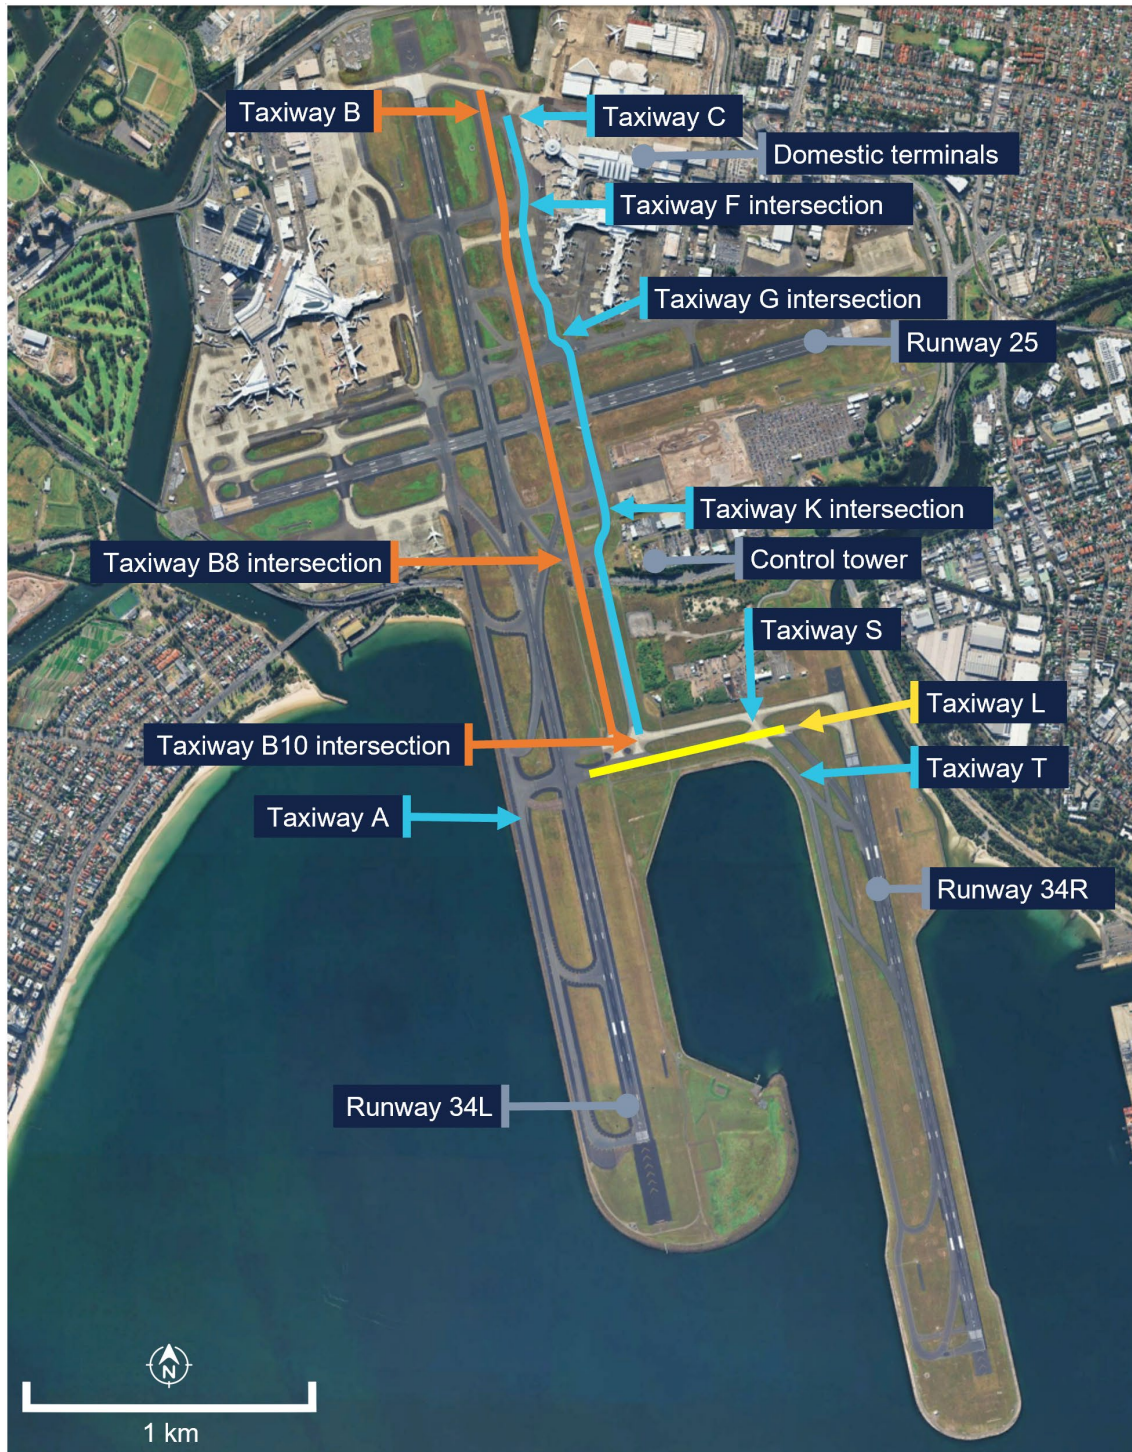
**Figure 1: Sydney Airport with key taxiways and intersections**

For the second departure, the flight crew decided to use the longer runway 34L. At around 0800, the flight crew contacted the surface movement controller (SMC) east, the air traffic controller responsible for ground movements in that part of the airport, and requested permission to taxi from the domestic terminal to runway 34L. The SMC east instructed the flight crew to follow the standard taxi route and initially to hold short of taxiway F (Figure 1).

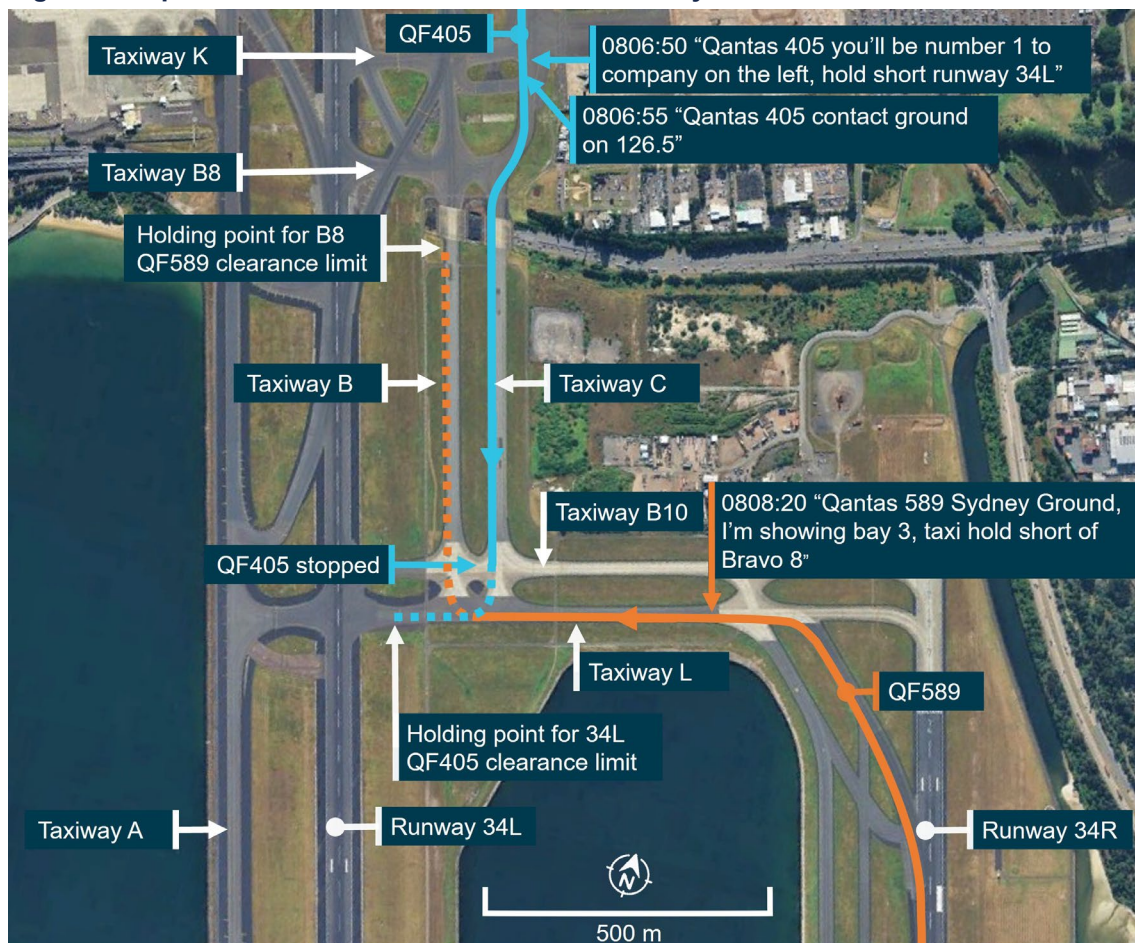
**Figure 2: Expanded view of aircraft taxi routes with key ATC communications**

Sydney Airport's standard taxi route from the domestic terminal to the threshold of runway 34L was along taxiways C, L and A, crossing runway 34L on taxiway L (Figure 2). As the aircraft moved south on taxiway C, the controller progressively extended the limit of its taxi clearance, first to hold short of taxiway G, and subsequently to cross runway 25 and hold short of taxiway B10.

At 0806, as the aircraft passed south of taxiway K, the SMC east informed the crew of QF405 that '... you'll be number 1 to company on the left ...' meaning that they had priority in sequence<sup>2</sup> over another taxiing Qantas aircraft that would approach them from their left (Figure 2).

At about 0808, a Qantas Airways Boeing 737-800, registered VH-VXL, operating flight Qantas 589 (QF589) from Gold Coast, Queensland, exited runway 34R after landing at Sydney. The aircraft had 2 flight crew, 4 cabin crew, and 144 passengers on board. As the aircraft entered taxiway L (Figure 2), the flight crew contacted the SMC east and

The published standard taxi route required the aircraft to continue along taxiway L then turn right onto taxiway B (Figure 2). After acknowledging the correct parking bay allocation, the crew readback the taxi clearance and the aircraft continued along taxiway L. The SMC east did not advise the flight crew of any sequence priority over other taxiing aircraft and did not mention QF405. The flight crew of QF405 did not recall hearing the communications between the SMC east and QF589, likely because they had already switched to the SMC west radio frequency.

As the flight crew of QF405 approached taxiway L, they sighted QF589 moving from east to west on that taxiway and identified it as the aircraft over which they had been given priority. As the 2 aircraft converged, the flight crew of QF405 noted that QF589 did not appear to be slowing and assessed that it would not give way to them. Having already slowed to navigate the turn onto taxiway L, the captain of QF405 applied additional braking and brought the aircraft to a stop, just beyond the holding point for taxiway B10, but short of taxiway L. QF589 continued its taxi along L, passing in front of QF405 at around 0809, then turned north onto taxiway B.

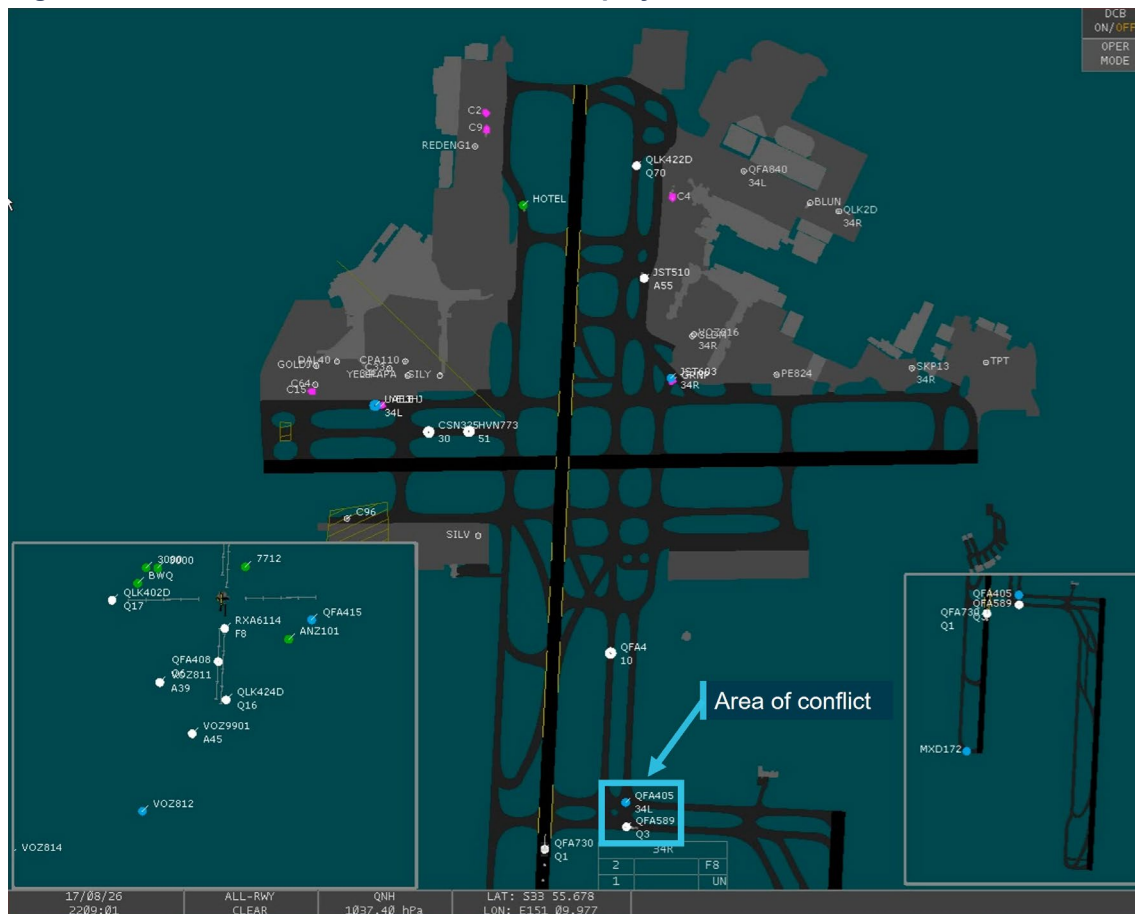
**Figure 3: A reconstruction of the A-SMGCS display around the time of the occurrence**

The SMC and ADC positions were equipped with advanced surface movement guidance and control system (A-SMGCS) displays (Figure 3). The A-SMGCS displayed the positions of aircraft and ground vehicles on a screen in front of the controller in the tower.

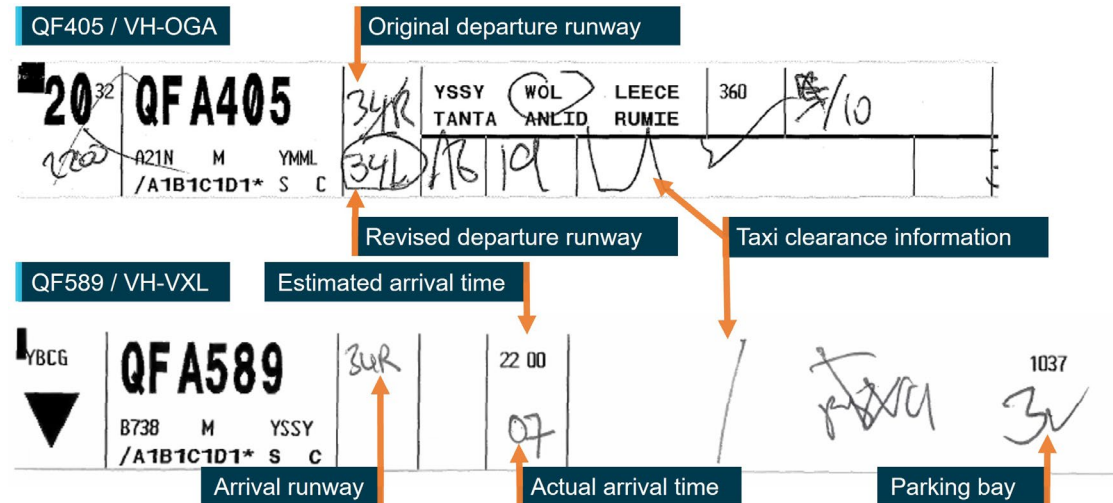
**Figure 4: Flight progress strips for QF405 and QF589**

Controllers used physical flight progress strip (FPS) to keep track of aircraft details and positions (Figure 4). The FPS were moved between different controller positions as aircraft moved around the aerodrome and transferred between controller frequencies. Within control positions, controllers arranged the FPS on a flight progress board to indicate the aircraft sequence, and which aircraft were cleared to occupy a runway.

Controllers were able to mark the FPS to record specific information, such as the limit of an aircraft's taxi clearance.

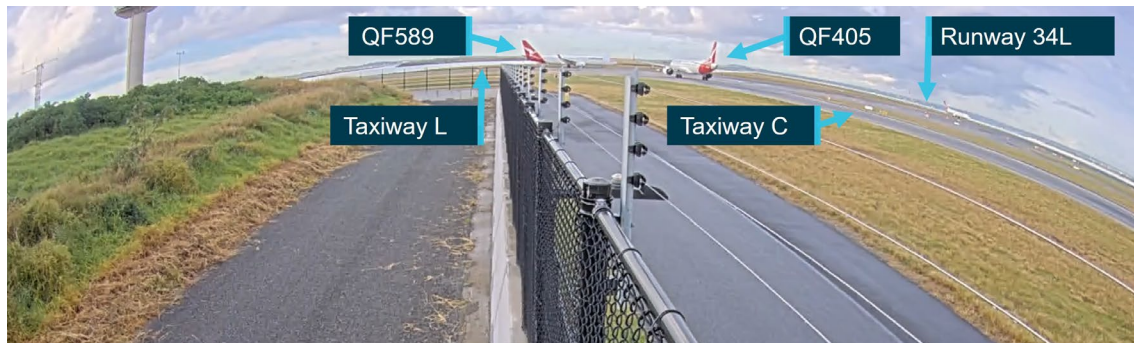
**Figure 5: CCTV image of intersection of taxiways C and L**

Sydney Airport provided recordings of closed-circuit television (CCTV) footage covering the area around the intersection of taxiways C and L (Figure 5). This captured the movements of QF589 and QF405 at the time of the occurrence.
