# Collision and derailment of trains 1150 and T296

Port Botany, New South Wales, on 13 January 2023

RO-2023-002

Final – 24 September 2026

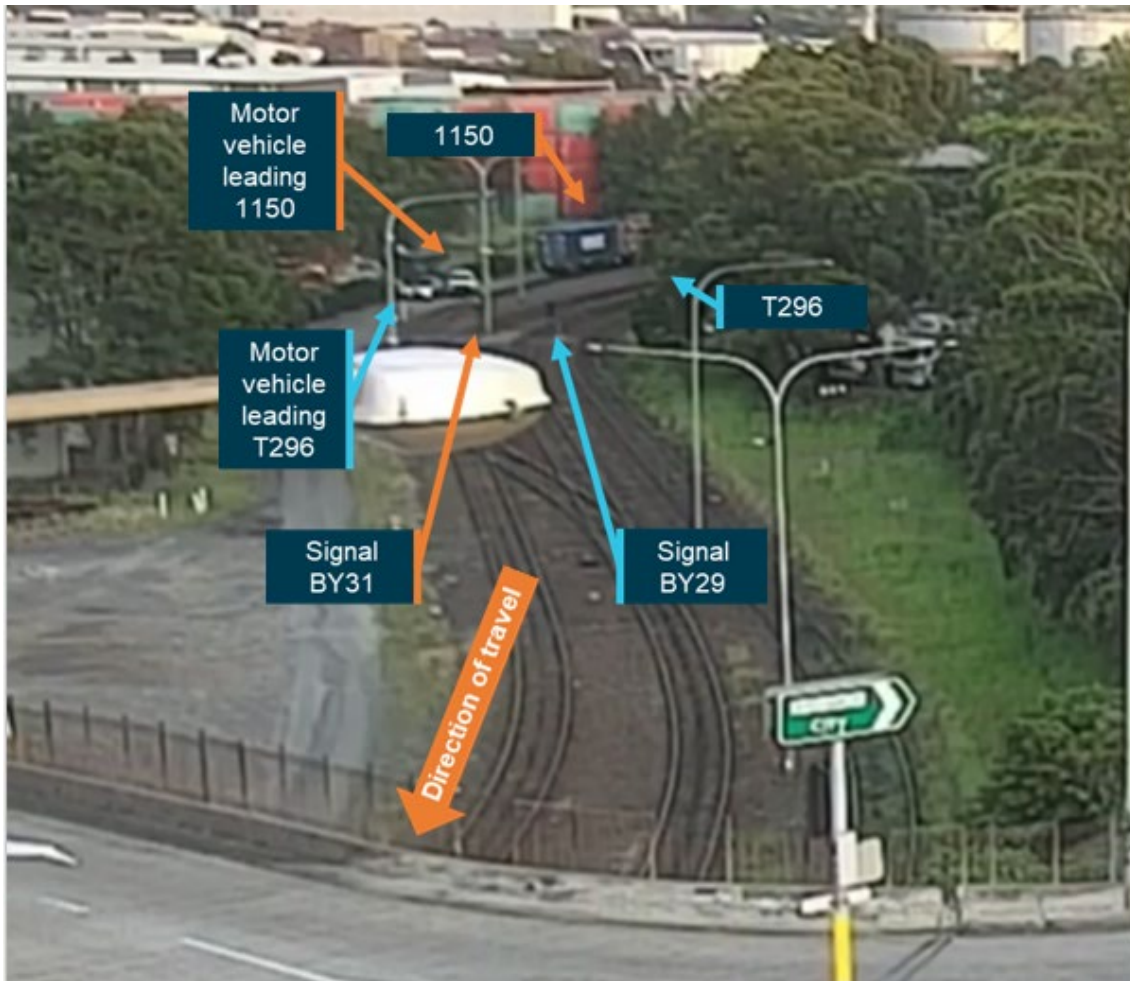
**Figure 1: Trains 1150 and T296 prepare to propel to the Stevedore Ports**

<sup>4</sup> Signals BY29 and BY31 were shunting signals that protected 163 points which converged arrival roads 1 and 2 into one track at the stevedore end (southern end) of Port Botany yard.

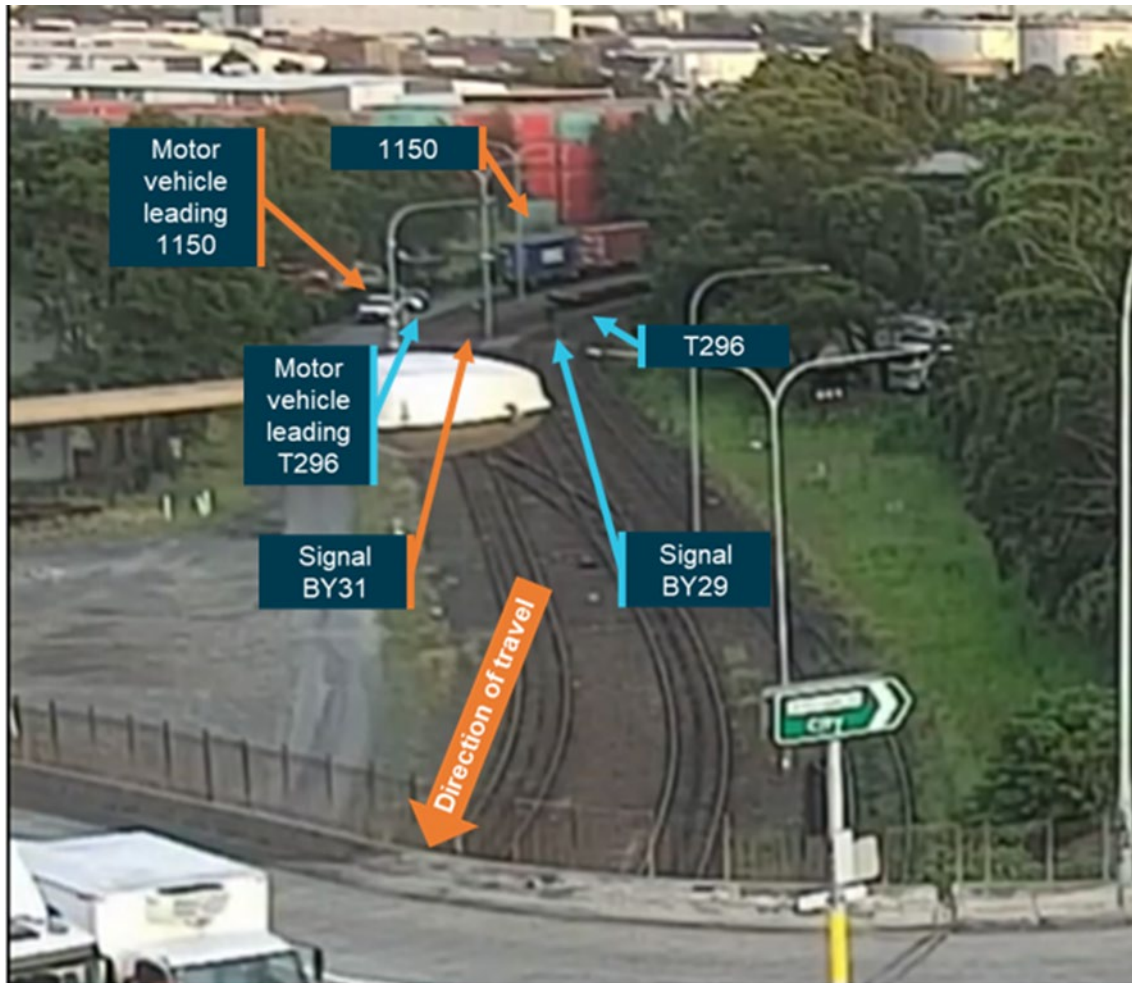
**Figure 2: T296 commencing its authorised propelling movement**

The lead wagon on T296 passes signal BY29 indicating proceed at 0606:17. Adjacent signal BY31 for 1150 located on arrival road 2 remained in the stop position (Figure 2).

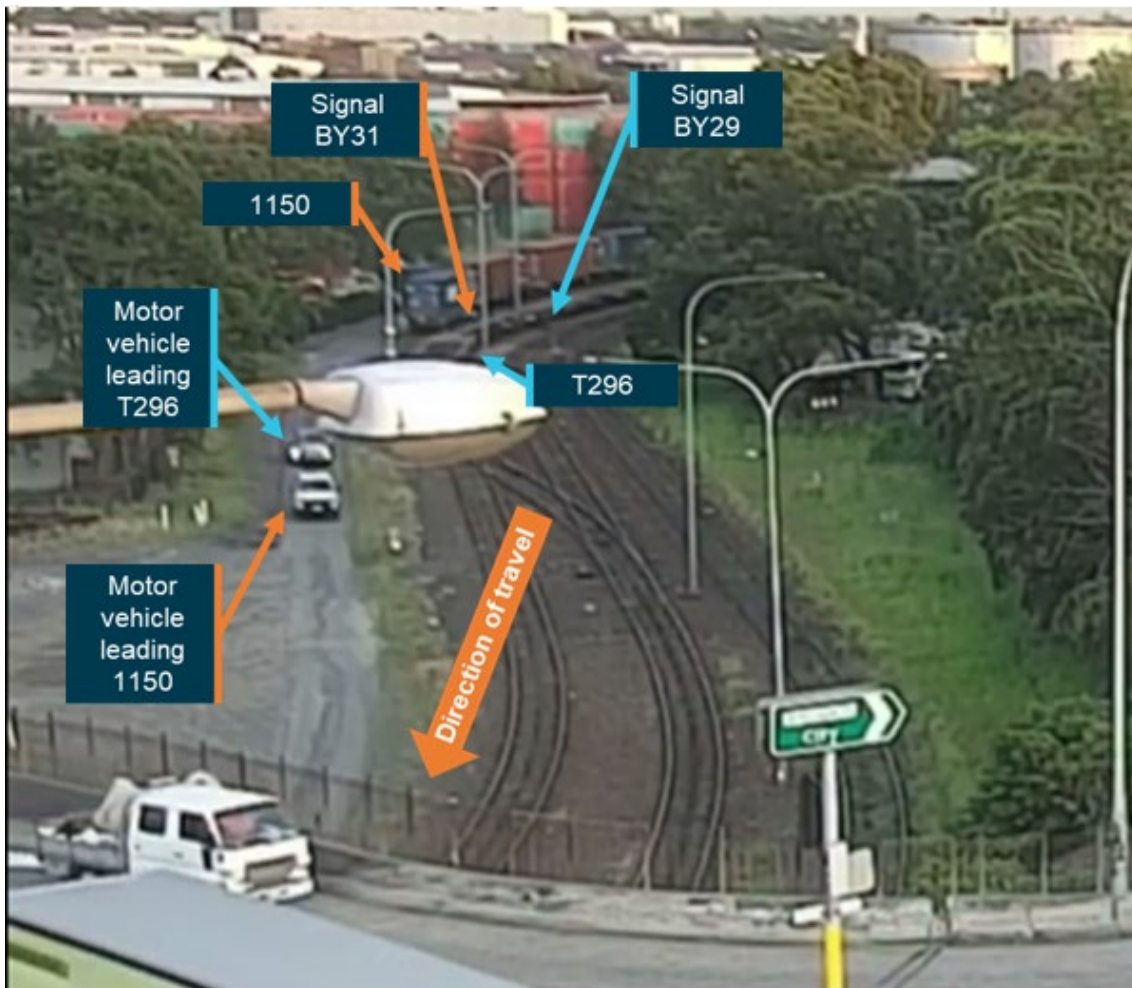
Figure 3: Motor vehicles for 1150 and T296 moving away from the propelling trains

Both motor vehicles are then observed on CCTV footage to be moving simultaneously with the movement of T296, towards the stevedore ports, with both vehicles eventually well ahead of, and facing away from, their propelling trains (Figure 3).

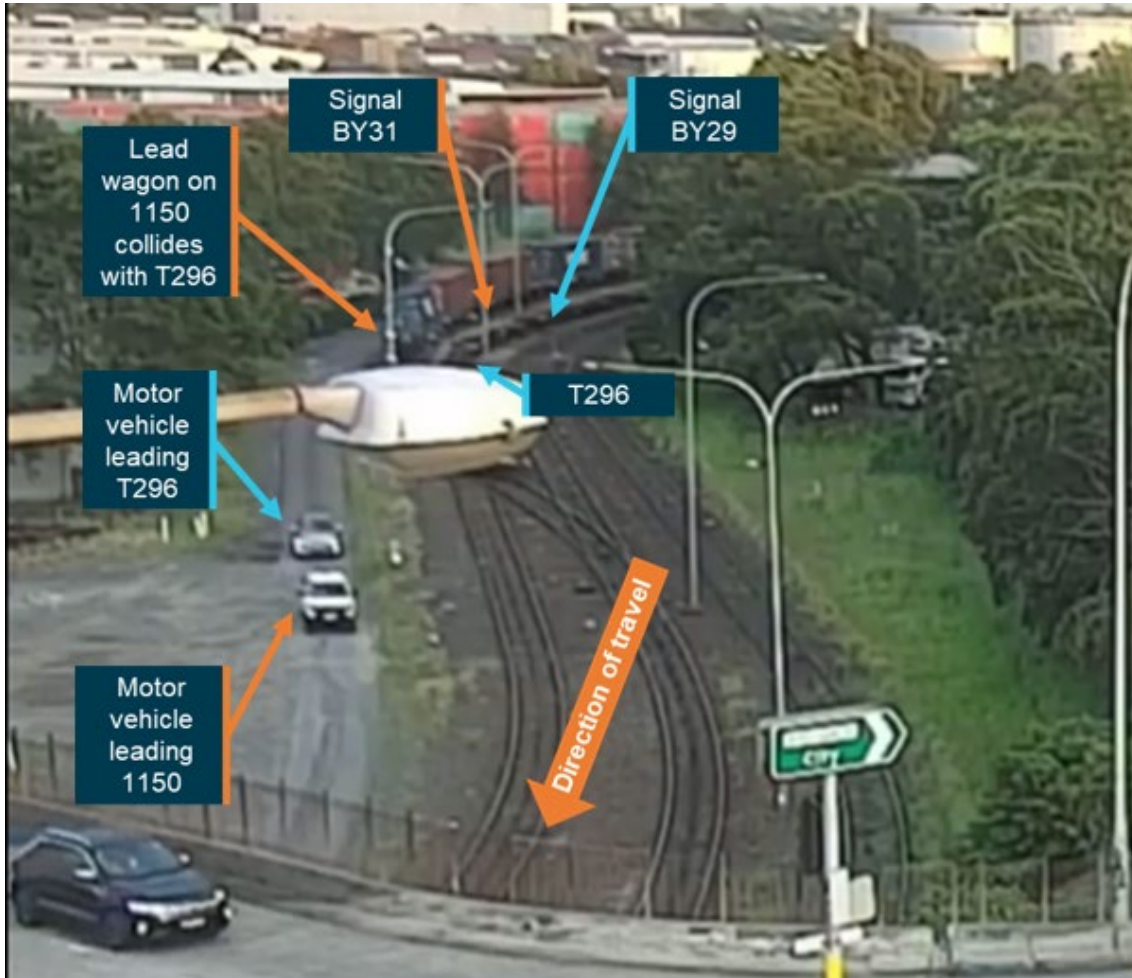
**Figure 4: Train 1150 colliding with the side of T296**

On train T296, the collision caused 4 wagons to derail and the fourth wagon to collide with a yard light pole. This pole then fell to the ground across tracks, triggering track circuit alarms on the network controller's panel, alerting the NCO to an issue in the yard.

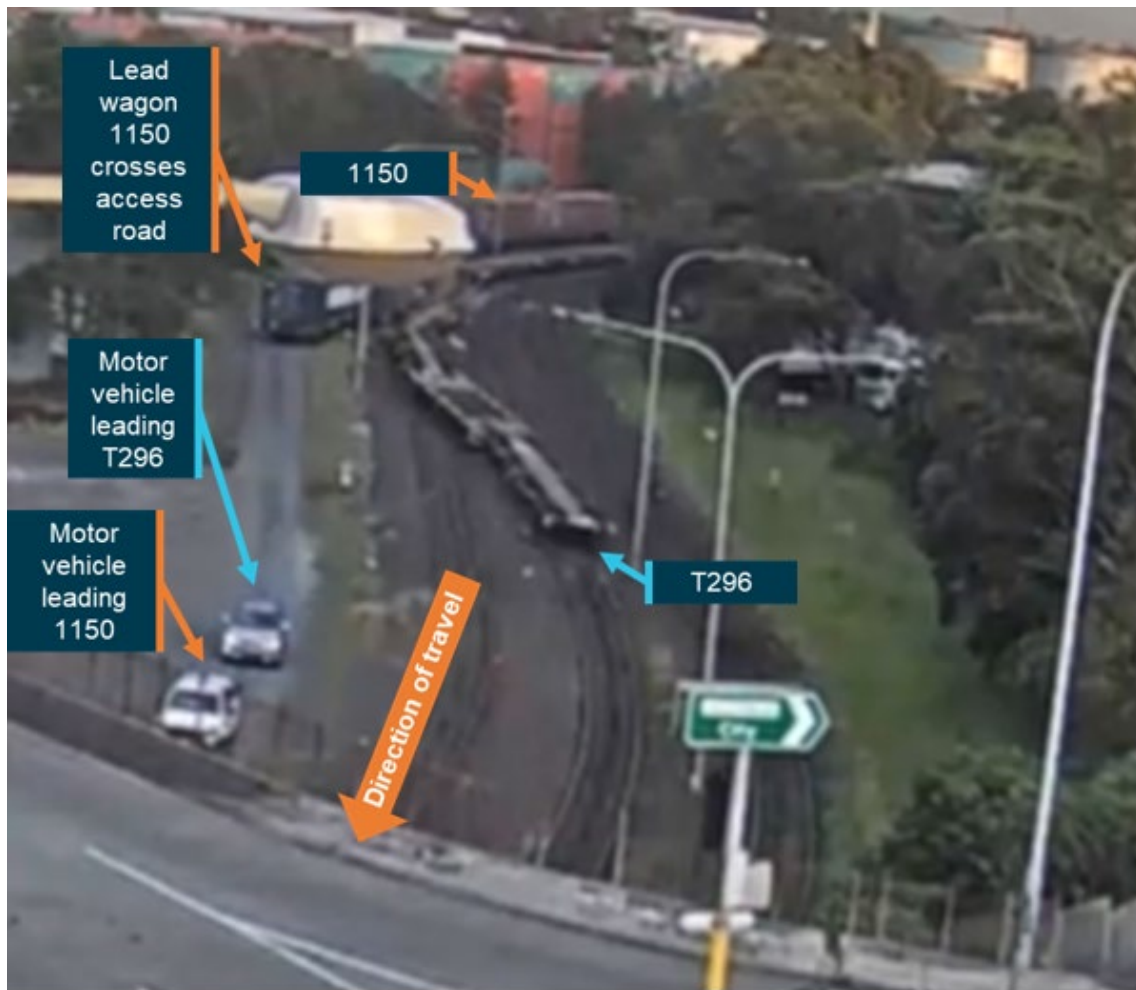
Figure 5: Train 1150 derailing with wagon crossing the access road

As a result of the collision, several wagons from both trains derailed and sustained significant damage. One derailed wagon crossed a vehicle access road and came to rest against a privately-owned building.

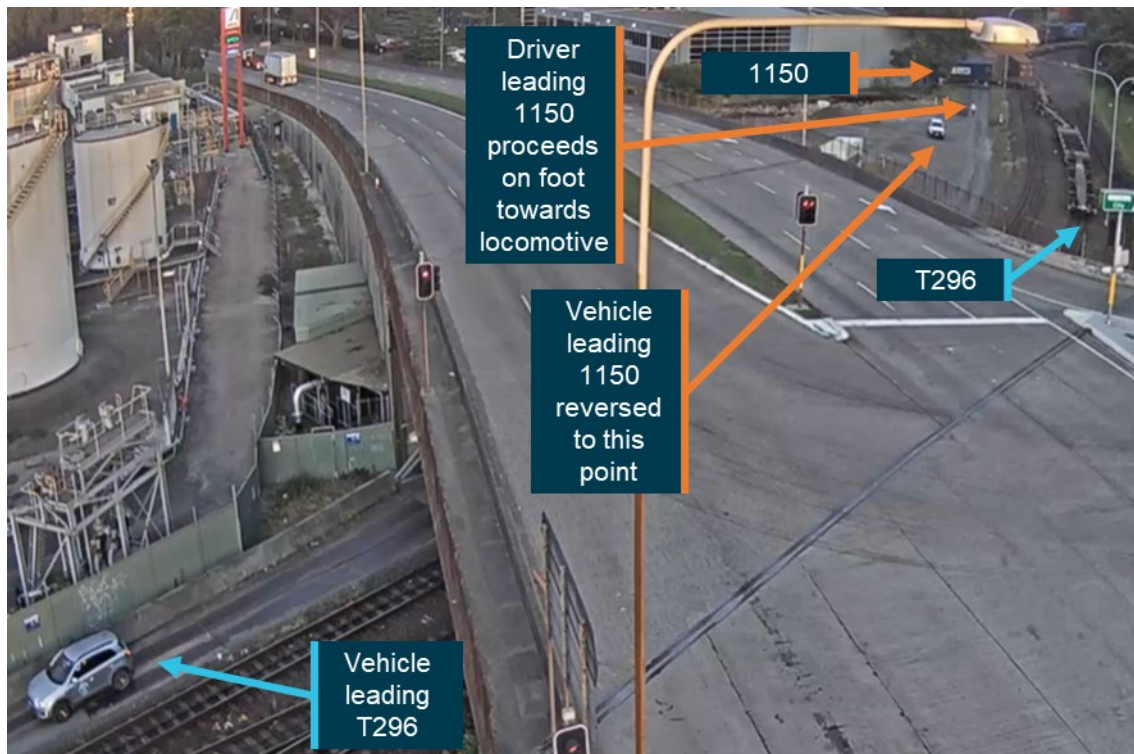
**Figure 6: Motor vehicle for train 1150 reversed back to collision site**

The qualified driver is then seen on CCTV to reverse their motor vehicle rapidly back to the point of collision. They are then seen to exit the motor vehicle, crouch under the derailed wagon that was blocking the vehicle access road and run towards the locomotive on the rear of the train (Figure 6).

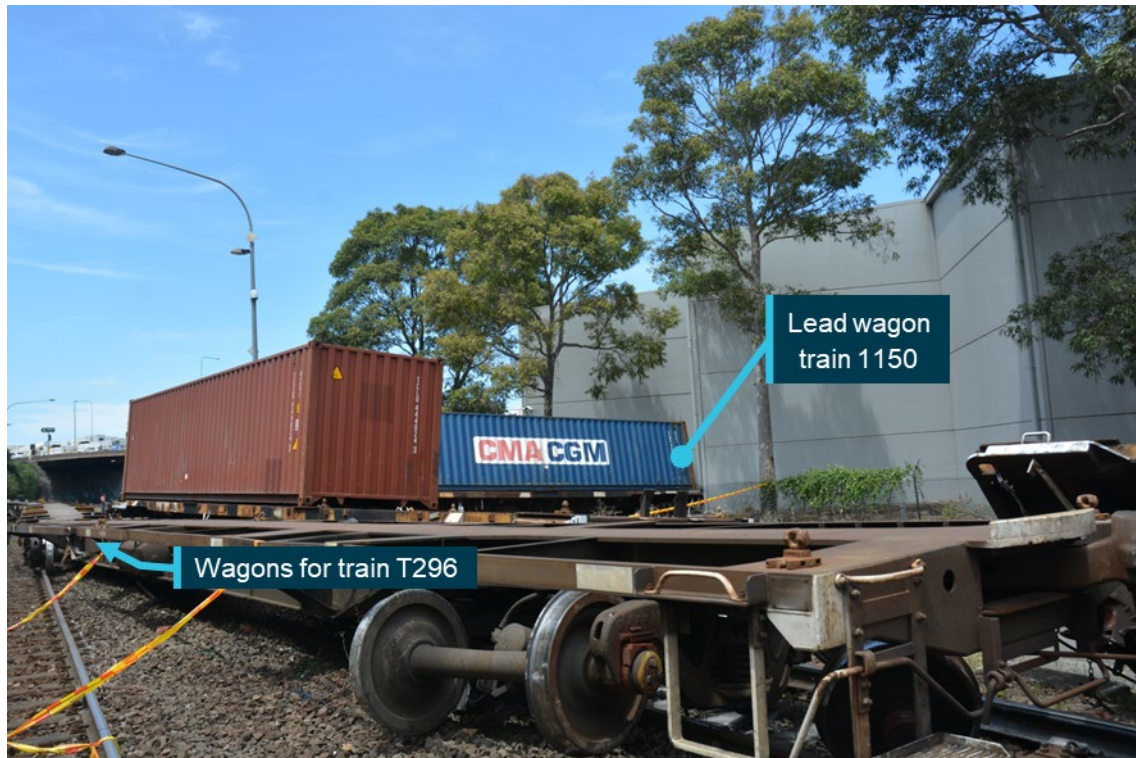
**Figure 7: Derailed wagons from trains 1150 and T296**

There were no injuries, but there was significant damage to rollingstock and rail infrastructure.

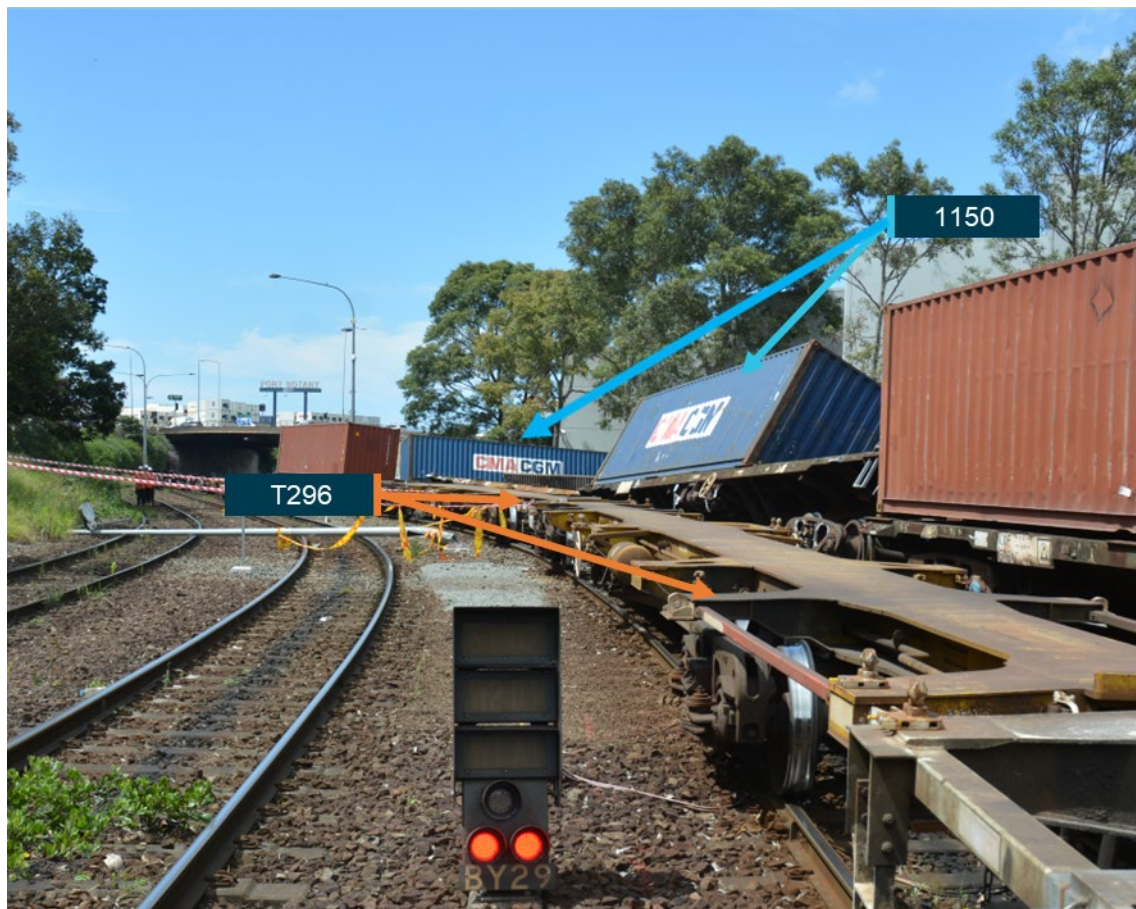
**Figure 14: Shunting signal BY29 at stop in Port Botany post-incident**

The shunting signals (Figure 14) used at the incident site in Port Botany yard were identical except for the signal numbering and were situated in line with one another on each adjacent arrival road.

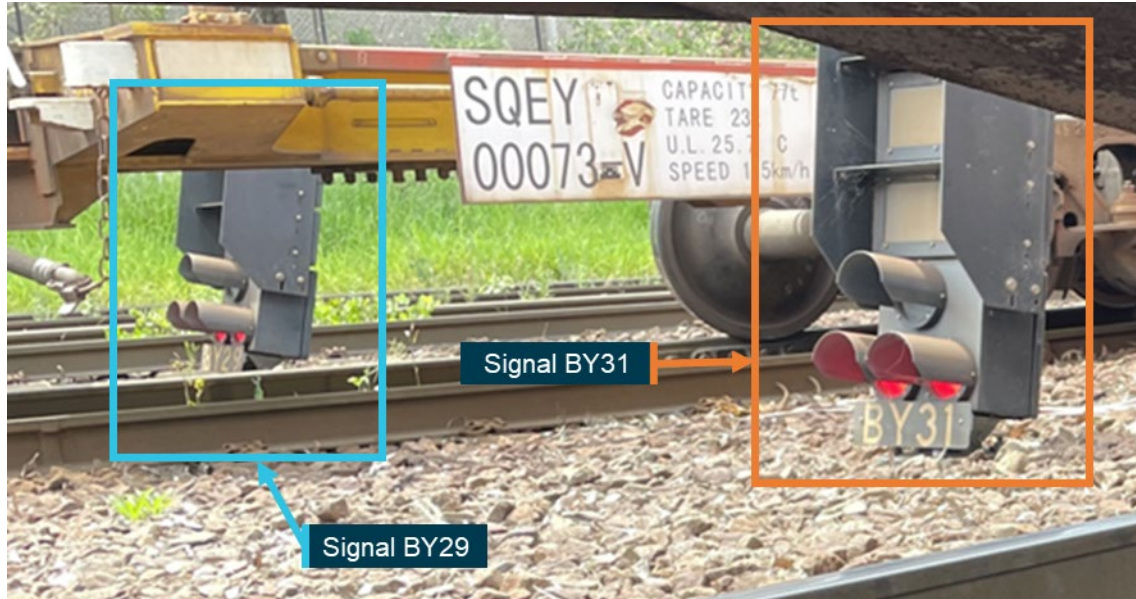
**Figure 24: View of signals BY29 and BY31 from access roadway adjacent to arrival roads 1 and 2, Port Botany**

RISB SPAD mitigation guidelines state that signal sighting decisions taken by RIMs can contribute to a more hazardous work environment. Reacting to the wrong signal or reading across through to a non-target signal occurs when a target signal has been stopped at correctly, however due to other distractions such as shunting duties, train crew respond to a change in aspect on a non-target signal that is also in view.

OTSI observes also that shunting signals at Port Botany were being observed from within a motor vehicle.

Also signal sighting standards are commonly based on the viewing of signals from within locomotives and not within motor vehicles. It was noted that the signal aspects were not fully visible from a motor vehicle, also potentially adding to the risk of read errors (see Figure 24).

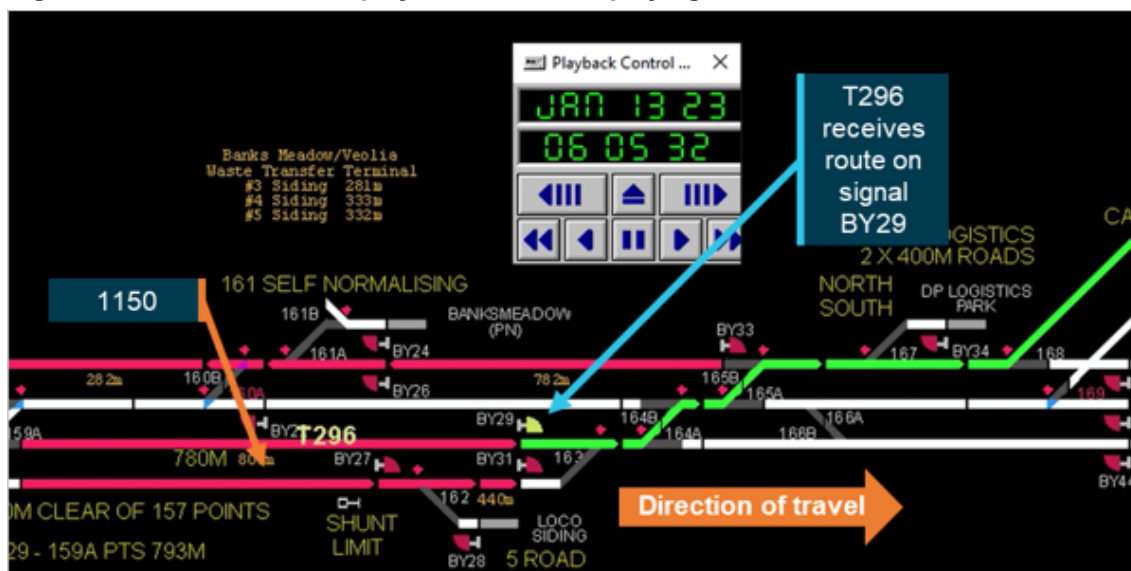
**Figure 25: ARTC Phoenix replay screenshot displaying route on BY29 for T296**

The Phoenix replay shows the route set by the NCO for T296 in green, with signal BY29 set to proceed and BY31 remaining at stop (Figure 25). Additional Phoenix replays show track circuit alarms seen by the NCO, caused by derailed wagons and a light pole when it fell across an adjacent unoccupied track (Figure 26 and Figure 27).

Propelling train 1150 passed signal BY31 at stop, converging into and colliding with train T296, which was propelling on the adjacent track.
