# Loss of separation involving a Beechcraft B300, VH-FIZ and a formation of four Boeing F/A18 aircraft

near Williamtown, New South Wales | 19 September 2013

## ATSB Transport Safety Report

AO-2013-160

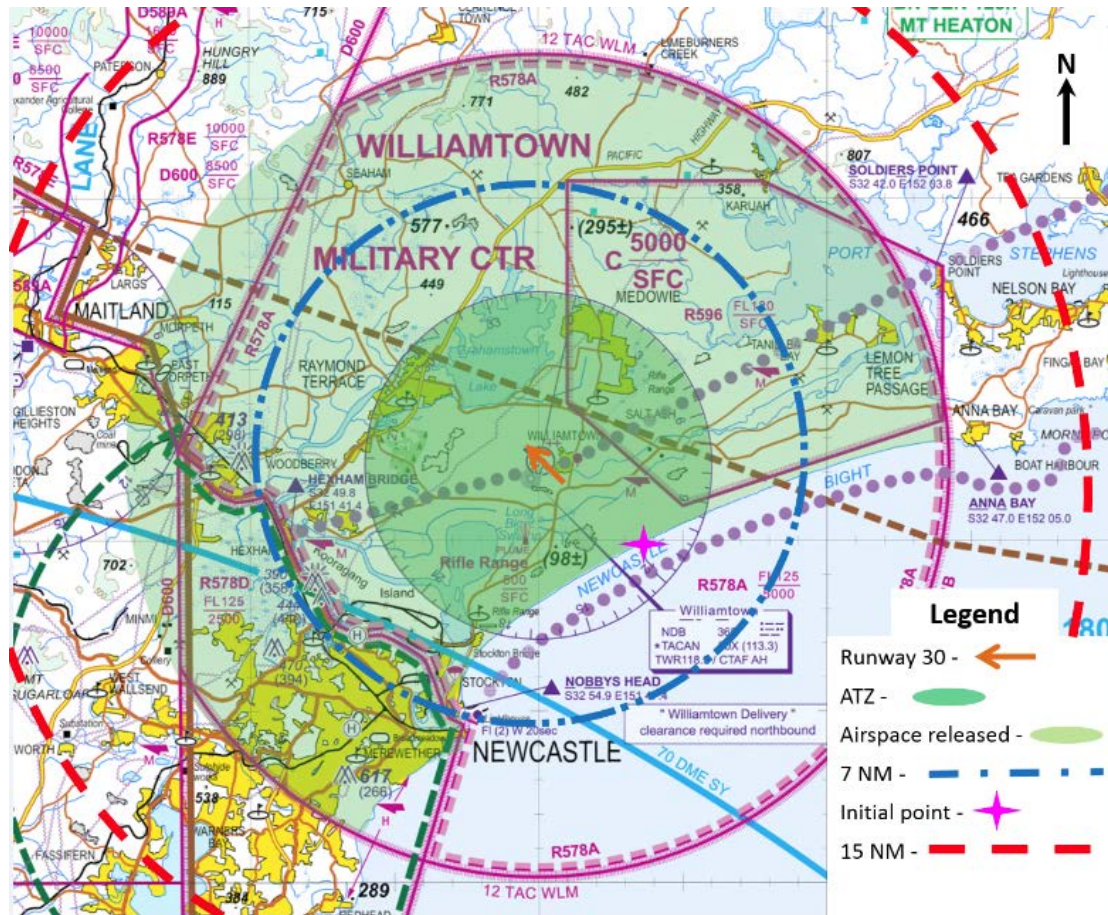
The Williamtown ATC Tower controller normally had jurisdiction over the airspace within 5 NM (9.3 km) of Williamtown over land (dark green area in Figure 1), from the surface to 1,500 ft above mean sea level (AMSL),<sup>7</sup> referred to as the aerodrome traffic zone (ATZ). Earlier in the day, additional airspace had been released by the Williamtown Approach controller to the Tower controller – over land within a 12 NM (22.2 km) radius of Williamtown, from the surface to 3,500 ft AMSL (light green area in Figure 1).

On the day of the occurrence, the wind at Williamtown favoured the use of runway 30 (marked in orange in Figure 1), so the majority of FIZ's approaches were to the opposite direction non-duty runway. To reduce traffic complexity, FIZ was permitted to conduct calibration runs while ATC held other aircraft on the ground or outside the airspace released to the Tower controller, while FIZ was held clear of traffic when a mix of military and civil aircraft were required to depart or arrive. The majority of military aircraft arrived via the *initial point*, marked by a pink cross in Figure 1 (see the section titled *Military operations*).

**Figure 1: Williamtown Tower airspace:** Dark green shading shows the usual airspace, light green shows additional airspace on 19 September 2013. An orange arrow indicates the duty runway location and direction. A blue dashed line indicates the intended flight path of VH-FIZ during the aerodrome orbit run. A pink cross indicates the initial point used by military aircraft.

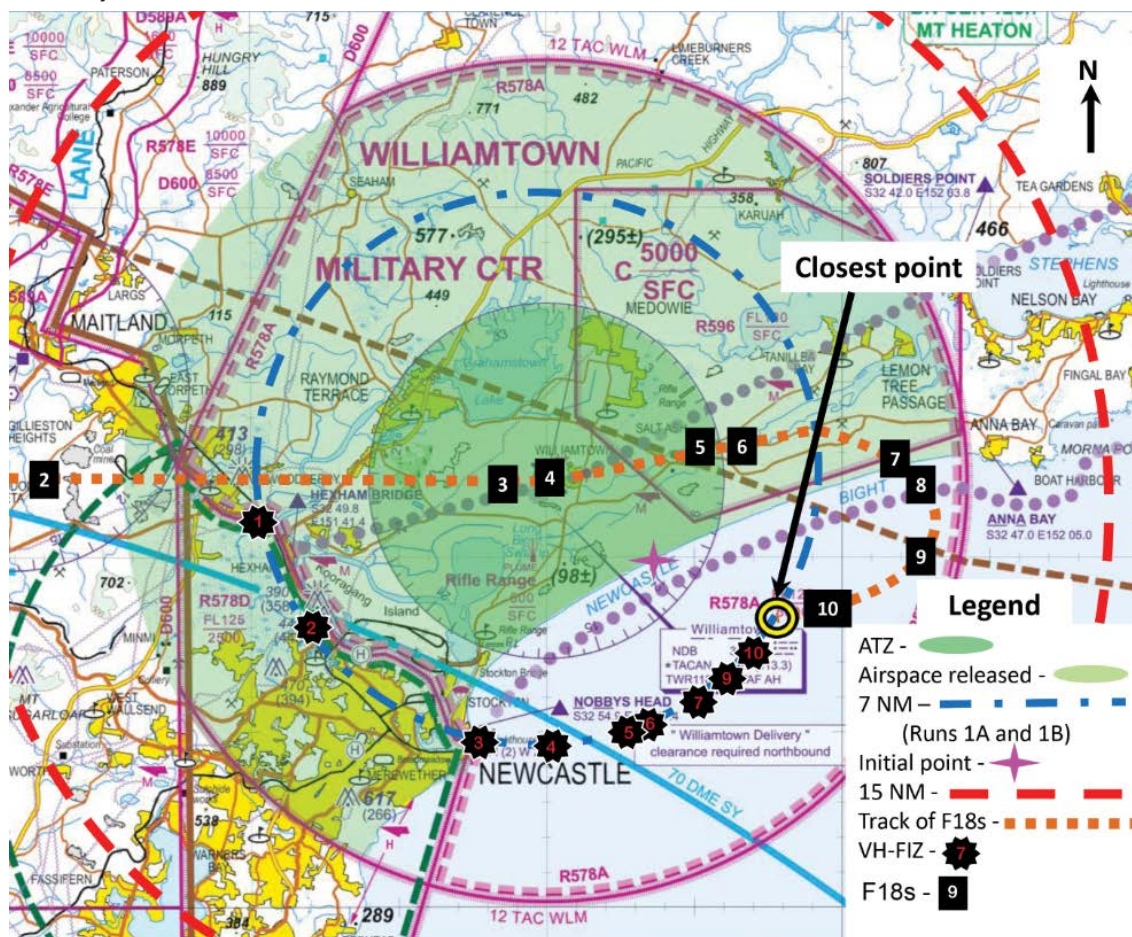
At 1543, the pilot of the first of the arriving aircraft, a passenger Airbus A320, contacted the Tower controller and was cleared to track from the north of Williamtown to the right base leg of the circuit for runway 30. At the same time, surveillance data showed that FIZ commenced flying in a counter-clockwise direction (run 1A) around Williamtown from a position 7 NM (13.0 km) to the west of the airfield (position 1 ✱ on Figure 2).

**Figure 2: Williamtown airspace showing the location and track of VH-FIZ and a formation of four Boeing F/A18 aircraft (numbers represent relative locations at the same time – see Table 1)**

At 1545, the Tower controller cleared the A320 to land and at 1546 cleared the Hawks for a visual approach. At the same time, the Tower controller was involved in coordinating personnel to enter the runway after the Hawks landed to retrieve the brake-chutes. The surveillance data showed that, nine seconds later, FIZ crossed the coast tracking in a north-easterly direction, leaving the airspace released to the Tower controller and entering airspace under the jurisdiction of the Approach controller (position 3 ●, Figure 2).

**Table 1: Location of VH-FIZ and the F18s at specified times as shown in Figure 2**
