# Loss of control and collision with terrain, Bell 206L-1 helicopter VH-VDZ

13 km SE of Essendon Airport, Victoria | 2 November 2013

**ATSB Transport Safety Report**  
Aviation Occurrence Investigation  
AO-2013-199  
Final – 1 June 2016

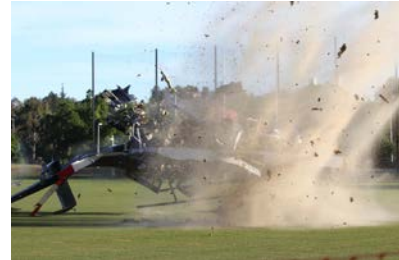
### Helicopter rollover

As the pilot lifted the helicopter into a hover it started rolling about the right skid, which was in contact with the ground. The helicopter rapidly rolled further right until the main rotor blades struck the ground. A large amount of main rotor and other high energy debris was released from the helicopter and impacted a nearby marquee, a number of vehicles and a helicopter on an adjacent helipad. The pilot sustained minor injuries.

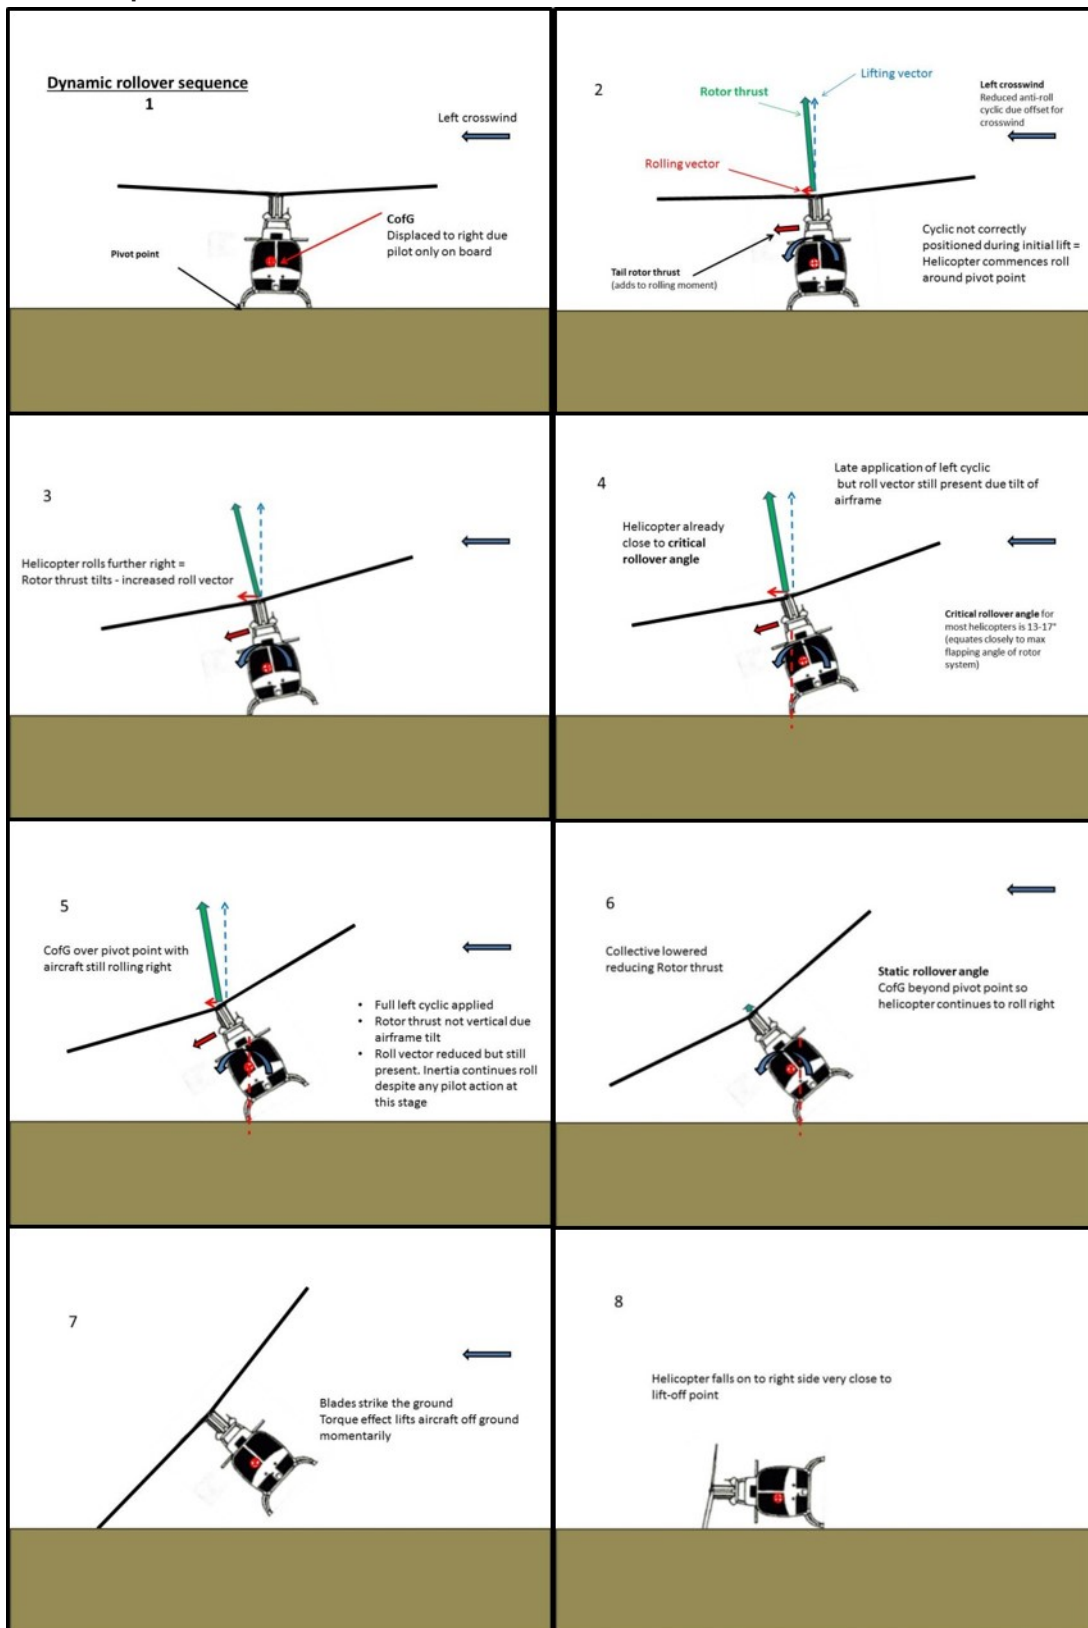
**Figure 2: Dynamic rollover of VH-VDZ showing the forces acting on the helicopter during the attempted lift-off and a representation of the approximate rollover angles relative to the helicopter's lateral CofG**

Failure to address any uncompensated roll with one landing skid or wheel in contact with the ground or other object can result in the helicopter quickly approaching its critical rollover angle. If the roll does not abate, exceedance of the helicopter's static rollover angle follows. Recovery is not possible and the helicopter rolls over.

Figure 2 illustrates the various forces acting on VDZ during the attempted pick-up to the hover and a representation of the approximate rollover angles relative to the helicopter's lateral CofG. The perception from the preceding discussion, and representation at Figure 2, may be that dynamic rollover in helicopters with counterclockwise rotating main rotors only occurs to the right. This is not the case. For example, consider a lift-off with the right landing skid down slope. If the pilot applies too much into slope cyclic during lift-off, or maintains too much into slope cyclic after the right skid breaks the ground, the helicopter may roll left, up the slope.

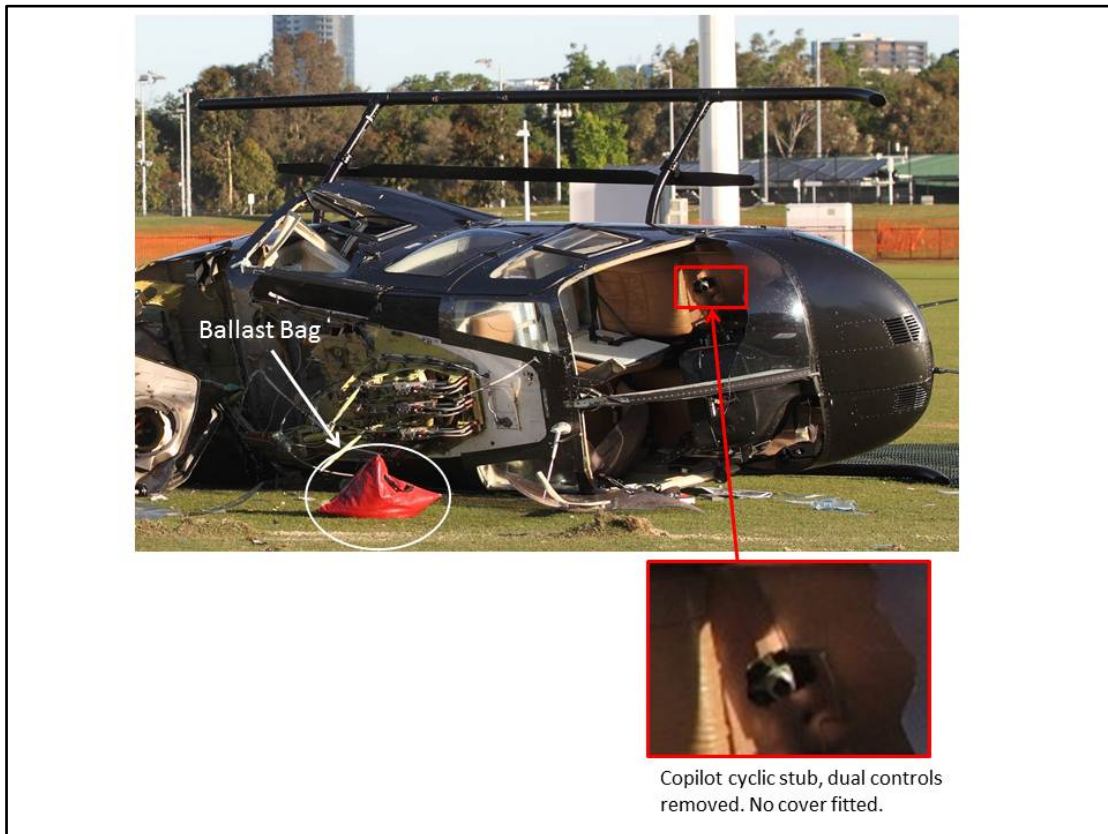
**Figure 3: Ballast bag and exposed cyclic control stub (at inset)**

The ATSB found that the pilot did not identify and react to the helicopter's right-skid low attitude in sufficient time to prevent the helicopter rolling over. In addition, an unsecured ballast bag was positioned on the left front floor of the helicopter, increasing the risk of injury to occupants. Further, the helicopter's dual flight controls were removed to facilitate the flights. The person who removed the controls did not have the training or authorisation to conduct the maintenance procedure. The left cyclic stub cover was not installed, leaving the stub exposed. This resulted in the potential for the ballast bag to inhibit movement of the pilot's cyclic control due to fouling of the left cyclic stub.

the risk of control fouling and damage to the control stubs. Steps to mitigate those risks include the installation of the control stub covers.

...INSTALLATION OF CYCLIC AND COLLECTIVE STUB SAFETY COVERS IS RECOMMENDED  
WHENEVER THE CO-PILOT QUICK-DISCONNECT DUAL CONTROL STICKS ARE REMOVED.

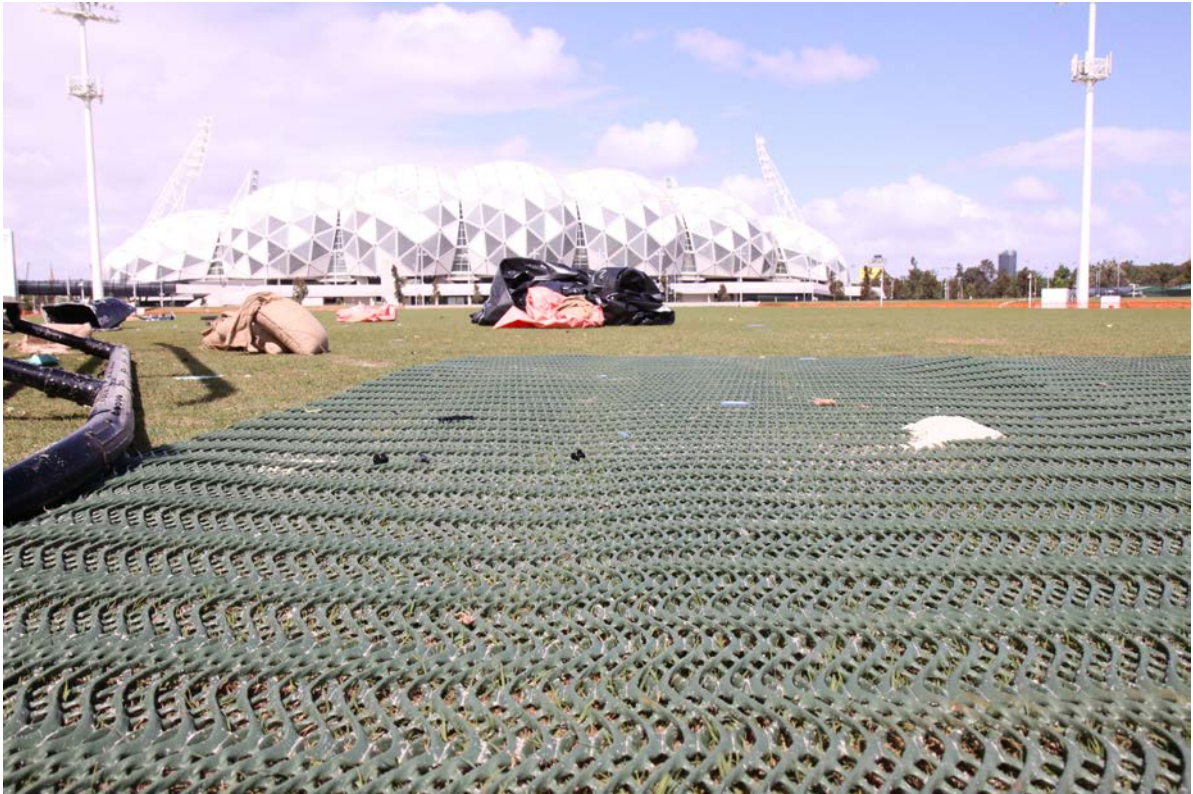
**Figure 4: Helipad landing mat and right landing skid (looking east)**

Examination of the wreckage and surrounding area indicated that the helicopter was orientated in a westerly direction and the right landing skid was located along the right edge of the helipad landing mat (Figure 4). The right side of the helicopter sustained significant damage and was resting on the ground.

The helipad landing mat was secured to the ground by small metal retaining pegs. These pegs were located at various intervals around the edge of the matting and along the midline where two sections of the matting adjoined. All retaining pegs were in place and, when examined, required a small amount of force to dislodge them from the grass and sandy loam subsurface. The charterer had reportedly used the semi-flexible meshed plastic matting on numerous previous occasions without incident. Witness photographs recorded the helicopter positioned with both skids on the landing mat immediately prior to the accident.

There was no evidence of a mechanical or other helicopter system failure that contributed to the occurrence. In addition, there was no evidence that the helipad landing mat impacted on, or interfered with the helicopter during the pick-up procedure.

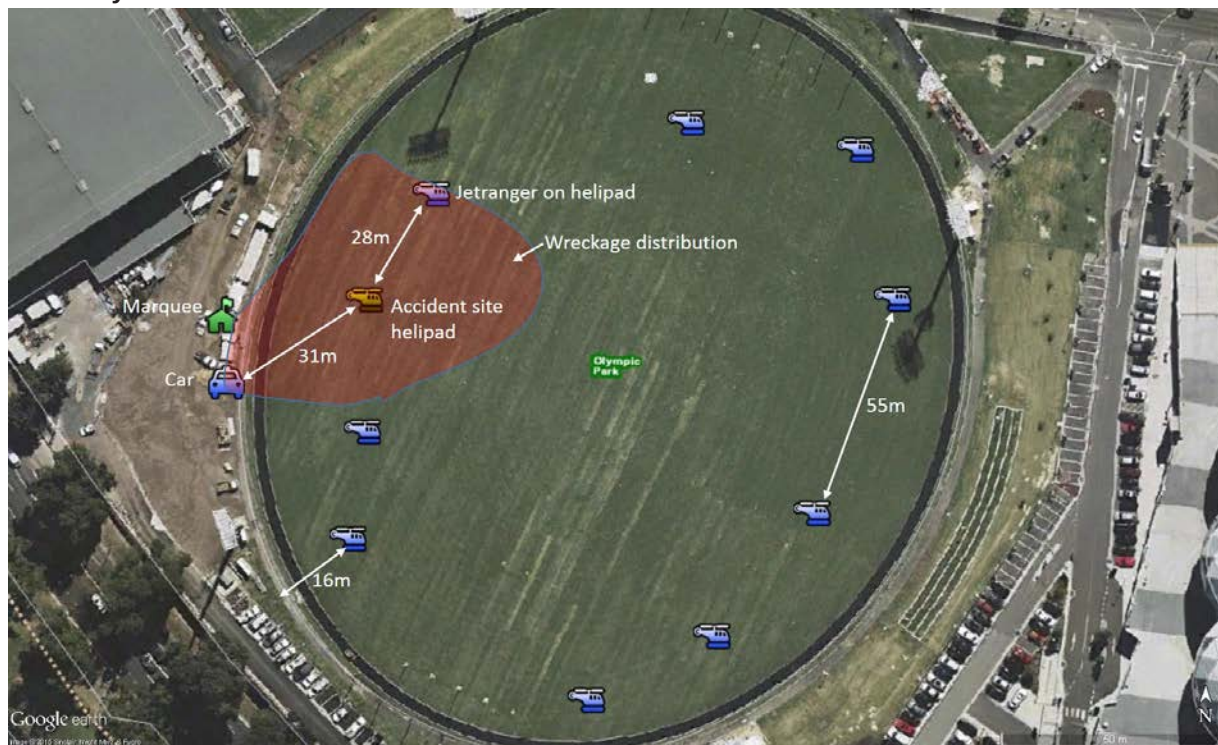
**Figure 5: Accident site and wreckage distribution showing the car and marquee that were struck by main rotor blade debris**

The helipad for VDZ was about 28 m from the perimeter of the oval where plastic bunting and a fence provided a barrier between the public access areas and the helicopter landing site. Distances from other helipads to the perimeter fencing varied, and in some instances were observed to have been closer than that of VDZ. The spacing between each of the helipads varied from about 24 m to 55 m (Figure 5).

Although the distance of some helipads to the perimeter fence or persons was less than the recommended 30 m, there were no reports of issues with rotor downwash or the operation of helicopters from the Olympic Park or Flemington venues.

oval was at least 24 m, other helipads were located within 15 m of the perimeter fence and nearby public walking tracks. These distances were less than the recommended 30 m in the CAAP, increasing the risk of injury to bystanders from rotor downwash.

It is therefore prudent that, where possible and operational and/or safety imperatives dictate, operators consider increasing the recommended distance from their helipads to public access areas. This will further reduce the potential for injury in the event of an accident during helicopter operations.

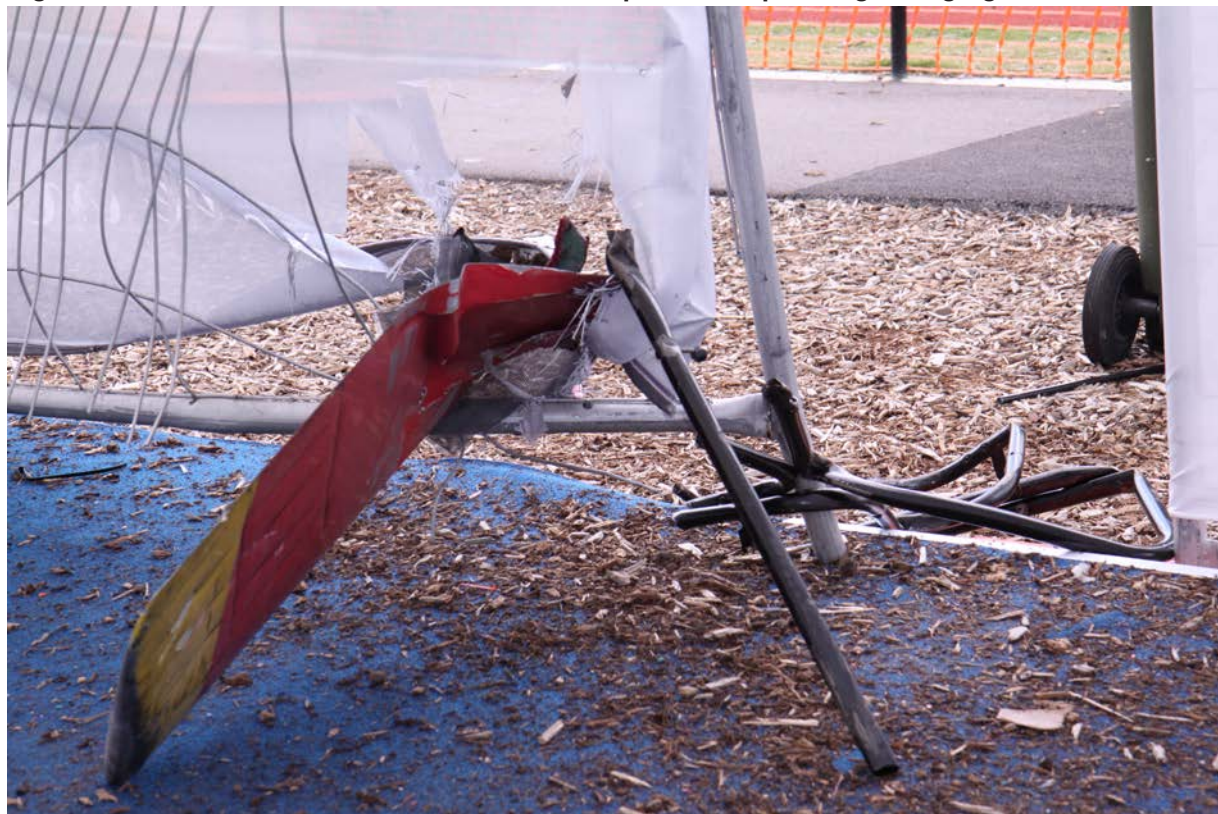
**Figure 6: Main rotor debris imbedded in the marquee in the passenger staging area**

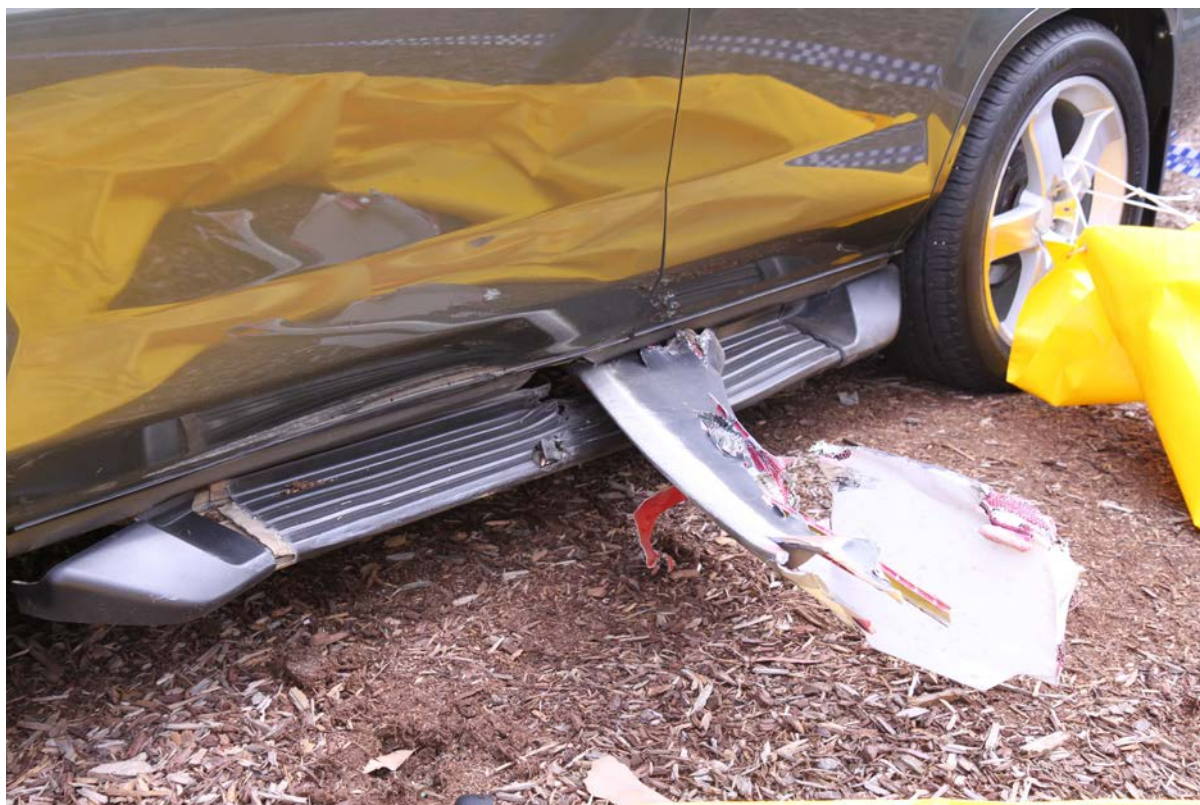
**Figure 7: Main rotor debris imbedded in the nearby car**
