# **Loss of control and equipment contact with water involving Bell 412EP, VH-VJF**

57 km north-east of Strahan Airport, Tasmania, on 10 March 2025

## **ATSB Transport Safety Report**

AO-2025-013

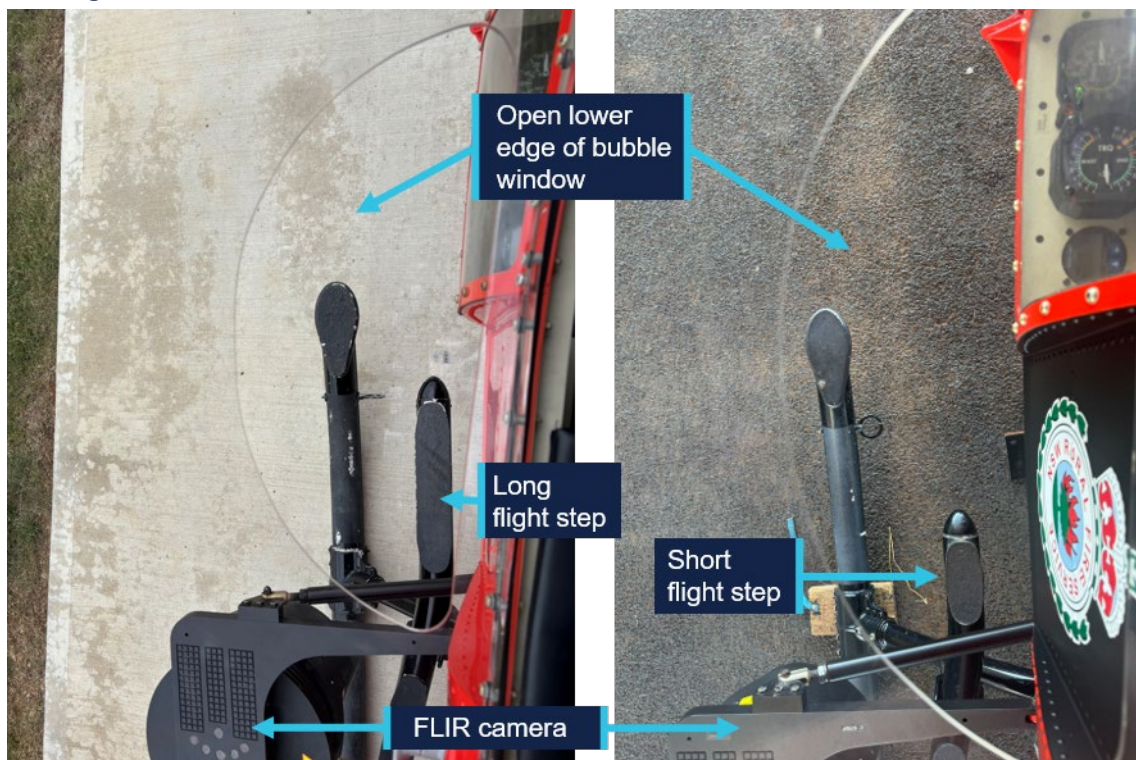
**Figure 9: Field of view with both the long flight step (left) and short flight step (right), looking down from the left seat from inside the bubble window**

The ATSB interviewed 7 pilots with experience conducting longline bucketing operations on the Bell 412s at Coulson Aviation Australia, including the occurrence pilot. Five of those pilots reported that the field of view from the cockpit during these operations was poor, with visibility of the suspended load restricted at times. When leaning out of the cockpit to look down along the longline, their view was impeded by both the flight step and, where fitted, the FLIR camera. This visibility issue was noted as recently relevant by

The flight step protruded into the downward field of view, while the FLIR camera extended externally by approximately 50 cm, obstructing the pilot's downward line of sight from the left seat (Figure 9). This was most pronounced during the approach, when the bucket trailed behind the aircraft and moved underneath as speed reduced, limiting the ability to visually acquire the load. Pilots described the need to adopt modified seating or head positions to maintain sight of the bucket. In addition, pilots reported that flight step length varied based on which aircraft was being flown (see *Bell 412 Fleet*).

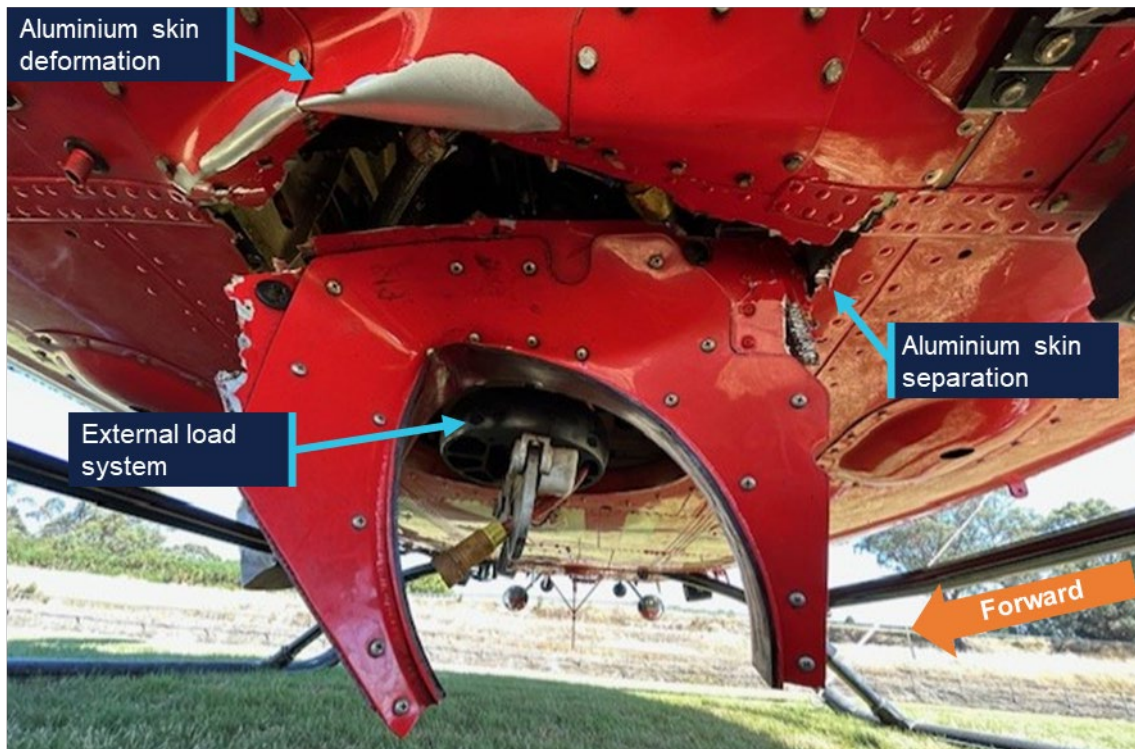
**Figure 10: Helicopter aluminium skin damage**

- The #1 (left) engine control tube had sheared at the lower tube end bell crank, resulting in a complete loss of pilot input to the engine.
- The #2 (right) engine control tube bell crank attachment bracket had detached from the helicopter structure's securing rib, restricting pilot control of the engine.
- The tail rotor control rod on the right side of the external hook's bell crank airframe attachment had broken away, with the primary structure also separated.
- The main transmission oil cooler pressure line exhibited significant contact damage, however, no splits or leaks were identified.
- The fuel tank interconnect braided hoses sustained minor contact damage.
- Multiple aft fuselage drain lines were damaged.

Images of the helicopter indicated that the structural fuselage honeycomb aluminium skin, adjacent to and aft of the external hook, was deformed and had separated from the primary structure (Figure 10).

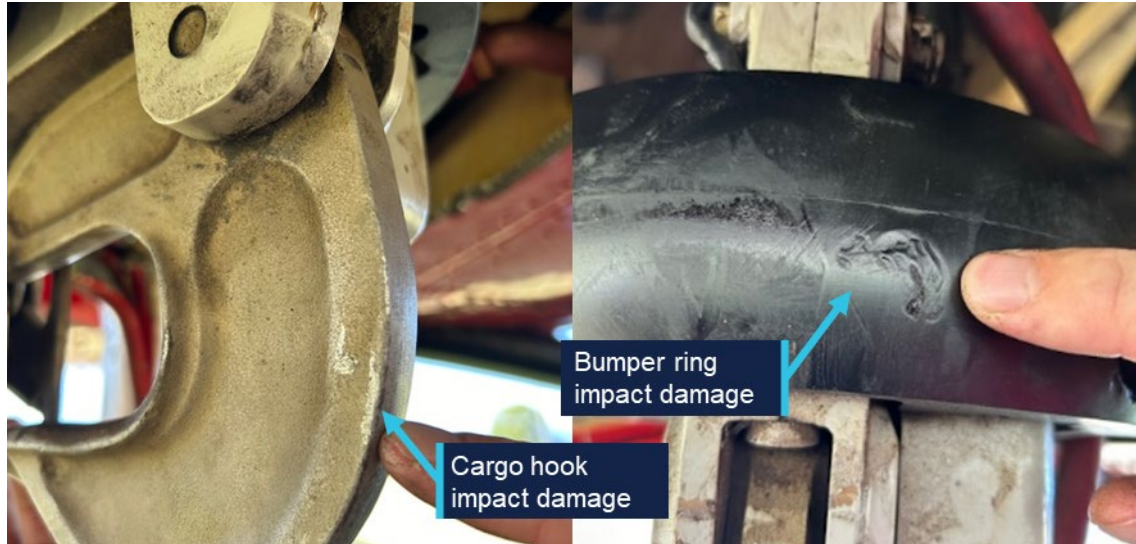
**Figure 11: External load system damage**

Images revealed indications consistent with contact between the longline and the rear cross tubes of the helicopter. In addition, inspection of the cargo hook and associated bumper stop components identified signs of impact damage (Figure 11).

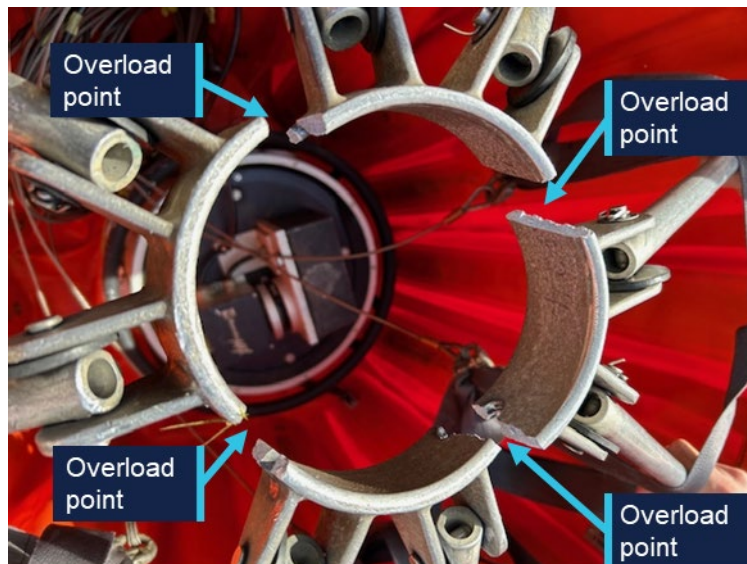
**Figure 12: Damage to bucket spoke assembly**

In addition, the ring in the middle of the Bambi bucket spoke assembly was fractured in 4 places (Figure 12).

Multiple instances of what was reported as cable 'bruising' and stretching were reported to have been observed on the bucket cable wiring and attachment eye ends.
