# **Descent below lowest safe altitude and ground proximity alert involving Cirrus SR22T, VH-XXO**

Canberra Airport, Australian Capital Territory, on 2 October 2025

## **ATSB Transport Safety Report**

AO-2025-061

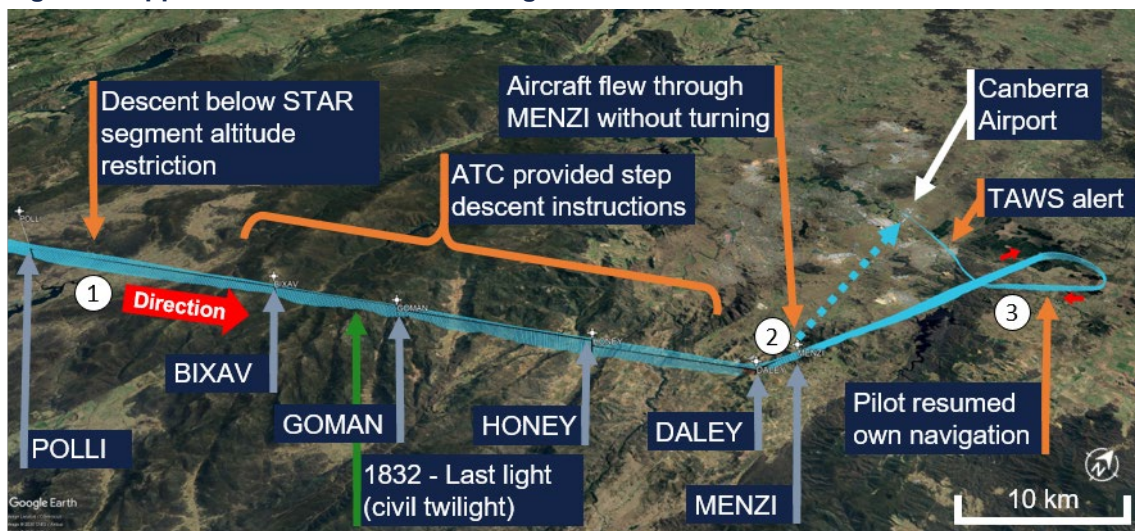
**Figure 1: Approach from cruise to landing**

An overview of the approach, descent and landing is provided in Figure 1 and Figure 2. During cruise the pilot contacted air traffic control (ATC) and was cleared to track direct to waypoint POLLI, to commence the POLLI 9 ALPHA standard arrival route (STAR) (see *Arrival and approach information*) for runway 35 at Canberra. The STAR was commenced shortly after sunset.

The STAR had a requirement to not descend below 9,000 ft<sup>1</sup> until after the waypoint BIXAV. As the aircraft approached waypoint BIXAV, the approach controller, based in Melbourne, provided the following clearance: 'when ready descend via the STAR to 7,000 [ft]'. The pilot asked the controller to repeat the clearance, which the controller did. The pilot read back the descent clearance, then read back the 'via STAR' condition in a second transmission. The pilot believed that they were cleared to descend immediately, and at 1829:29, the pilot commenced a descent from the cruising altitude of 9,000 ft (point ① on the diagrams).

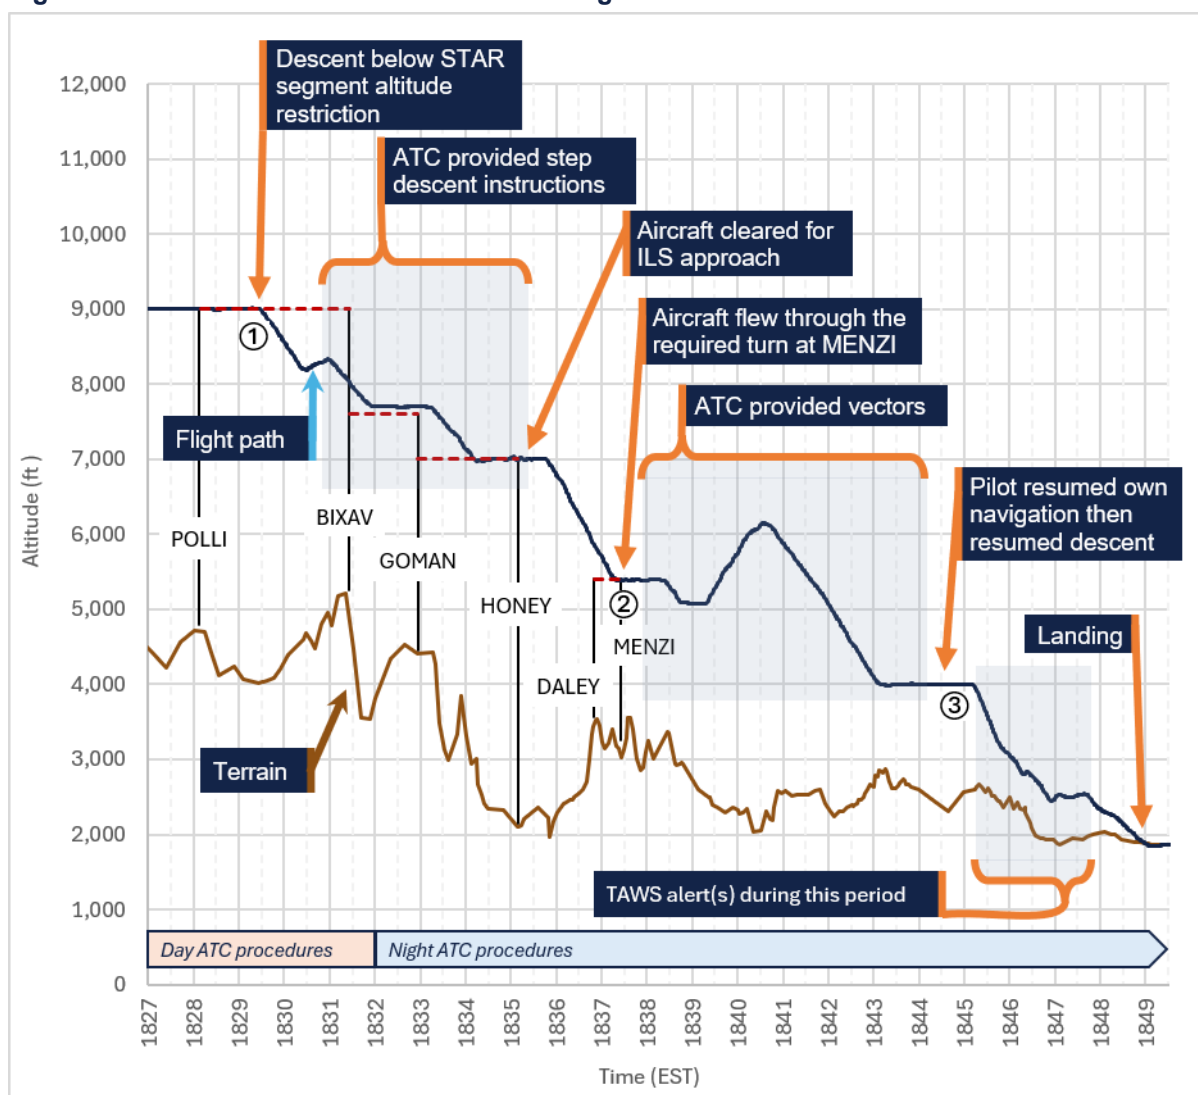
**Figure 2: Aircraft altitude from cruise to landing**

Minimum STAR segment restrictions are shown by red dotted lines.  
Source: ATSB

The pilot recommenced descent, and the aircraft became compliant with the STAR altitude restrictions when passing waypoint BIXAV at about 8,000 ft at 1831:26. The aircraft did not descend below the STAR lowest safe altitude (LSALT) or minimum sector altitude (MSA).<sup>2</sup>

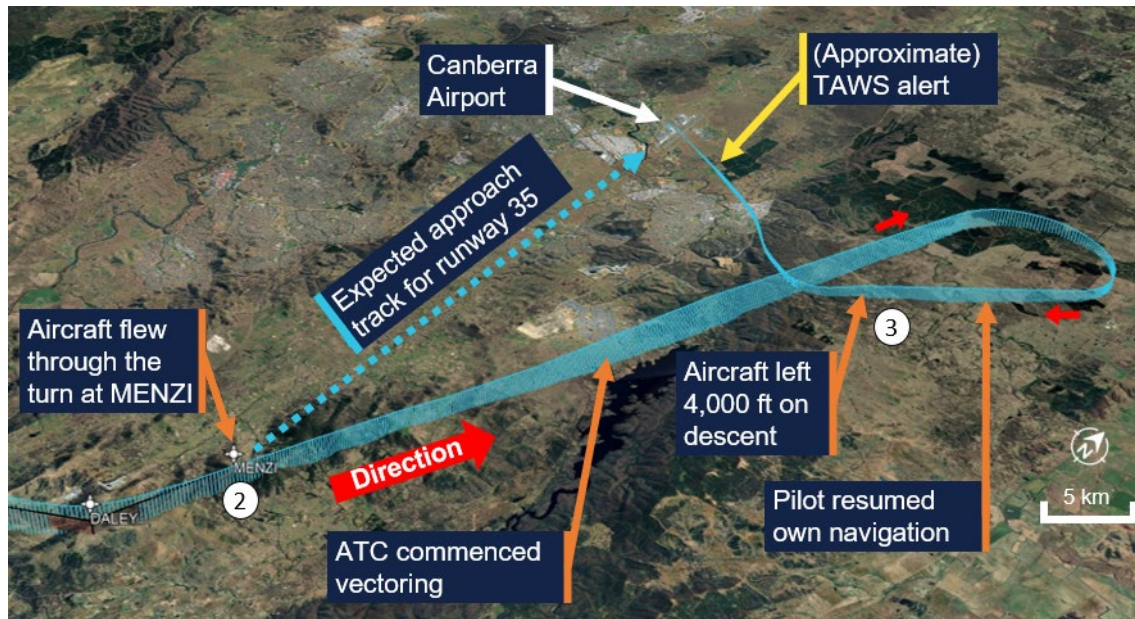
**Figure 3: Flight path once the standard arrival route (STAR) was discontinued**

The approach required a left turn at waypoint DALEY, and then almost immediately, a second slight left turn at the last waypoint (MENZI, the initial approach point) onto the runway heading. The aircraft turned left at waypoint DALEY towards MENZI as required, completing the turn at about 1837:02. The aircraft levelled out at 5,400 ft, due to the vertical mode changing, and the lateral navigation mode changed, or was changed, to 'wings level' as the aircraft headed towards MENZI.<sup>5</sup> A few seconds later at 1837:26, the aircraft flew through the localiser at MENZI for runway 35 without turning left towards the runway as required (Figure 3, point ②).

The approach controller identified the lateral deviation and offered the pilot radar vectors.<sup>6</sup> Immediately after this transmission, before the pilot had responded, flight data indicated that the FMS vertical mode changed to VPTH (vertical navigation path), which allows the aircraft to attain a set altitude (at that time, set to 1,400 ft) while following pre-programmed altitude restrictions. The aircraft then descended below the 5,400 ft minimum vector altitude (MVA) (see *Lowest safe altitudes*).

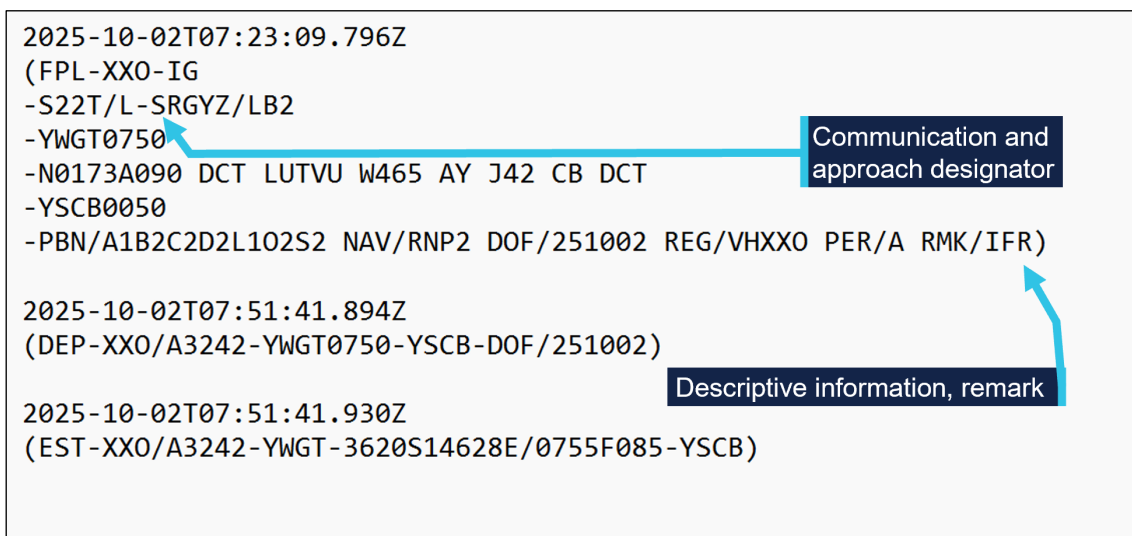
**Figure 7: Flight notification**

The IFR designator should have been PIFR (private IFR) with a listing of specific capabilities. The IFR designator here instead indicates that the pilot and aircraft had multiple capabilities that indicated a full instrument rating rather than a PIFR. With a PIFR rating, the flight plan should list specific capabilities.

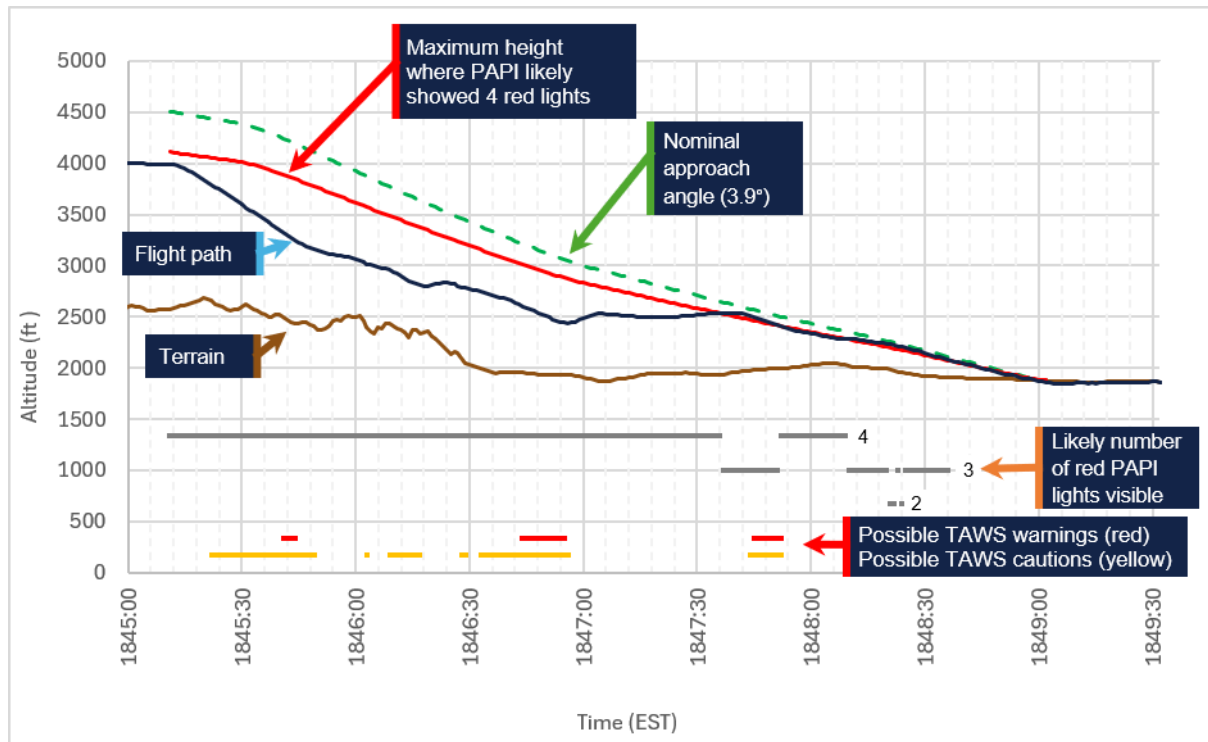
**Figure 8: Indication of possible TAWS alerts**

Figure 8 shows the results of ATSB analysis of what the pilot probably would have seen on the PAPI, and periods during which TAWS alerts were calculated to be possible. There were 4 possible periods that TAWS caution(s) may have occurred and 3 possible periods of TAWS warning(s). The aircraft levelled out for about one minute from about 1846:50, which coincided with one of the possible TAWS warning points.

TAWS alerts were not recorded by the systems on the aircraft. The ATSB used a simple forward-looking terrain avoidance algorithm to estimate when the projected flight path intersected the terrain along the flightpath, based on an algorithm described by another approved TAWS system.

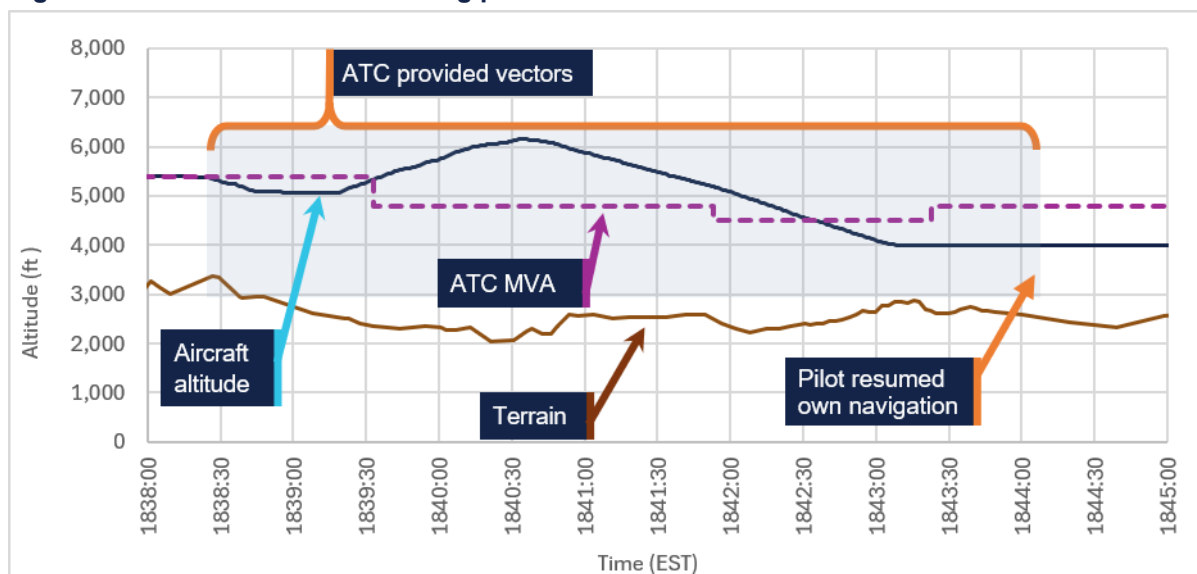
**Figure 9: Air traffic control vectoring period and MVA**

continuing to the west. The aircraft descended below the MVA, which was 4,500 ft in that area, at 1842:36.

The MVA at the aircraft's location during the period of being vectored by the approach controller is shown in Figure 9.
