# **Runway incursion and near collision involving Fairchild SA227-DC, VH-HPE, and an airport safety vehicle**

at Mackay Airport, Queensland, on 12 November 2025

AO-2025-067

Final – 2 October 2026

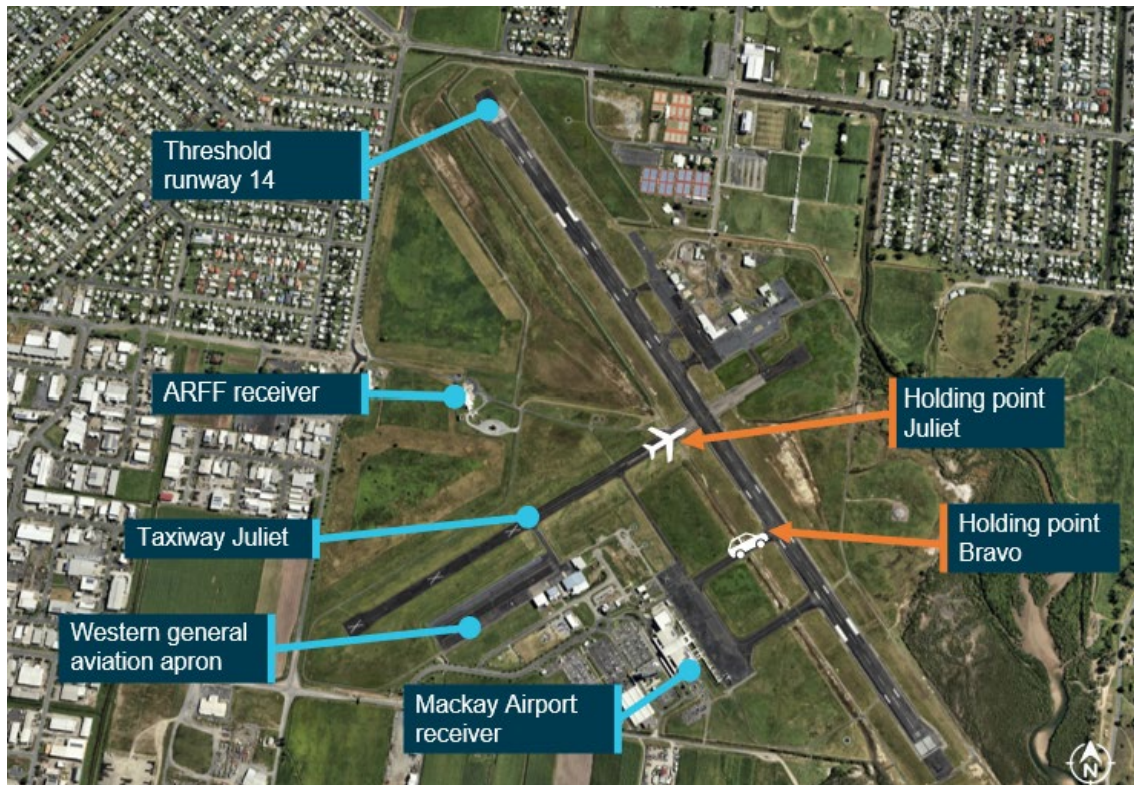
**Figure 1: Holding points and receivers at Mackay Airport**

The pilot commenced taxiing for departure from the western general aviation apron, along taxiway 'Juliet' and made a taxiing broadcast on the Mackay CTAF (Figure 1 and Figure 3). A subsequent review of this broadcast identified that the quality of the transmission was poor and barely audible. In addition, the pilot did not state they were at Mackay, advised they would hold short of the incorrect holding point, and used the incorrect flight number.

After being stopped at the holding point for about 1 minute and 30 seconds, the pilot made a broadcast on the CTAF advising they were entering and backtracking runway 14. Again, this broadcast was of poor quality and barely audible. While the pilot did state 'Mackay' at the end of the broadcast, it was difficult to hear.

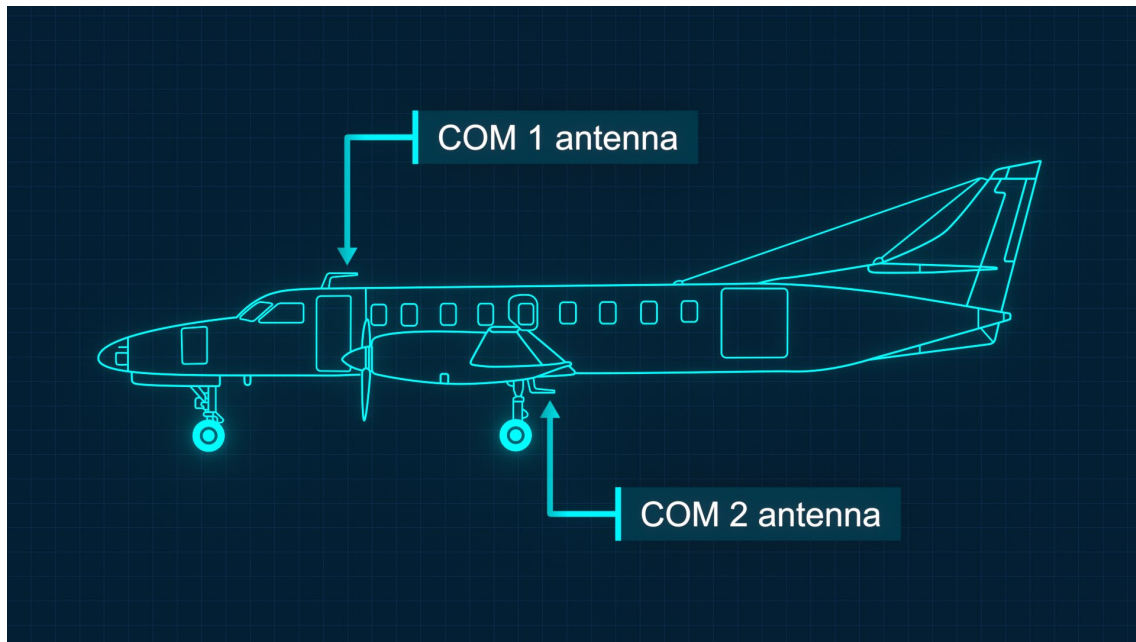
**Figure 2: Antenna positions on VH-HPE**

The pilot confirmed they could hear received transmissions from both COM 1 and 2 at the same time when there were simultaneous transmissions on both frequencies.

An inspection was also conducted on the antennas, and the operator reported that corrosion was detected on the connectors for the coaxial cable for COM 1 and the cable was returning a higher than acceptable resistance. This likely reduced the transmission strength of the broadcasts. However, there was no reported corrosion present under the COM 2 antenna, which was likely the antenna in use for the CTAF transmissions.

Common traffic advisory frequency radio transmissions from the aircraft were of poor quality. This was due to a combination of the pilot's rapid speech, non-standard phraseology and interference caused by use of the VHF COM 2, the radio with the ground-facing antenna.

antennas on its aircraft and pilot's radio selection at non-controlled aerodromes, with detail incorporated into its risk register.

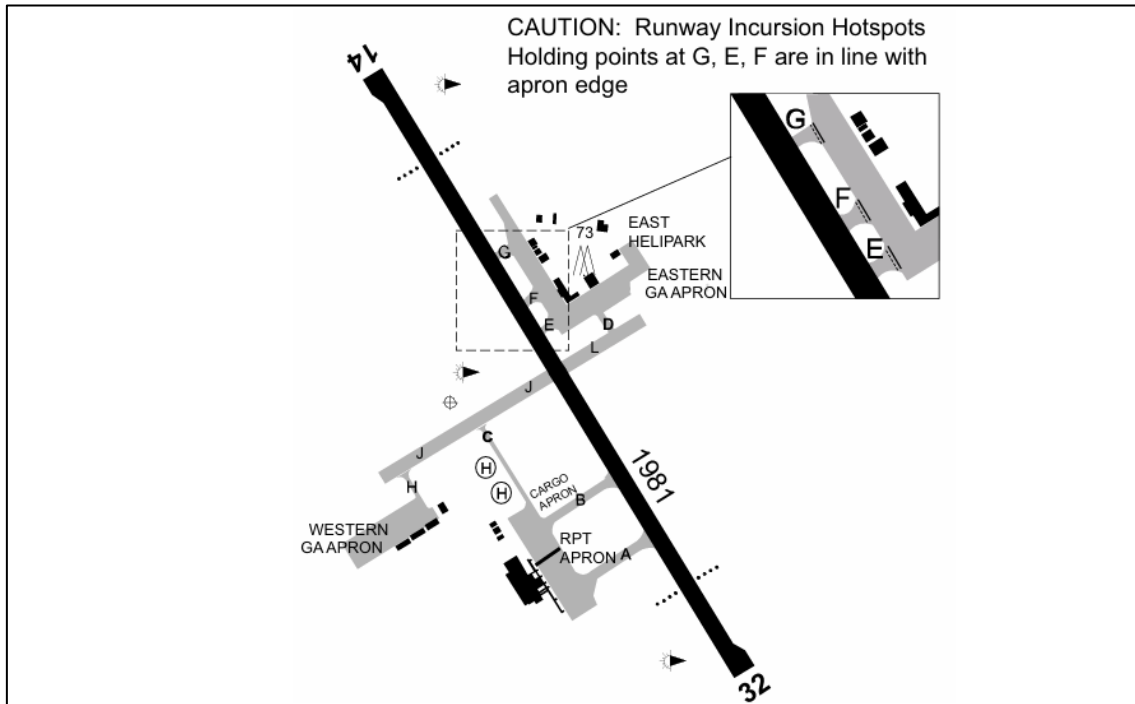
**Figure 4: Mackay Airport**

Mackay Airport is a certified airport at an elevation of 19 ft above mean sea level, with a sealed runway orientated in a north-west/south-east direction – 14/32. The runway was 1,981 m long and 45 metres wide (Figure 4).
