# Partial power loss involving Diamond DA20, VH-HUU

Near Toowoomba Wellcamp Airport, Queensland, on 5 December 2025

Aviation Occurrence Investigation (Defined)

AO-2025-073

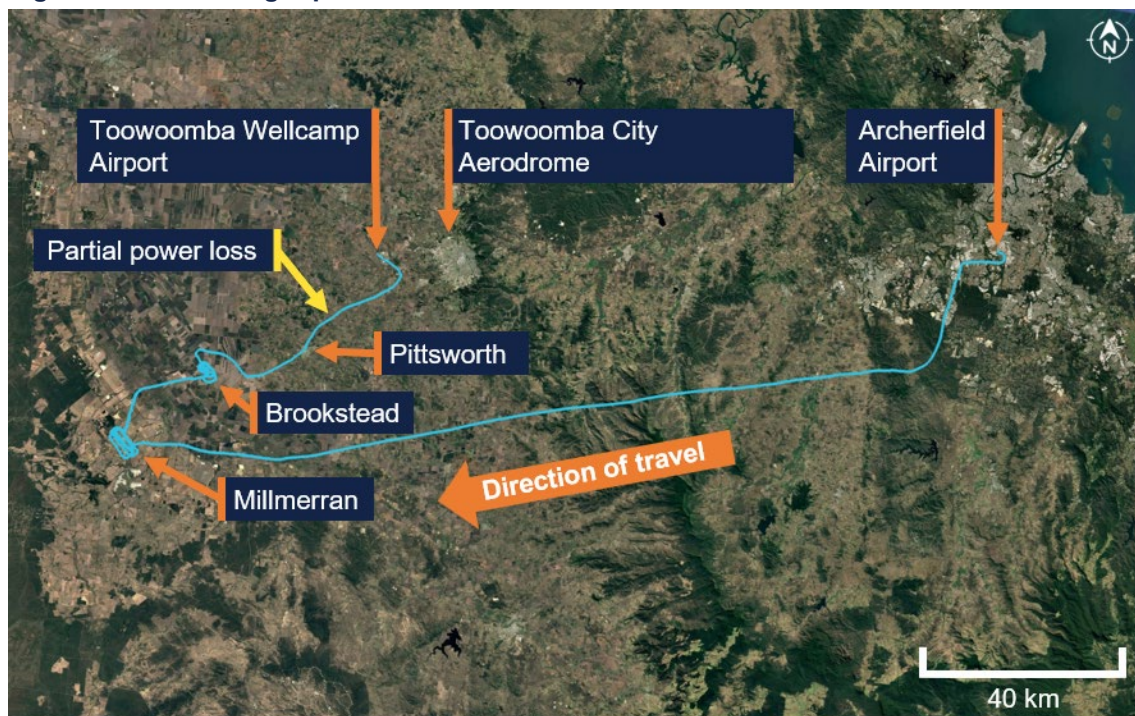
**Figure 2: VH-HUU flight path**

The flight departed Archerfield at 1346 local time and progressively climbed through controlled airspace (Figure 2). The instructor recalled that, shortly after departure, they experienced an uncommanded momentary reduction in engine power after which power restored. As this was consistent with previous occurrences they had experienced in this aircraft (see the section titled *Previous momentary power loss occurrences*), they messaged the head of flying operations (HOFO) to inform them of the power variation and continued the flight.

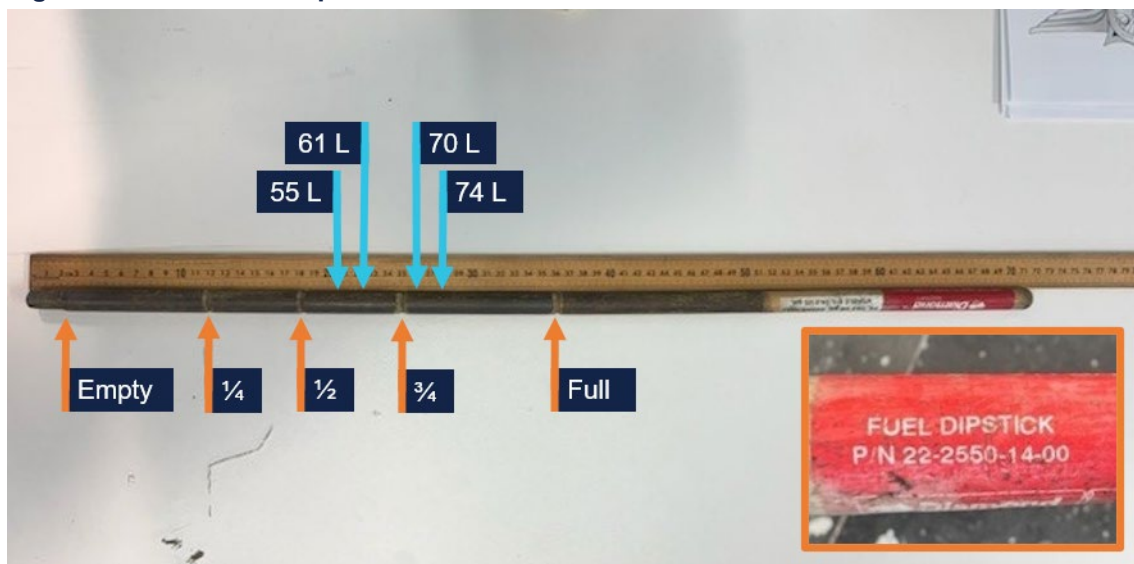
**Figure 5: VH-HUU fuel dipstick**

The dipstick associated with VH-HUU was labelled with the appropriate part number and the distances between the graduations were as expected (Figure 5). During the fuel quantity indication test (see the section titled *Fuel quantity indication system*) conducted after the occurrence, the maintainer confirmed that the dipstick read accurately.

While consideration was given to the age and colour of the dipstick affecting the ability to accurately read the fuel level, both pilots had considerable experience using this dipstick with this aircraft and were familiar with the DA20 fuel dipping procedure, having conducted it regularly. The expected fuel level was a similar distance on the dipstick from the '½' graduation as the observed readings were from the '¾' graduation and it is possible that both pilots misread the reading in the same manner. As shown by the United States National Transportation Safety Board investigation, this has occurred previously.

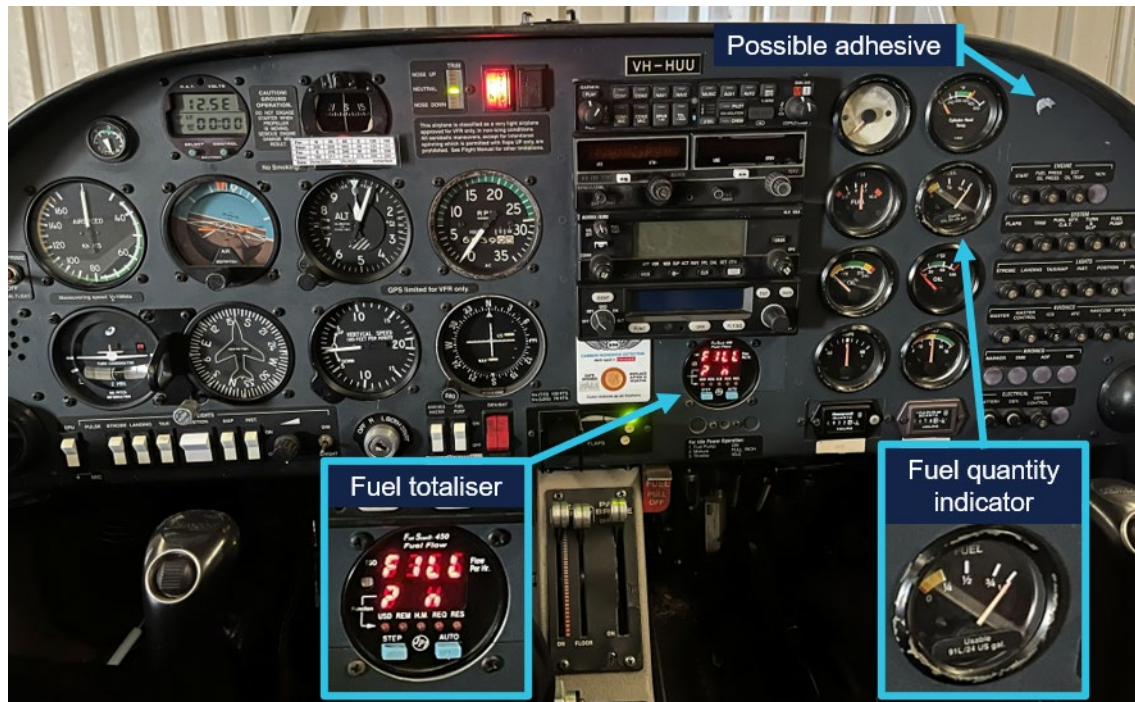
Figure 6: VH-HUU instrument panel

The DA20 had a float-type fuel quantity sensor located in the fuel tank. This sensor was connected to a fuel quantity indicator on the right side of the instrument panel (Figure 6). The gauge could be adjusted during maintenance to give a correct zero indication. The movement of the float changed the resistance of the circuit through the sensor. This changed the current flowing in the system, which set the pointer on the gauge.

The aircraft did not have a fuel calibration card displayed on the instrument panel. Following the occurrence, the maintainer<sup>6</sup> observed possible adhesive in the area to the upper-right of the fuel gauge where a card may have previously been attached and since fallen off. They further advised that they would have expected that the absence of a calibration card would have been identified during a periodic inspection.

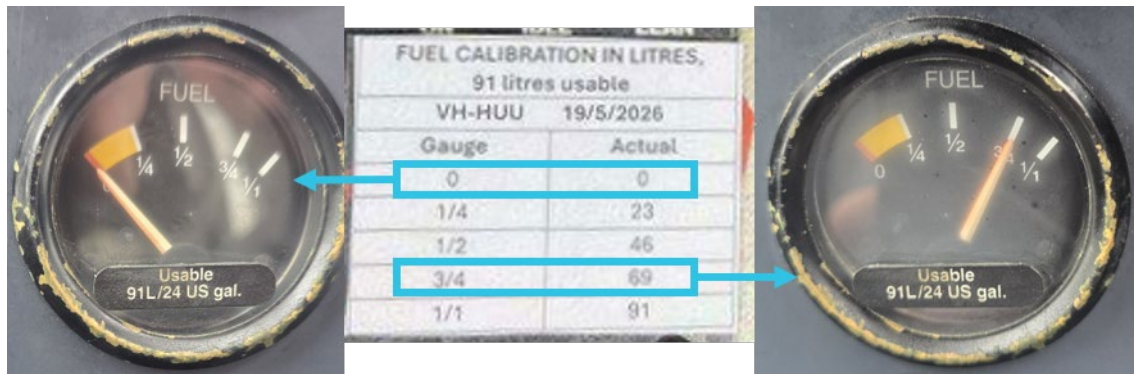
**Figure 7: Fuel quantity indicator readings and calibration card after the occurrence**

At the conclusion of the test, a fuel calibration card was added to the cockpit correlating the readings at each graduation with the fuel quantity observed during the test (Figure 7). A test was also conducted for another DA20 that the operator had identified did not have a fuel calibration card displayed. The fuel quantity indicator of this aircraft also read accurately at empty, and at all other graduations. The operator operated other aircraft, including another DA20, all of which were reported to either have a fuel calibration card displayed or did not require one.
