# Restraint release and loss of control involving Avions Mudry & Cie CAP 10B, VH-YAO

28.5 km west-north-west of Edinburgh Airport, South Australia, on 4 February 2026

**ATSB Transport Safety Report**  
Aviation Occurrence Investigation  
AO-2026-066  
Final – 20 October 2026

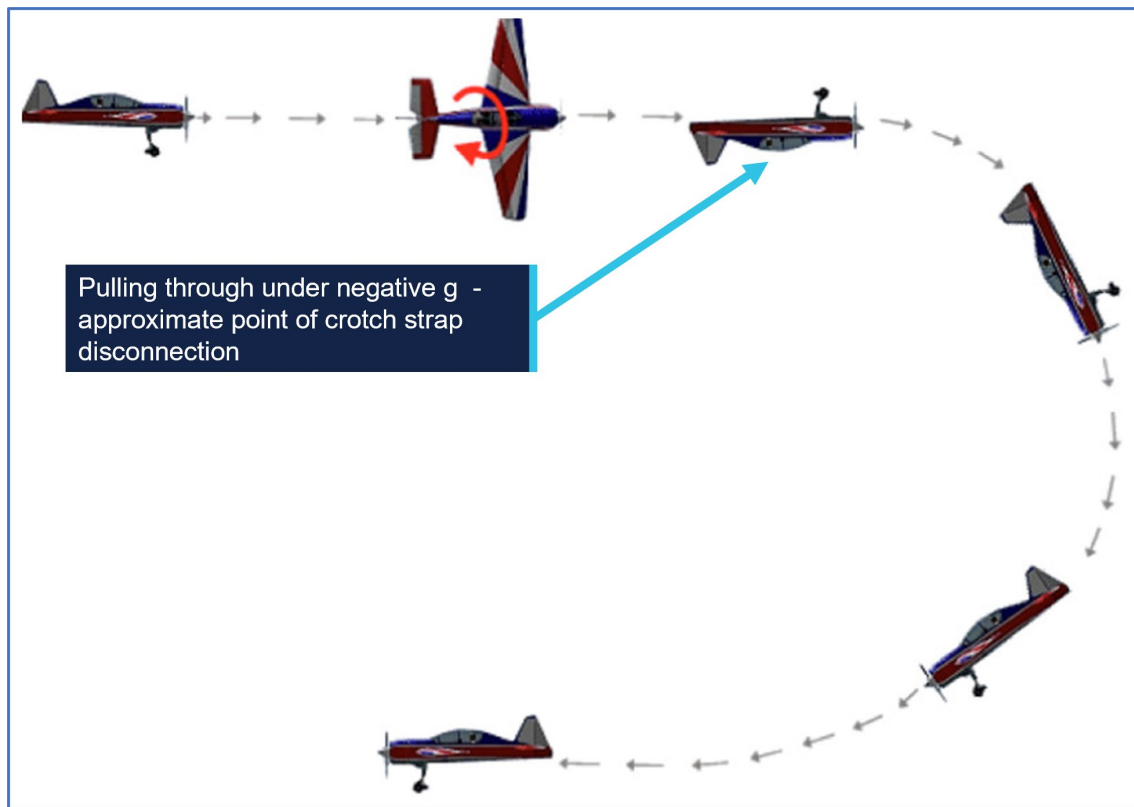
**Figure 1: Split S manoeuvre and point of crotch strap disconnection**

Approximately 30 minutes into the flight, following completion of the first manoeuvre, which included inverted flight, the instructor commenced the demonstration of a split S manoeuvre<sup>3</sup> from about 7,000 ft above mean sea level (Figure 1). The instructor recalled that, as they rolled the aircraft to the left, just as the wings levelled in inverted flight and as they were about to pull through with the aircraft under negative g,<sup>4</sup> their crotch strap suddenly released.

*The Split S manoeuvre depicted indicates a roll to the right, the manoeuvre conducted involved a roll to the left.*  
 Source: Journal of Computational Science, volume 81, September 2024, amended and annotated by the ATSB

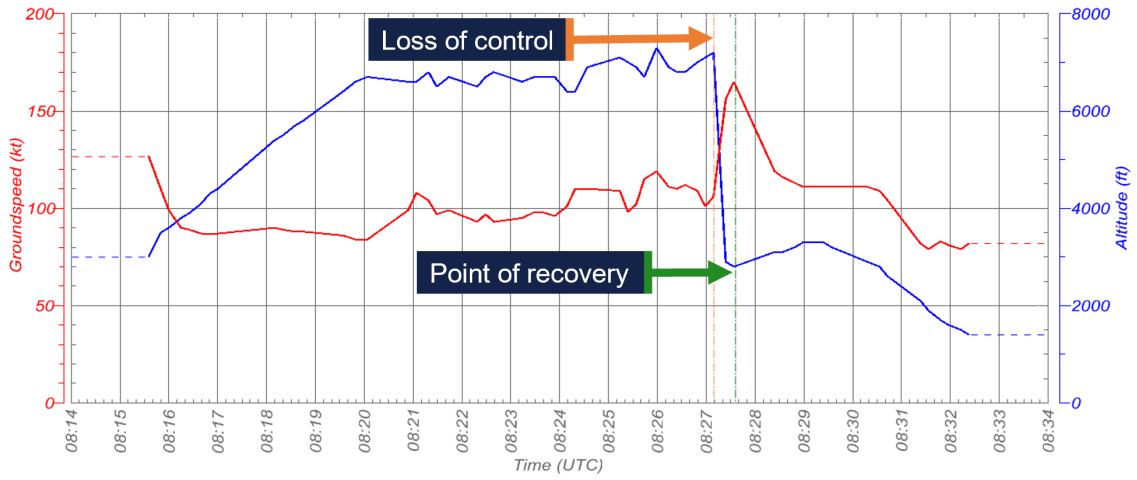
**Figure 2: Secondary surveillance radar data of loss of control and recovery**

The instructor stated that the aircraft 'gained a lot of speed', reaching the never exceed speed<sup>5</sup> of 184 kt and descending about 4,000 ft. Due to the high airspeed, the instructor reported completing a pitch roll to the left, and gently pulling out to ease out of the dive recovering to normal flight. While the instructor recalled that they recovered at about 5,000 ft, based on secondary surveillance radar data, control of the aircraft was recovered at about 3,000 ft (Figure 2). The instructor then contacted Adelaide air traffic control to request approval to descend and return to Parafield Airport. The pilot immediately returned to Parafield Airport and the aircraft landed without further incident. As a result of impacting the aircraft canopy, the instructor received a minor head injury, and the canopy sustained minor damage.

Data obtained from secondary surveillance radar, which records to the nearest 100 ft standard atmosphere altitude. The parameter horizontal dashed lines depict periods when the aircraft was not identified.  
Source: Flight Aware, annotated by the ATSB

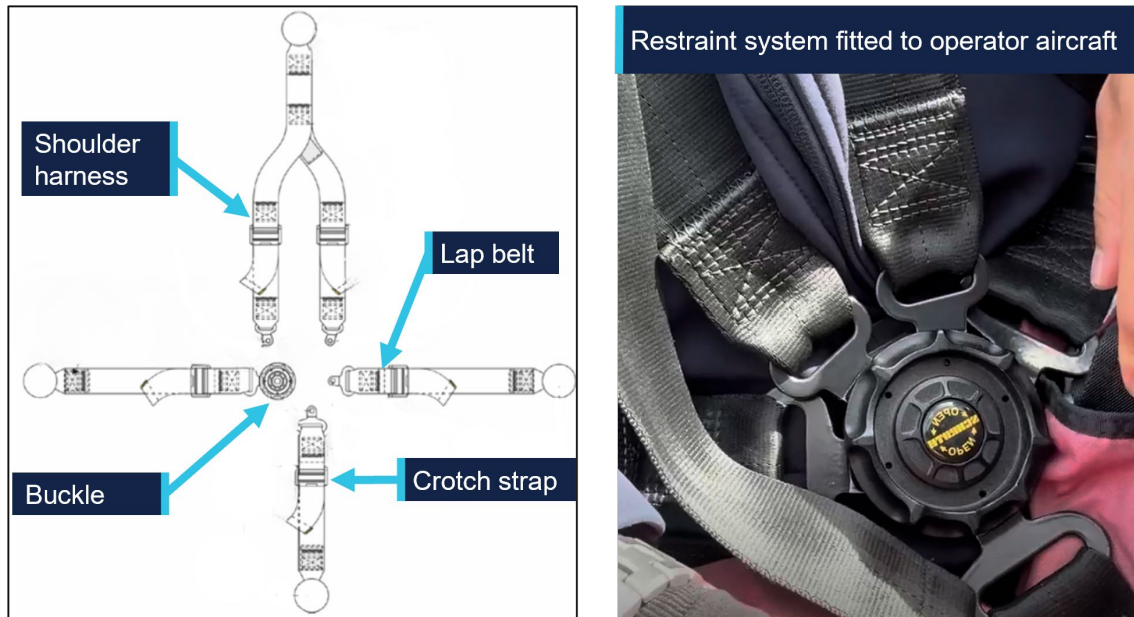
**Figure 3: Restraint system fitted to VH-YAO**

VH-YAO was fitted with a Schroth Safety Products GmbH (Schroth) 5-point harness restraint system, which consisted of 2 shoulder straps, 2 lap belts and a crotch strap (Figure 3), (P/N 4-04-385A01) and a rotary buckle (P/N SL 11.52). The buckle was fixed to one half of the lap belt and was fixed in this position by the manufacturer.

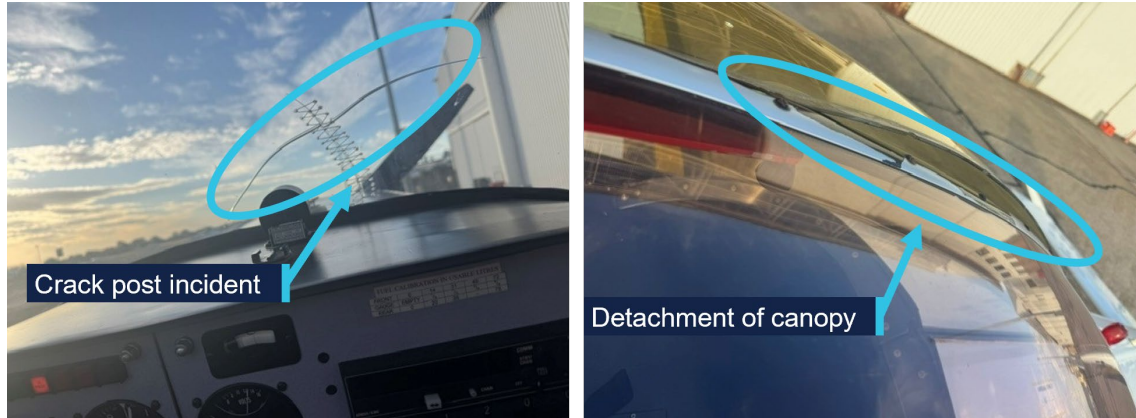
**Figure 4: Images taken immediately after the event showing damage to the aircraft**

A post-incident inspection by the operator identified that a pre-existing windshield crack had increased in size likely due to the nosedive and there had been partial detachment of the aircraft canopy from the impact with the instructor's head. (Figure 4).

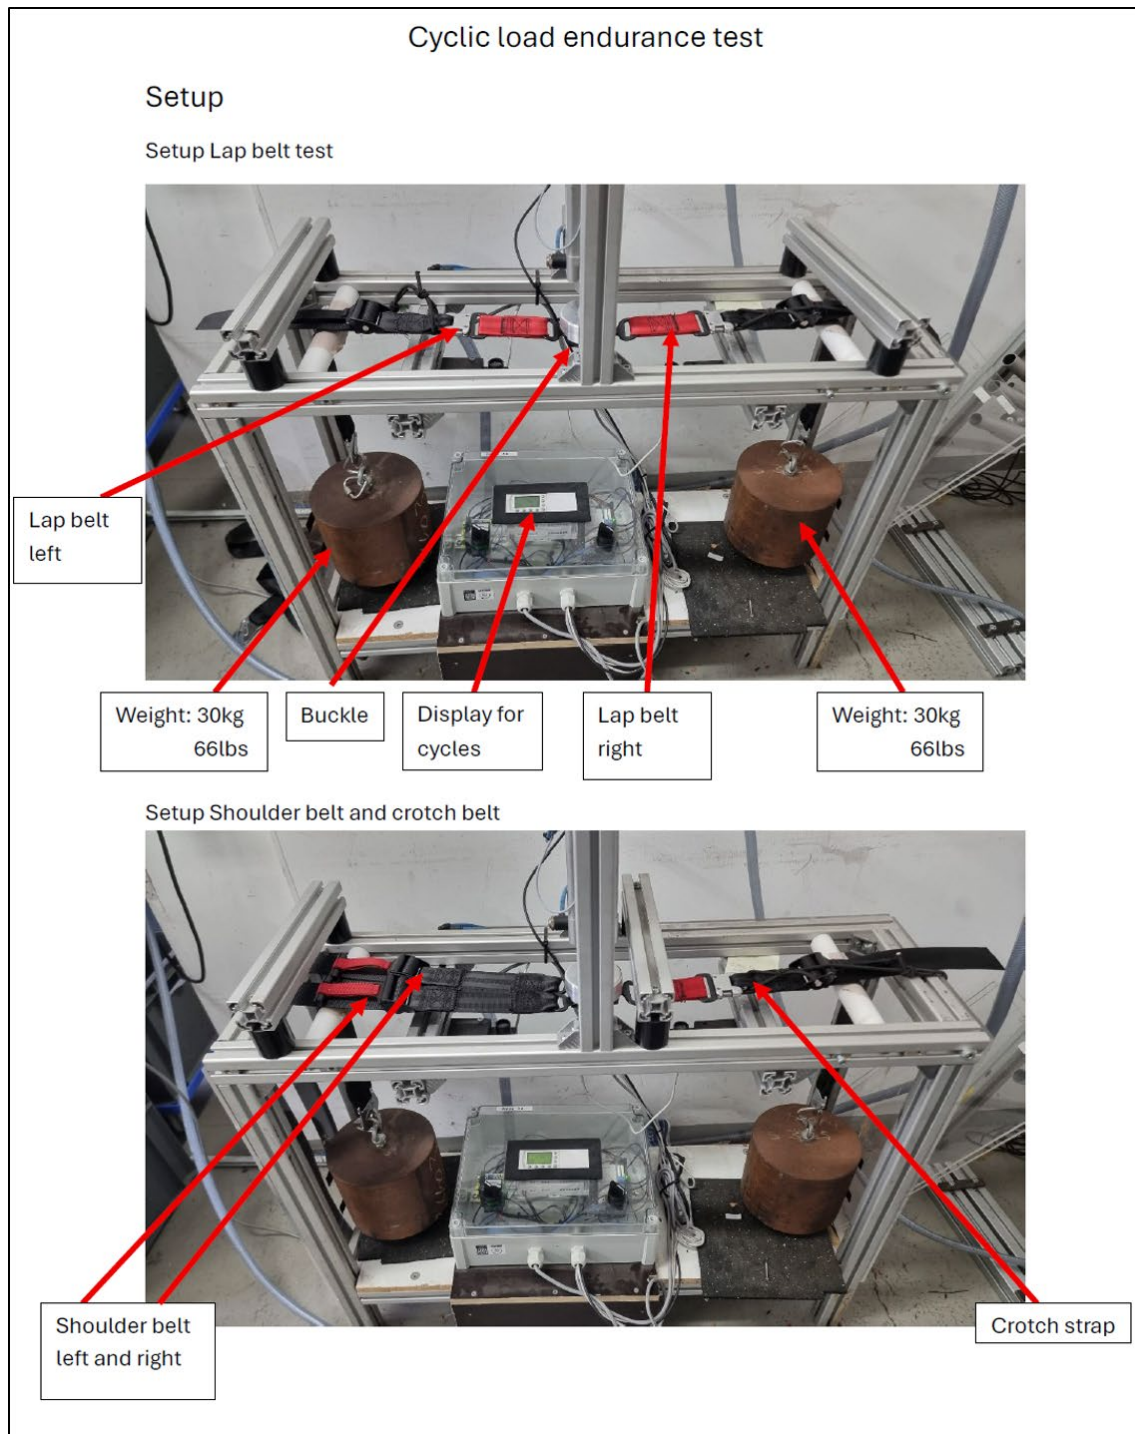
**Figure 5: Manufacturer testing set up**

The manufacturer examined and tested the restraint system from VH-YAO, conducting cyclic load endurance testing of the belts and the buckle (Figure 5). The manufacturer subsequently requested that all Schroth restraint systems in use by the operator be returned for testing to assist in being able to establish a flight hour limit.

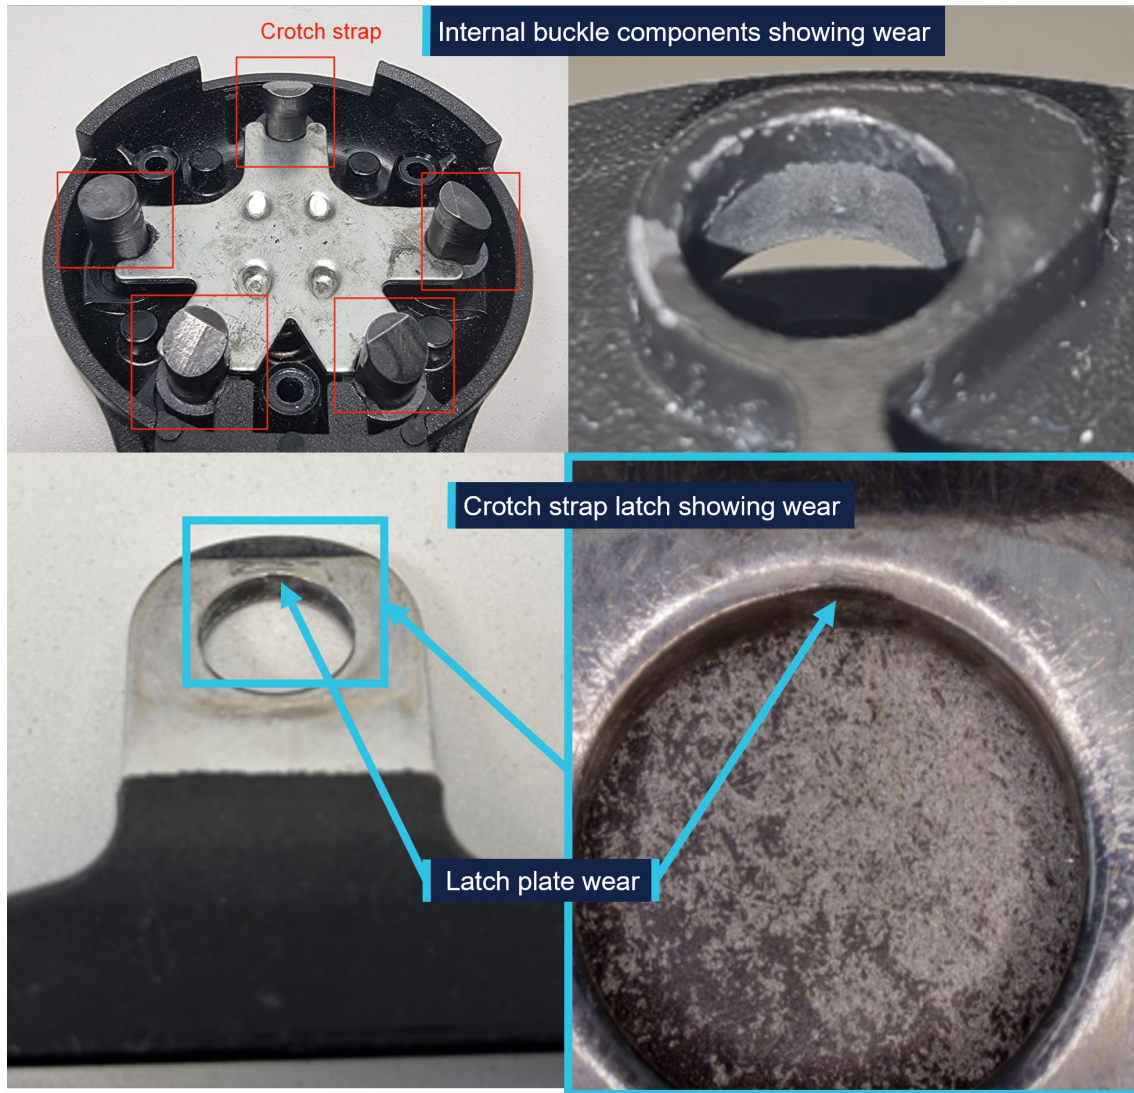
**Figure 6: Manufacturer examination, showing wear to latch and buckle components**

- the fault could be replicated
- while the latches on the restraint appeared serviceable, there was wear present that could affect operation
- the disconnection occurred due to wear on several sub-parts inside the buckle and, to a lesser extent, wear on the latches (Figure 6).

The manufacturer advised that the wear that was present at the time of the incident would not be detectable by the operator or its maintenance organisation using the procedures outlined in the CMM, and that specialist examination by a person with a technical product background would be required. In addition, the manufacturer reported that the extent of the usage by the operator, 1,329 hours time in service, had not been accounted for in the 5-year service life, at the time of distribution of service bulletin 40.073-25-01.

As a result of worn internal buckle sub-parts and latches, the crotch strap of the flight instructor's 5-point harness disconnected during an aerobatic manoeuvre.

As a result of the incident, Schroth, the restraint manufacturer, advised of an intention to revise the service life for use during aerobatic flight to include a time in service hour limit, in addition to a calendar life limit.

The operator has limited the use of the restraint system to a 3-year period or 1,000 hours, with a 50-hour tolerance, and this is tracked within its maintenance system. The limit will remain, with the operator continuing to monitor manufacturer advice.
