# Main landing gear wheel fracture involving Saab 340B, VH-VEF

Melbourne Airport, Victoria, on 1 April 2026

**ATSB Transport Safety Report**

AO-2026-071

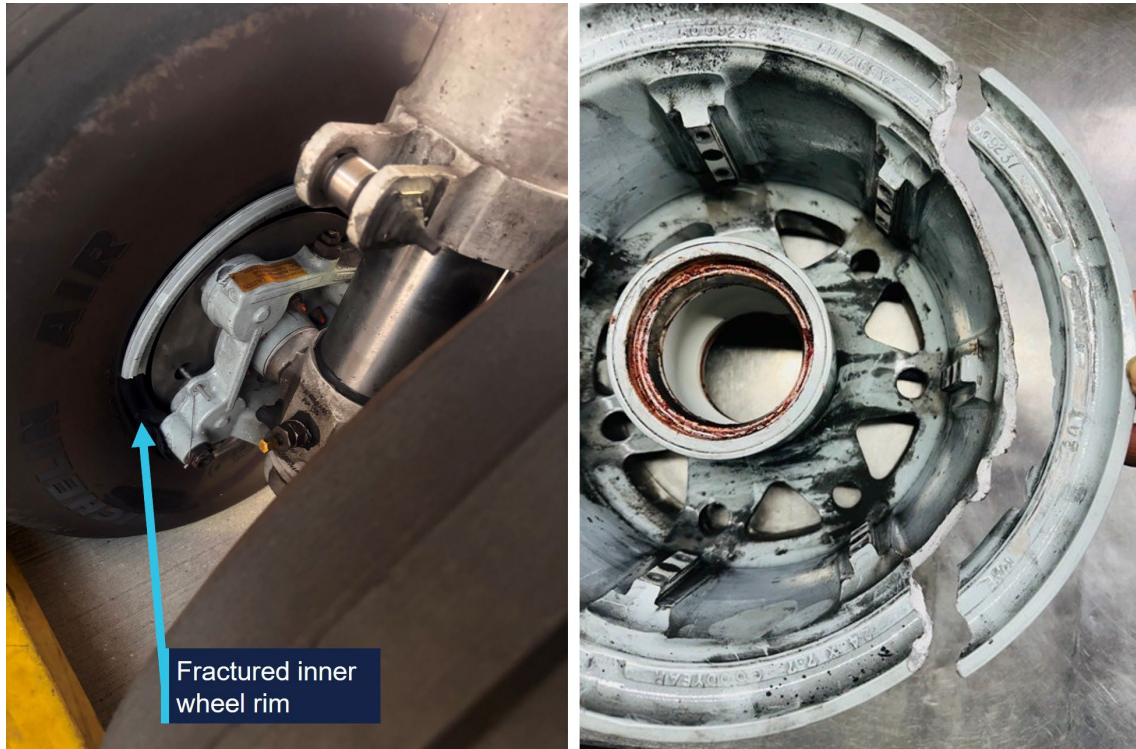
**Figure 1: Main landing gear wheel with fractured inner rim section**

On 1 April 2026, a Saab 340 aircraft, registered VH-VEF and operated by Link Airways, arrived at Melbourne Airport, Victoria, after a flight from Orange, New South Wales. Post-flight inspection of the aircraft identified that the left, inboard main landing gear tyre had deflated, and a section of the inner wheel rim had fractured and separated while taxiing on the lead-in to the aircraft's parking bay.

Post-occurrence precautionary inspection of the other wheel on the same landing gear leg identified a crack in the inboard, bead seat area, which was in a similar location to the fractured wheel section.

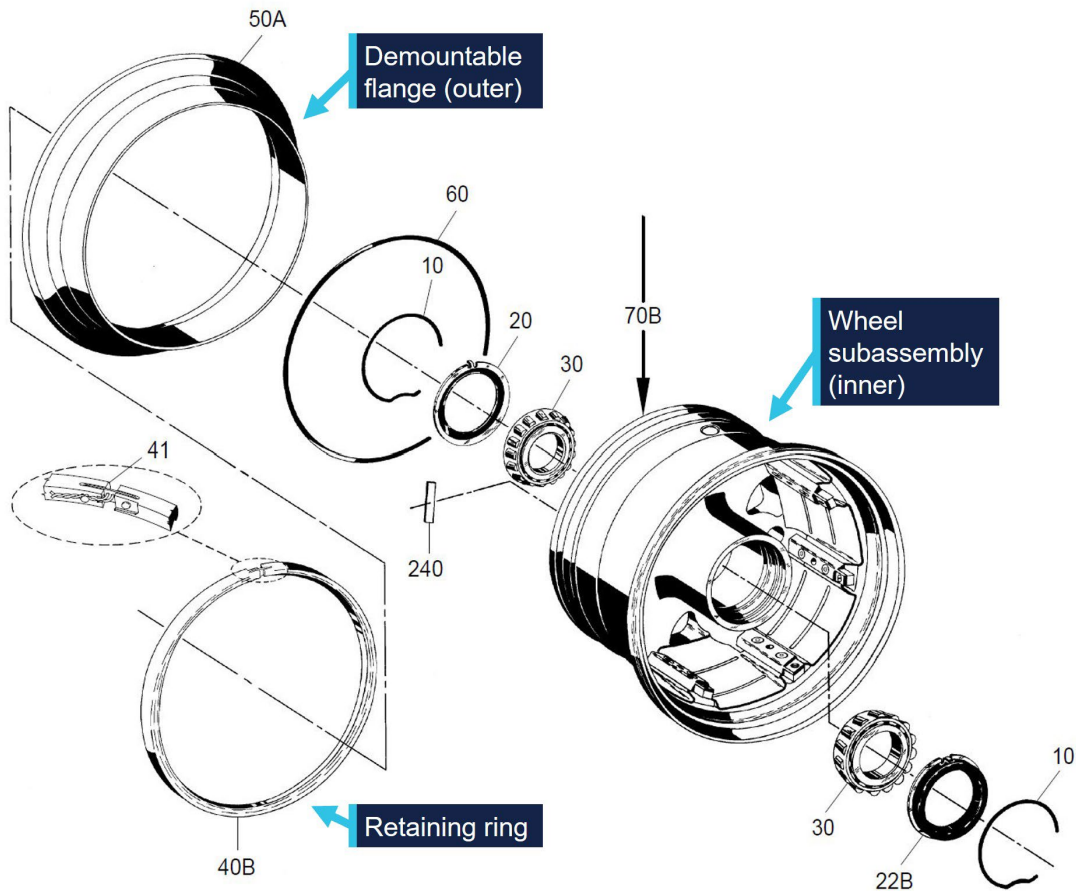
**Figure 2: Main landing gear wheel assembly**

The fractured and cracked wheels were manufactured by the Aircraft Braking Systems Corporation (ABSC), now Meggitt Aircraft Braking Systems (MABS). The fracture and cracking was on the inner subassembly of each wheel (Table 1 and Figure 2).

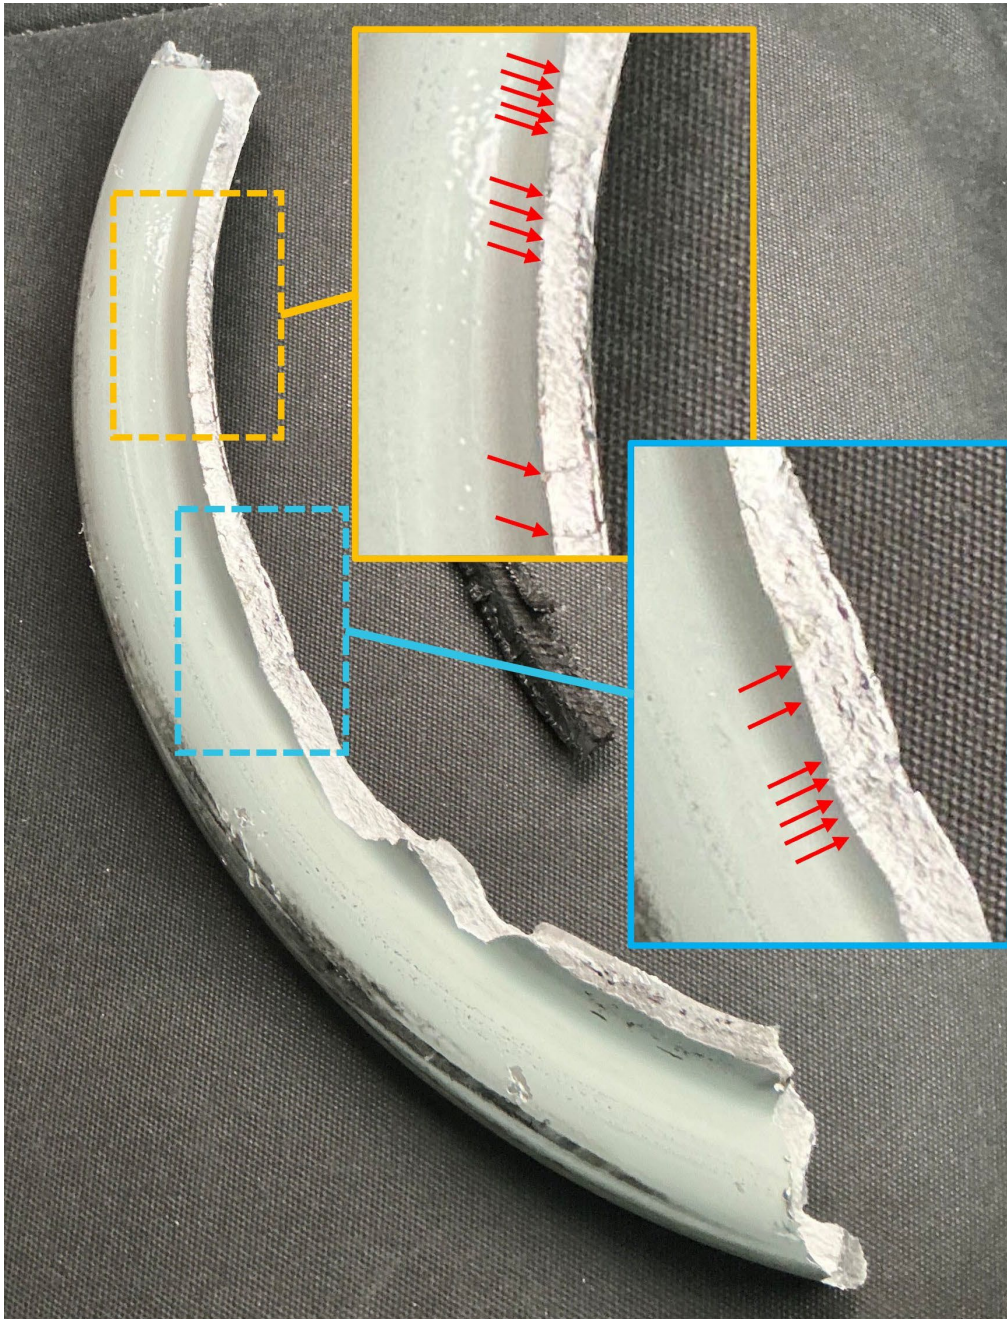
**Figure 3: Crack progression features (arrowed) on separated wheel rim section**

The operator returned the occurrence wheels to the organisation that conducted the most recent overhaul, VSE Aviation, and they were not examined by the ATSB. ATSB examination of images supplied by the operator identified features on the fracture surface consistent with fatigue cracking (Figure 3). The fracture was in a similar location and manner to 2 previous occurrences investigated by the ATSB (see *Previous occurrences*).

Fracture and separation of the section of inner wheel rim was the result of fatigue cracking. The fracture occurred between routine maintenance inspections, around the inner bead seat area of the wheel subassembly that was previously established to be susceptible to cracking.

Fracture of the main landing gear wheel resulted from fatigue cracking in the bead seat area.

The aircraft operator advised the ATSB that, at the time of the occurrence, it had 8 of the main landing gear wheels remaining in service, of the design that was susceptible to cracking. While the wheels were permitted to remain in use, the operator removed them from service to mitigate any ongoing safety risk.
