# Taxiing conflict involving Airbus A320, VH-VFX, and Bombardier DHC-8, VH-48N

Sydney Airport, New South Wales, on 25 August 2026

Aviation Occurrence Investigation

AO-2026-092

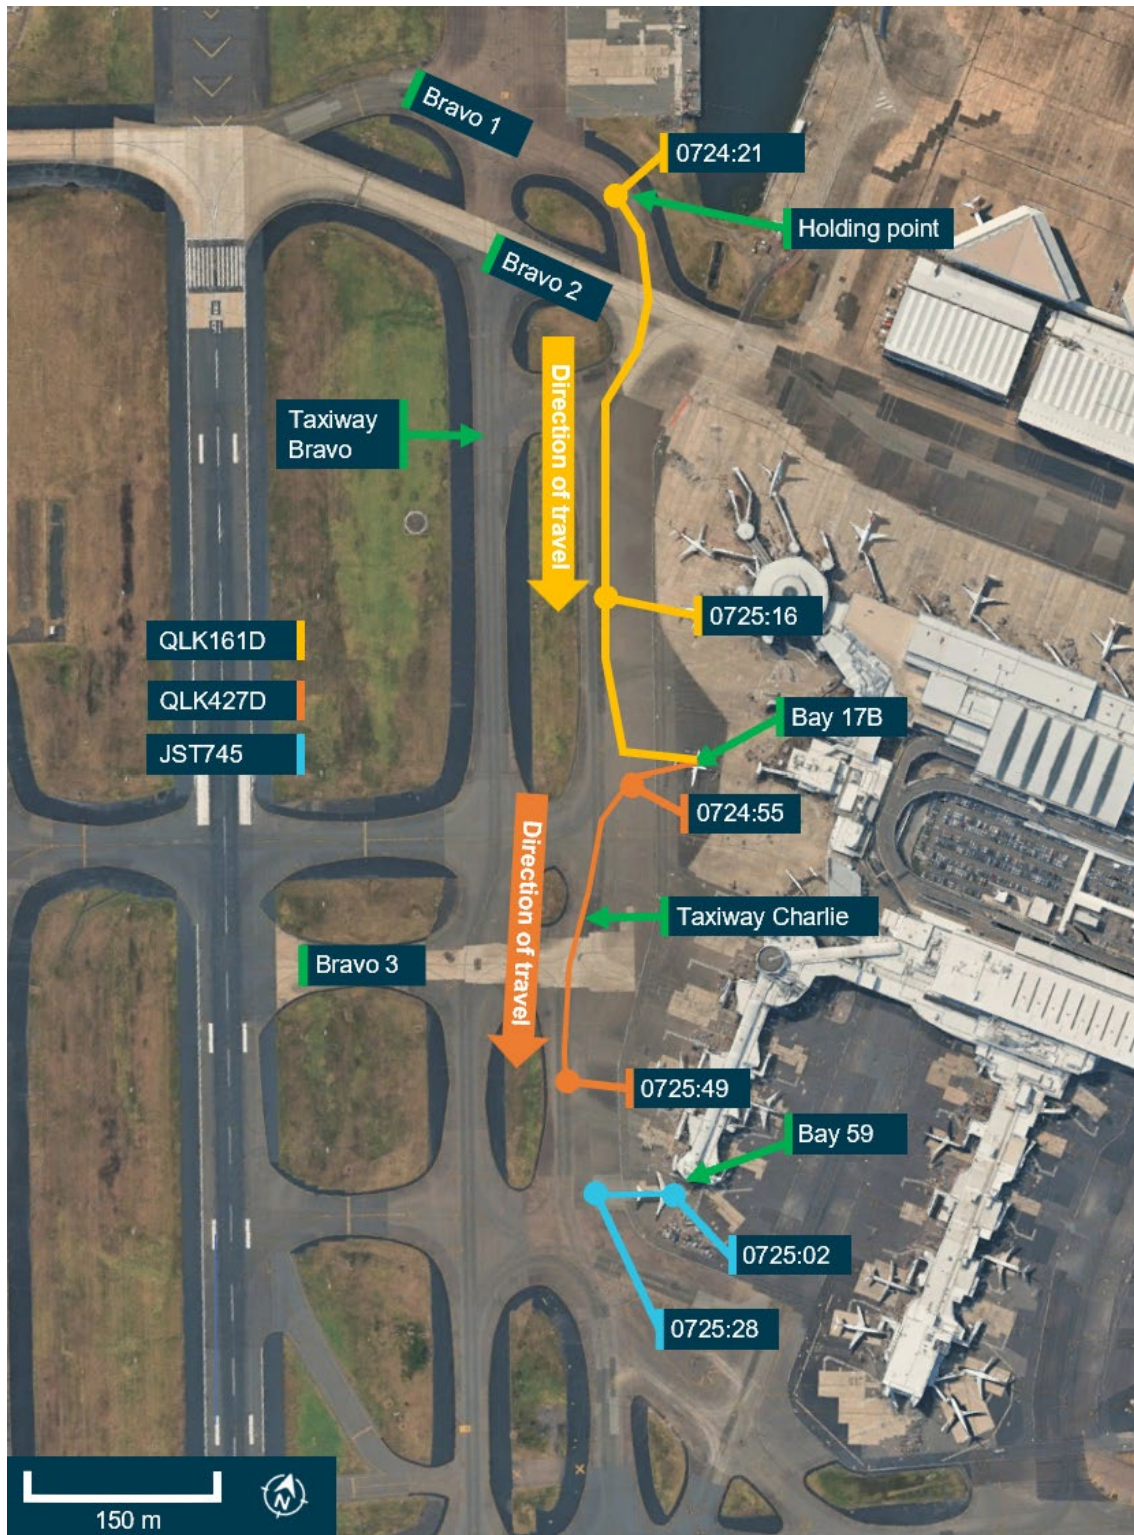
Figure 1: Aircraft taxiing routes

On the morning of 25 August 2026, a Jetstar Airbus A320, registered VH-VFX and operating as JST745, was preparing to push back from bay 59 onto taxiway Charlie (C) at Sydney Airport, New South Wales (Figure 1).

About 30 seconds later, the same controller cleared the crew of a Qantas Link Bombardier DHC-8, registered VH-84N and operating as QLK427D, to taxi and hold short of taxiway Golf (G) from its position at bay 17B. This required a 180° right turn to exit the bay, followed by a 90° left turn, to align the aircraft with taxiway C, facing south.

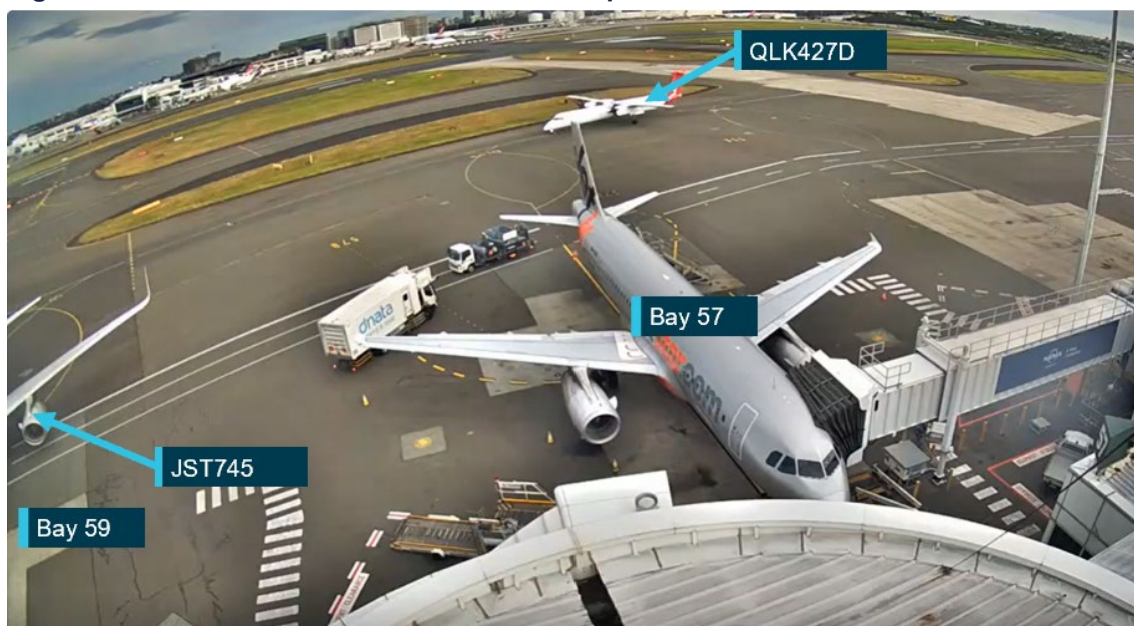
**Figure 2: QLK427D and JST745 at their closest point**

By this time, QLK427D had commenced taxiing, and as the captain was aligning the aircraft with taxiway C to head south, they noted the tail of JST745 seemed to be 'a long way off the bay'. As it appeared stationary at the time, the captain thought it was possible

the aircraft was entering the bay and waiting for the nose-in guidance system<sup>1</sup> before moving forward. The captain then noted the tail was moving backwards. The crew recalled their own speed to be around 10 kt, prior to stopping their aircraft approximately 100 m from bay 59.

The pushback driver and dispatcher<sup>2</sup> of JST745 both observed the approaching DHC-8 (QLK427D), stopped the A320's pushback and advised the flight crew of the conflict.

Closed-circuit television (CCTV) footage was provided by Sydney Airport from cameras directed towards bay 57 and captured the position of both JST745 and QLK427D during the occurrence (Figure 2).

The controller instructed JST745 to tow back onto the bay while QLK427D passed behind, before JST745 was again cleared for pushback.

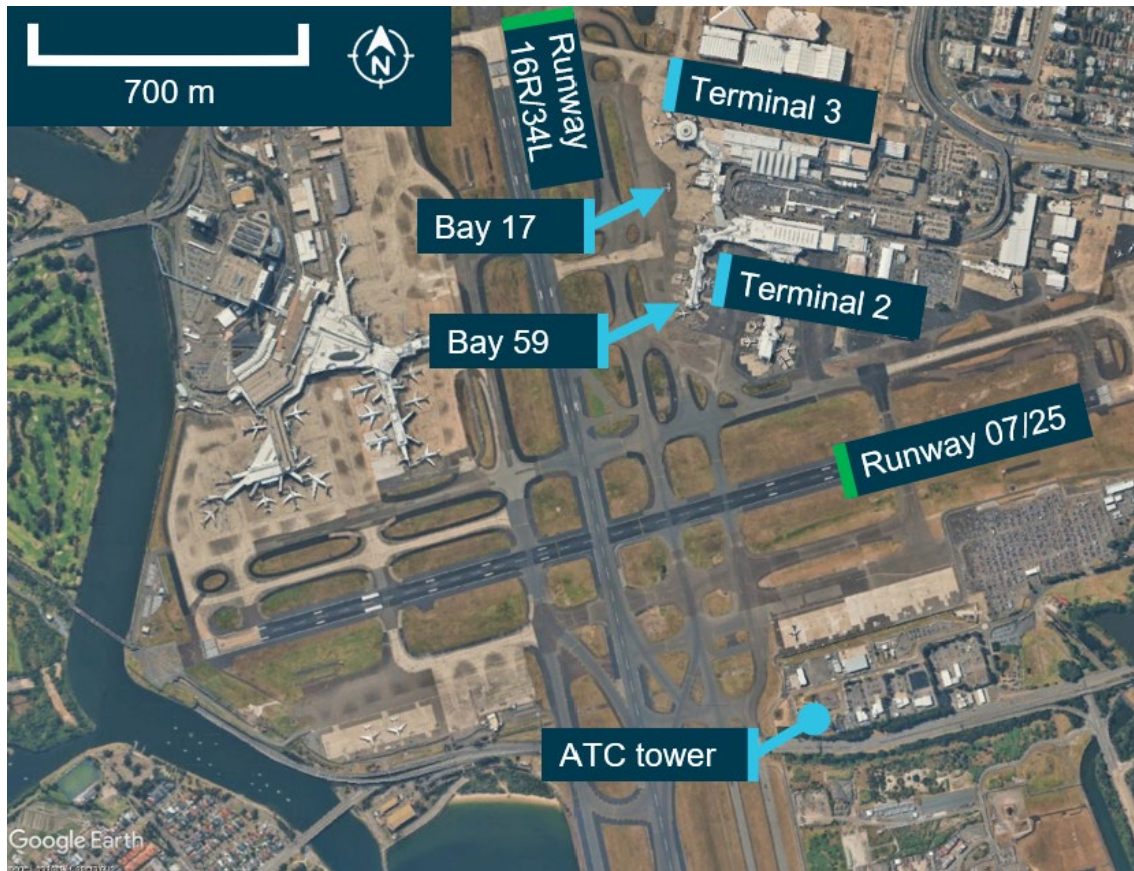
**Figure 3: Terminal positions relative to tower**

Terminals 2 and 3 (Figure 3) located at the north-eastern section of the airport were used for domestic departures and arrivals and were the responsibility of the surface movement controller east (see *Surface movement control*) located in the air traffic control (ATC) tower.

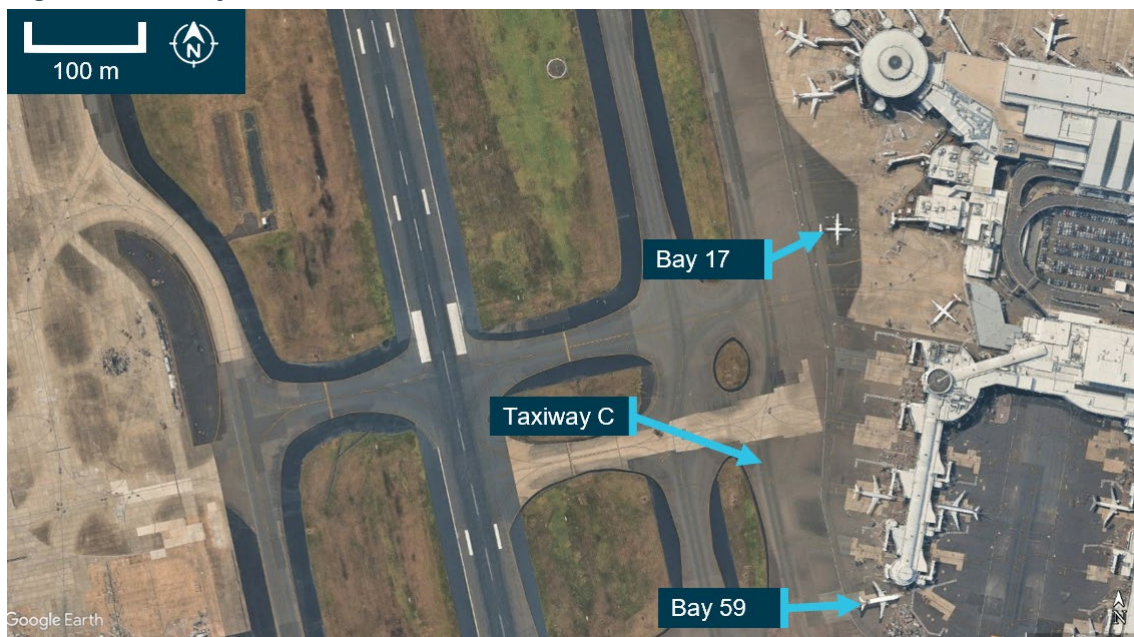
**Figure 4: Taxiway C**

Gates 8–19 at Terminal 3 and gates 49–59 at Terminal 2 backed directly onto taxiway C (Figure 4). The 3 controllers interviewed stated that pushbacks from these gates were prone to conflicts, due to aircraft pushing back directly onto an active taxiway, rather than an apron.

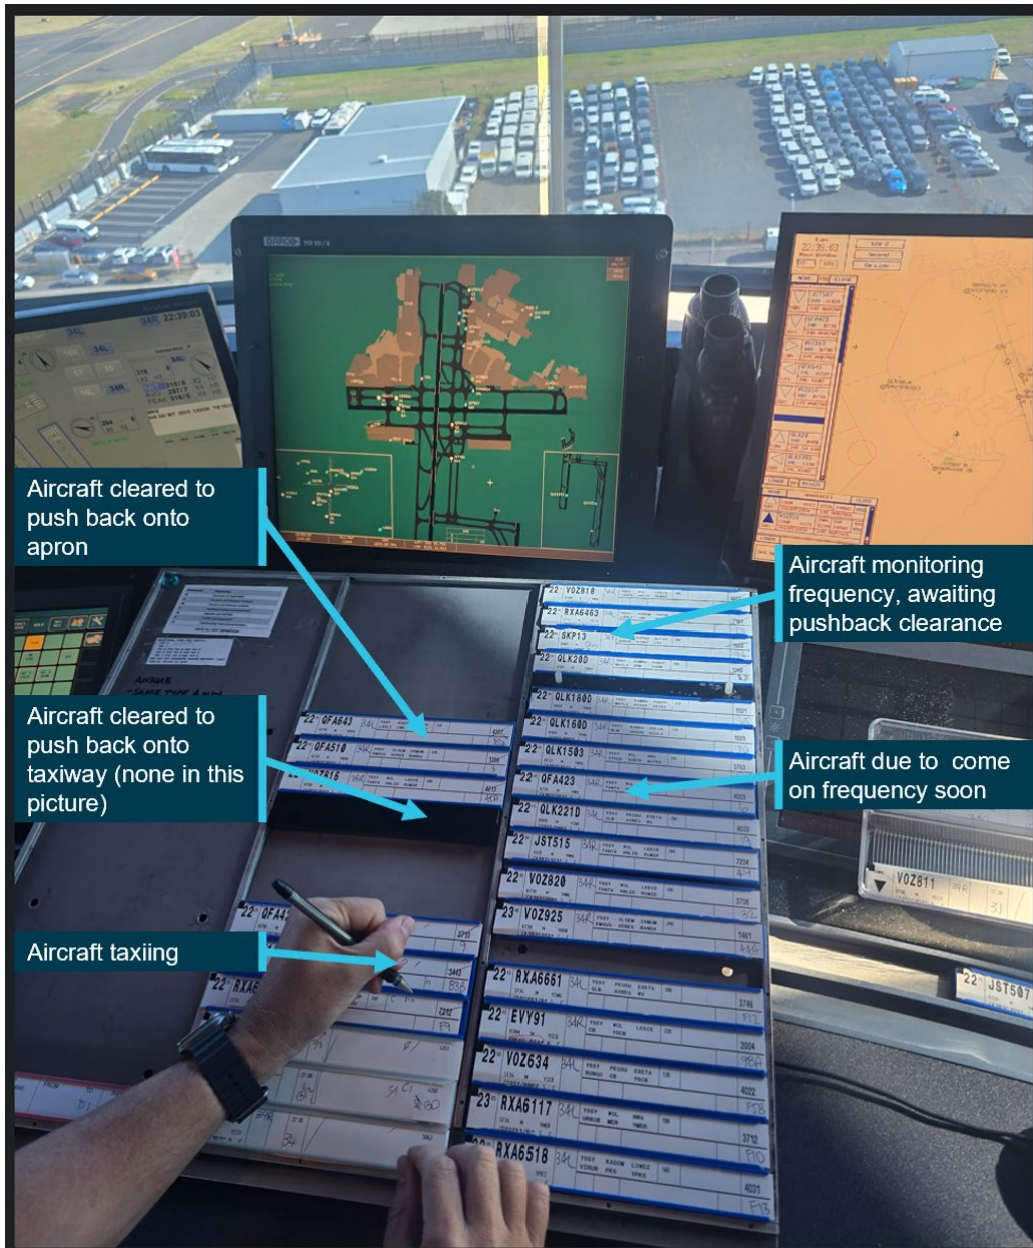
Figure 5: Example of flight strip board (not at time of occurrence)

The SMCE, TSM and OJTI controllers stated that there were no set procedures on how the FPS were to be moved or organised within the board. It was up to the individual controller to organise the strips in a manner which assisted them best with situation awareness.

The SMCE controller advised that it was their own methodology to bring strips into the upper section of the centre section of the board when an aircraft was cleared for pushback onto the apron, the middle part of the centre section between black dividers when aircraft were pushing back onto a taxiway, and into the lower part of the centre section of the board when an aircraft was taxiing (Figure 5).

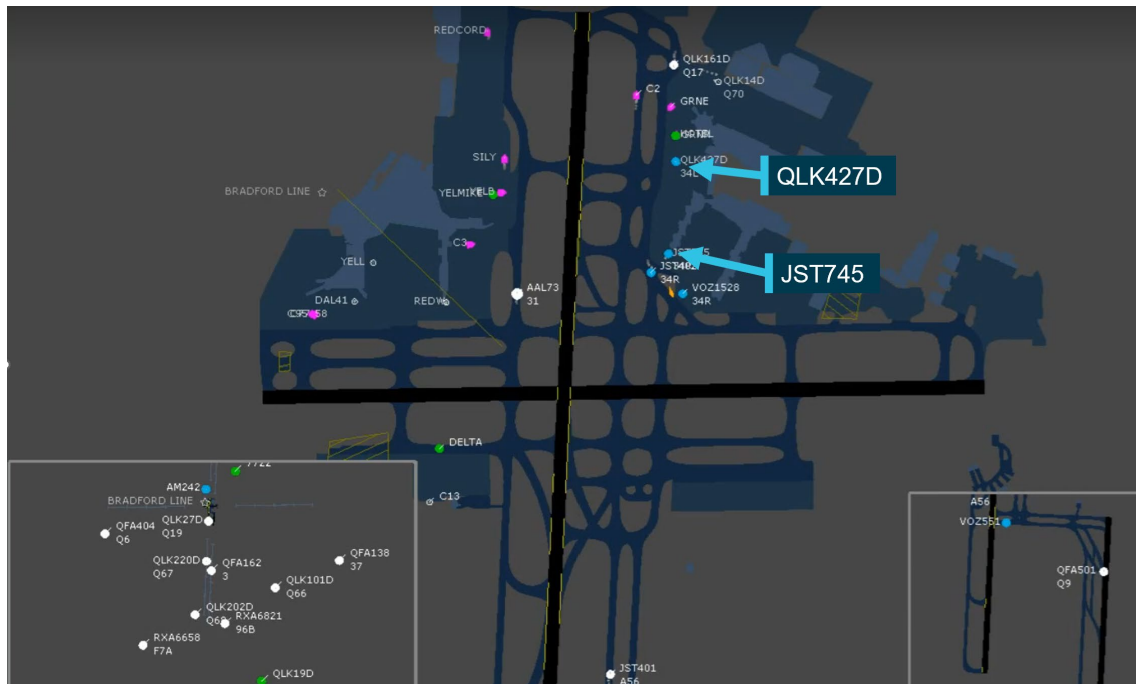
Figure 6: A-SMGCS screen capture at 0724:54 EST

Airservices A-SMGCS recordings captured the position of aircraft and ground vehicles at the time of the occurrence (Figure 6). Both the coordinator/TSM and SMCE had access to an A-SMGCS display at their controller positions in the tower.

The A-SMGCS system did not provide alerts for aircraft taxiing conflicts on taxiways and aprons.

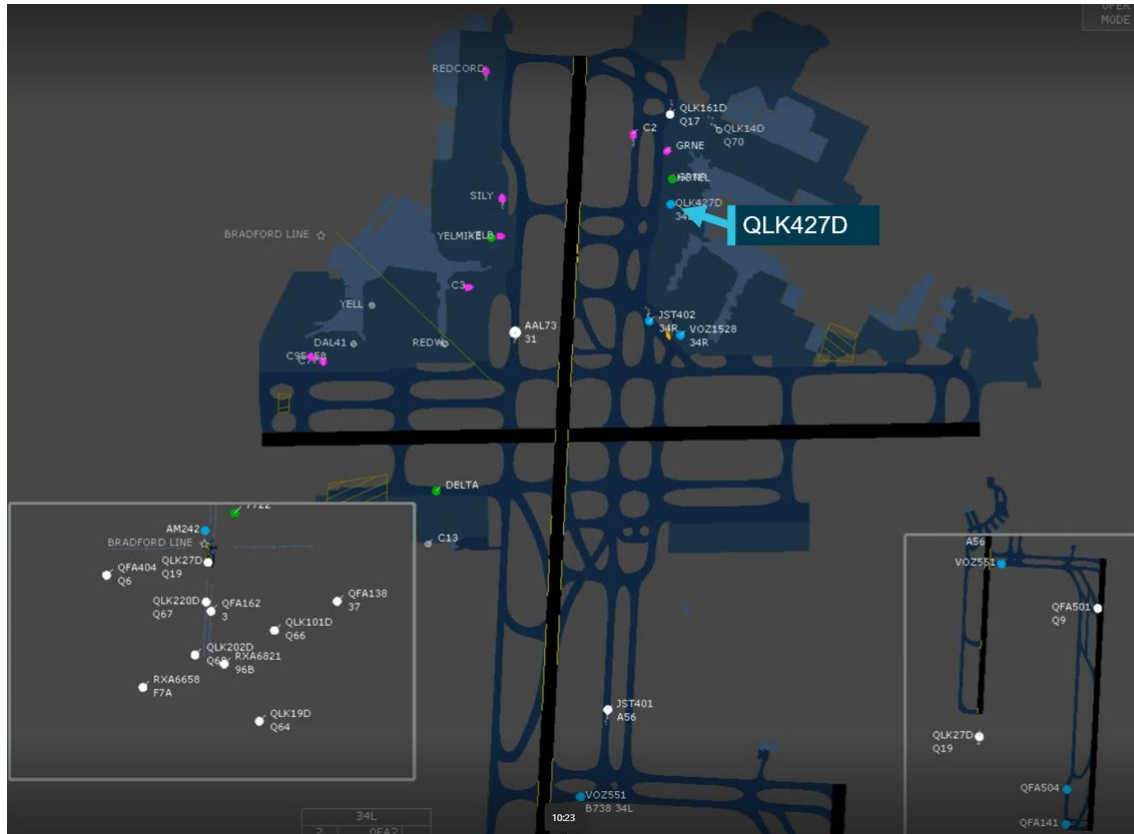
**Figure 7: A-SMGCS screen shot at 0724:57 EST, with JST745 not visible**

The TSM and OJTI reported to the ATSB that bays in that area can be a 'black spot,' as the A-SMGCS receiver did not always detect aircraft in the bays, and sometimes only displayed aircraft once they were established on the taxiway (Figure 7).

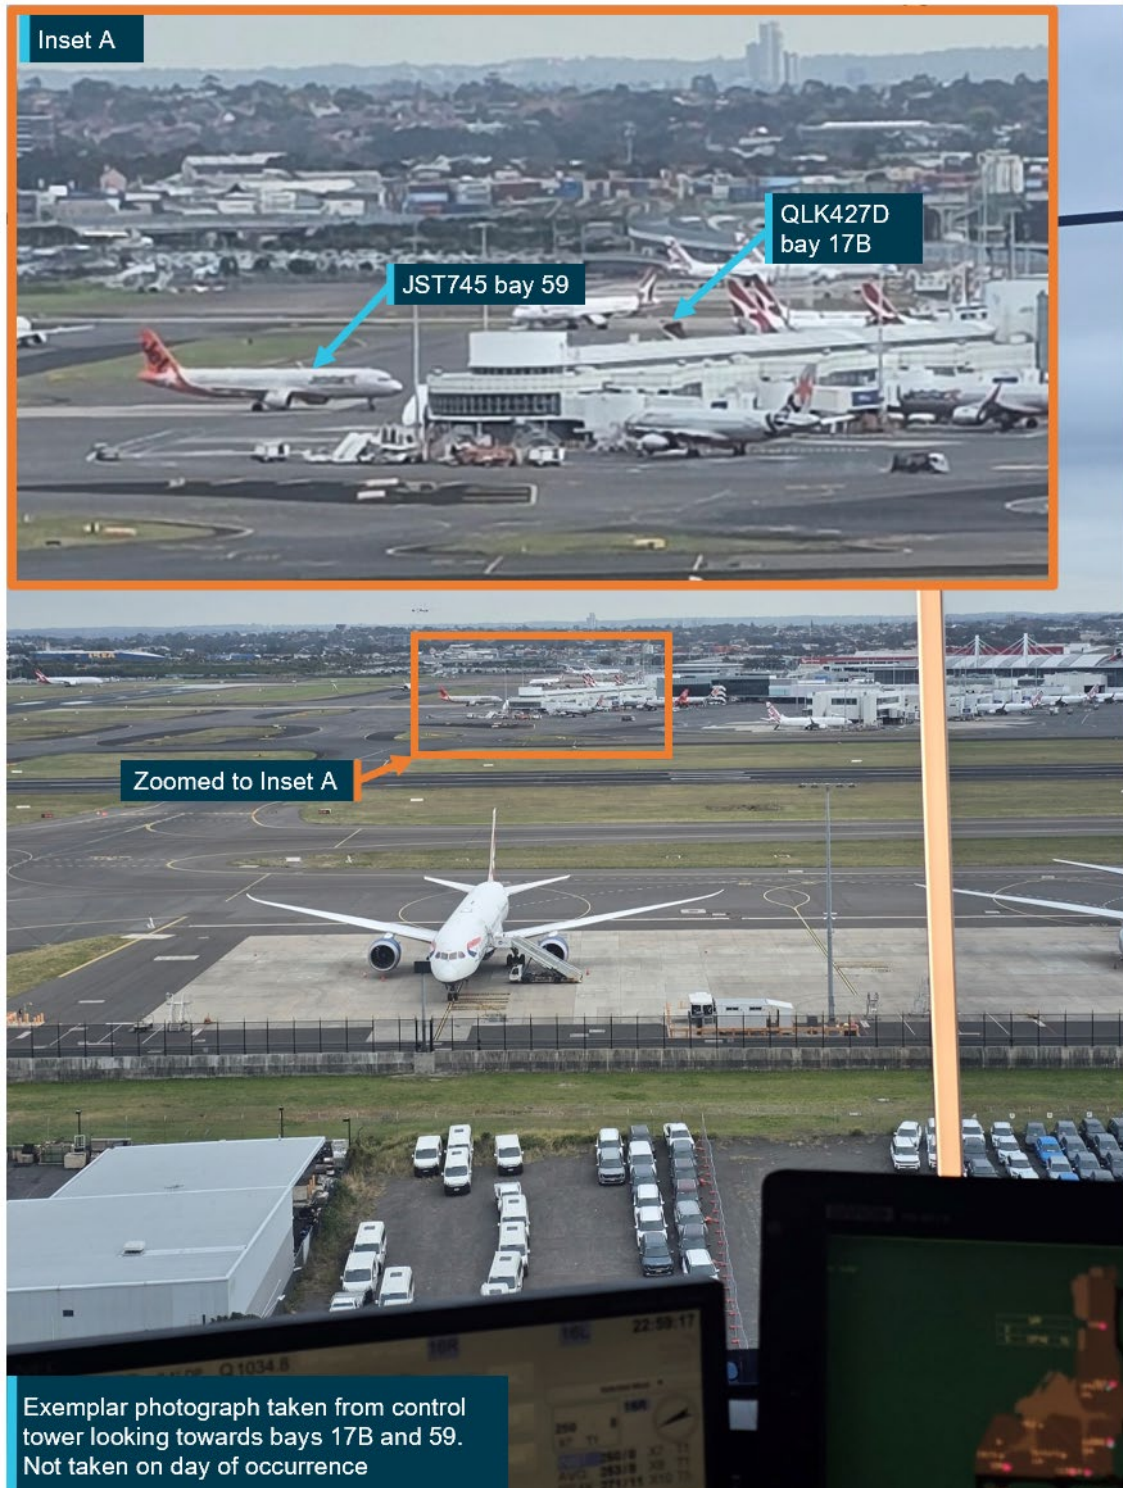
Figure 8: View of bays 59 and 17B from SMCE position in tower

Multiple bays along domestic terminal 1, including Bay 17, were only partially visible to controllers for smaller aircraft, such as the DHC-8 (Figure 8).
