# **Taxiing conflict involving Boeing 737, VH-IXJ and Boeing 737, VH-VZV**

Sydney Airport, New South Wales, on 17 August 2026

AO-2026-093

Preliminary – 26 October 2026

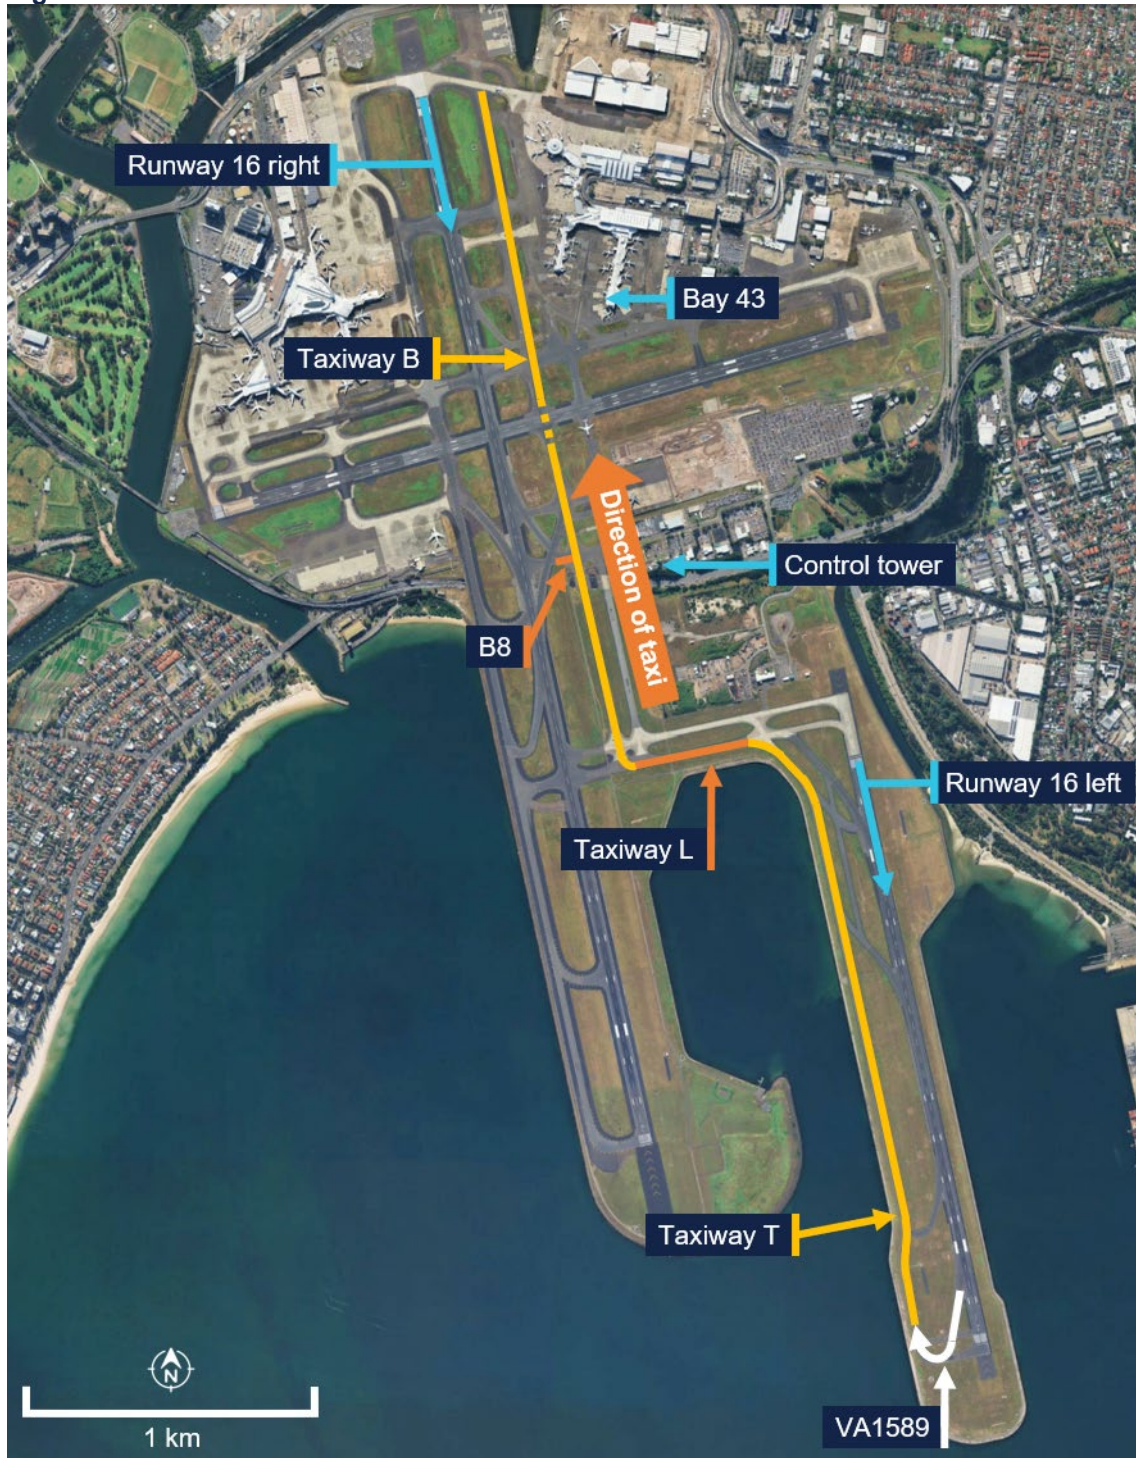
Figure 1: Taxi route for VA1589

At 0933 local time, VA1589 landed on runway 16 left (16L) at Sydney. The aircraft vacated the runway and followed the standard taxi route (see *Airport information*) from runway 16L along taxiways T, L and B towards the domestic terminal's bay 43 (Figure 1). At 0939, as VA1589 taxied west along taxiway L, the surface movement controller (SMC) east (see *Air traffic services*) instructed the crew to hold short of taxiway B8 and the crew read back this instruction. At the same time, a Qantas Airways Boeing 737-800, registered VH-VZV and operating as flight QF420 from Melbourne to Sydney, was on final approach to runway 16 right (16R) at Sydney.

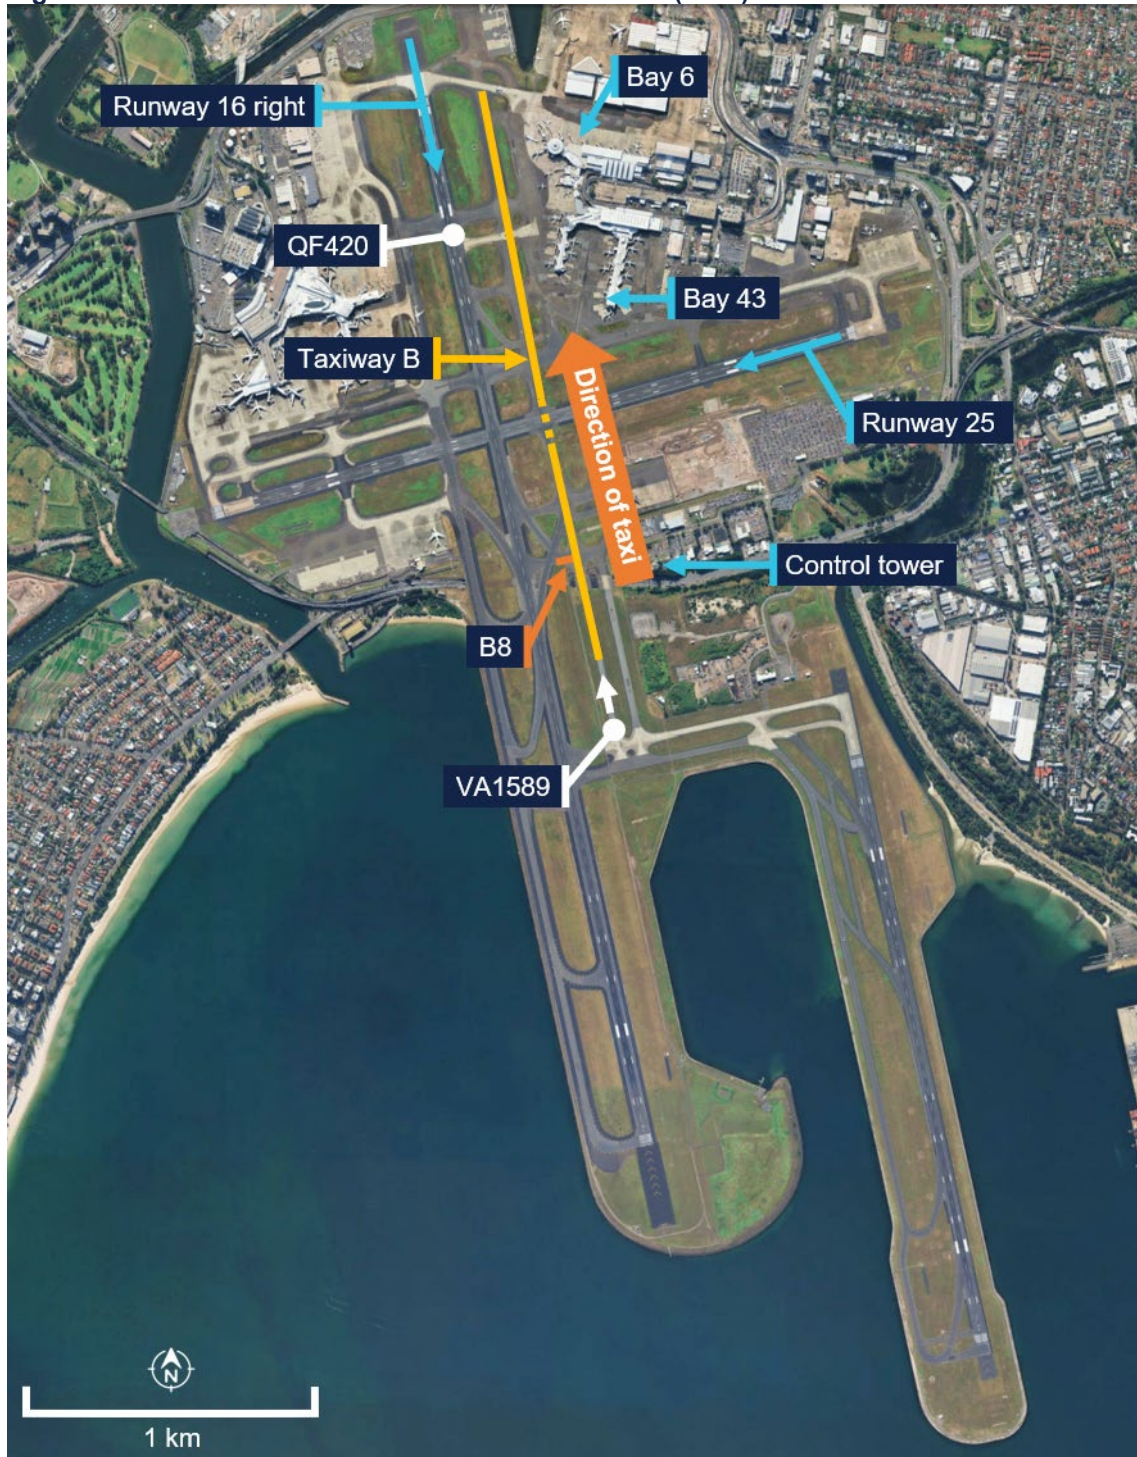
**Figure 2: Positions at the time of ‘follow’ instruction (0940)**

At 0940, while VA1589 was at the southern end of taxiway B and QF420 was touching down on runway 16R, the VA1589 first officer contacted Virgin Australia's Sydney ground operations via radio to discuss arrival arrangements. At the same time, the SMC east instructed the crew of VA1589 to 'follow the Qantas to vacate ahead, hold short runway 25' (Figure 2). The captain of VA1589 read back 'hold short of runway 25' and did not readback the 'follow the Qantas' instruction (see *Recorded information*). The SMC east did not recognise the incomplete readback and moved on to other tasks. At that time, the

crew of QF420 were communicating with the aerodrome controller using a different air traffic control frequency (Sydney Tower) and did not hear these communications.

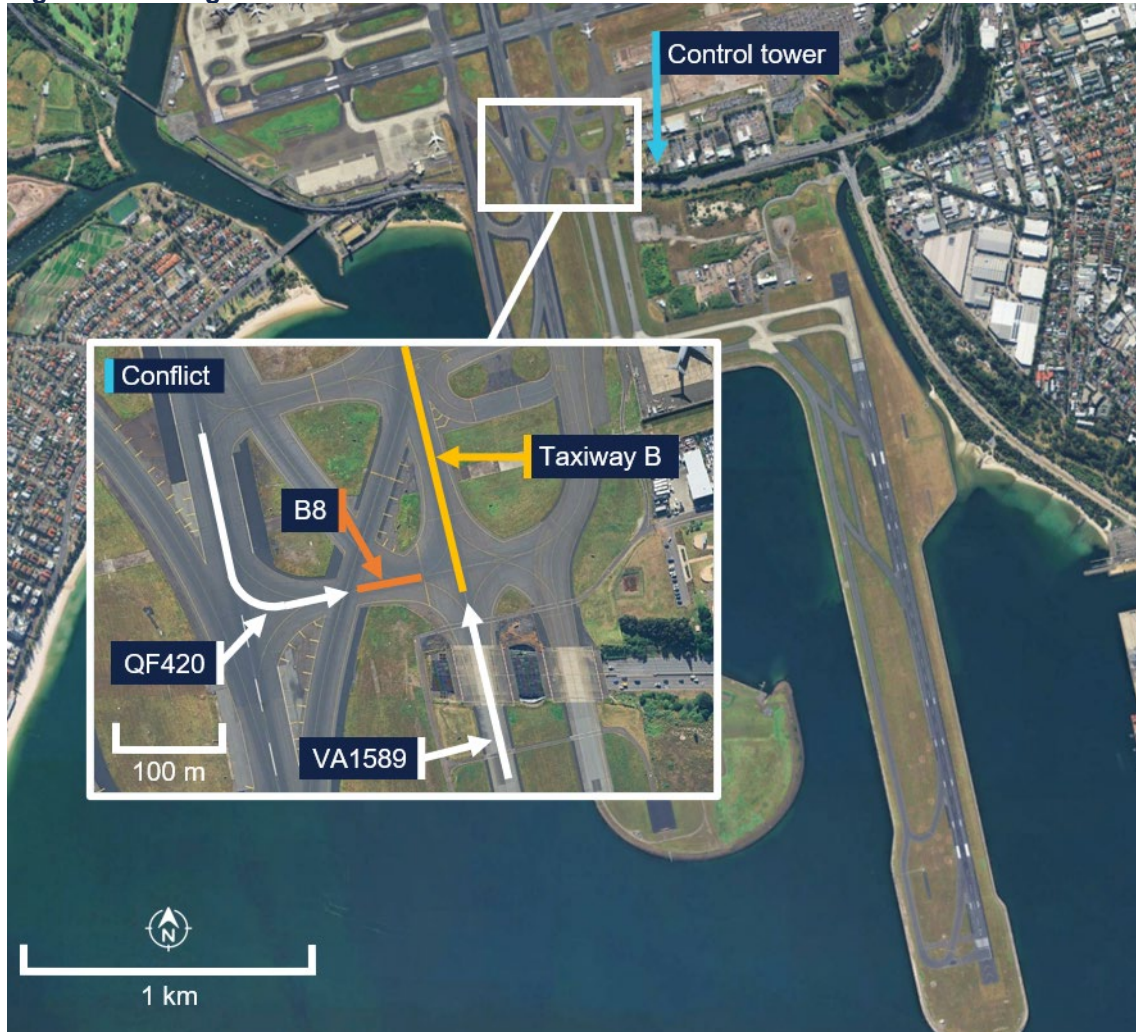
**Figure 3: Taxiing conflict**

As QF420 slowed on runway 16R, the crew elected to use taxiway B8 to vacate the runway. As QF420 turned into the taxiway, the crew contacted the SMC east to request taxi clearance along the standard taxi route (taxiway B) to domestic bay 6. The SMC east instructed the crew of QF420 to follow that route and hold short of runway 25.

As the crew of QF420 read back the taxiing instructions, they sighted VA1589 and noted that it was approaching the taxiway B and B8 intersection at a speed that indicated that it would not give way. The crew of QF420 stopped the aircraft using normal braking and asked the SMC east if they were to give way to VA1589 (Figure 3). The SMC east responded that VA1589 should have given way, but that QF420 should now follow VA1589.

The crew of VA1589 were not aware of the conflict until hearing the question from the crew of QF420. By that time, VA1589 was already passing in front of QF420. Both aircraft then taxied to the terminal without further incident.

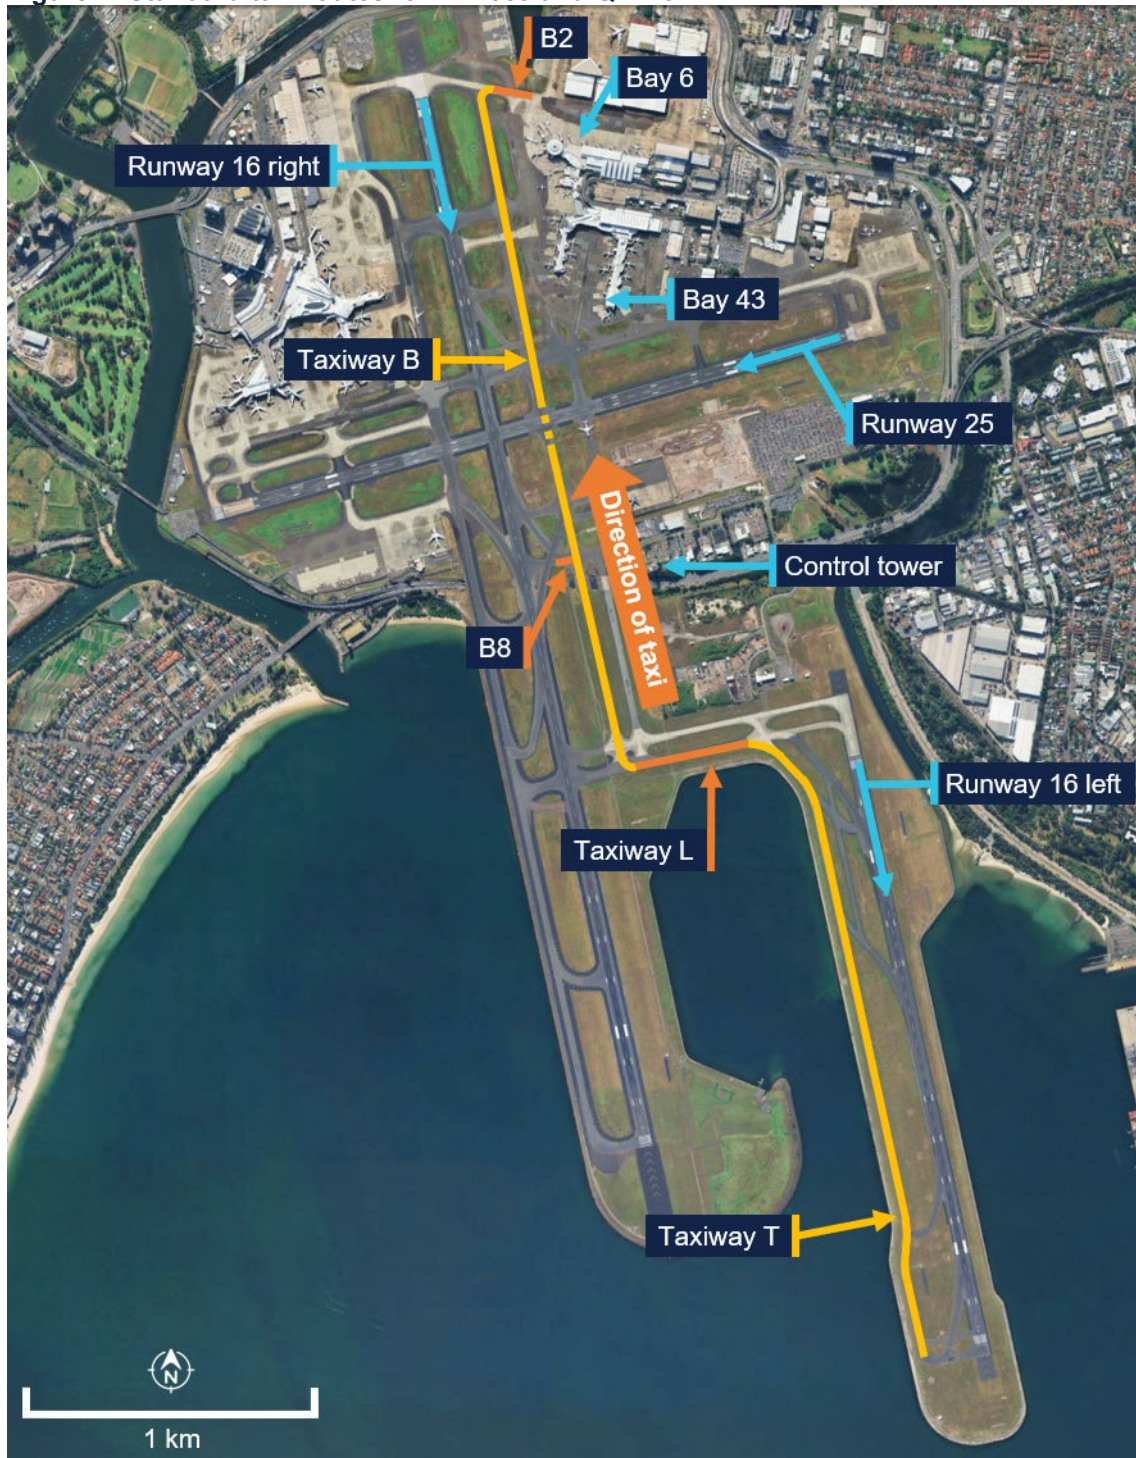
**Figure 4: Standard taxi routes for VA1589 and QF420**

For domestic arrivals, the Aeronautical Information Publication (AIP) Departure and Approach Procedures provided standard taxi routes from the runways to the domestic terminals on the eastern side of the airport (Figure 4) which pilots were required to follow unless explicitly instructed otherwise by an air traffic controller. The standard taxi route for domestic aircraft arriving on runway 16L bound for bay 43 (the bay for VA1589) followed taxiways T, L and B. A domestic aircraft arriving on runway 16R bound for bay 6 (the bay for QF420) followed taxiways B and B2.

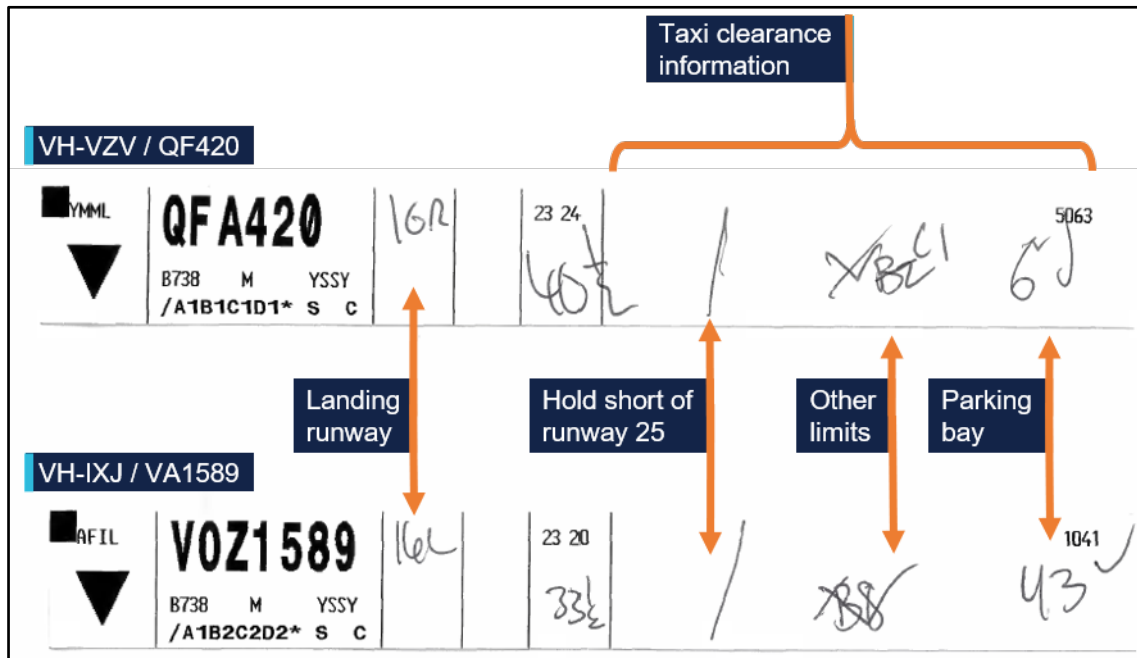
Figure 5: Flight progress strips for the involved aircraft

Controllers used physical flight progress strips (FPS) to keep track of aircraft details and positions (Figure 5). The FPS was moved between different controller positions as aircraft moved around the aerodrome and transferred between controller frequencies. Within control positions, controllers arranged the FPS on a flight progress board to indicate the aircraft sequence, and which aircraft were cleared to occupy a runway. Controllers were able to mark the FPS to record specific information, such as the limit of an aircraft's taxi clearance.

Note: The taxi clearance information includes annotation changes for instructions that were provided after the conflict was resolved. The forward slash in the taxi clearance information represented an instruction to hold short of runway 25.  
Source: Airservices, annotated by the ATSB

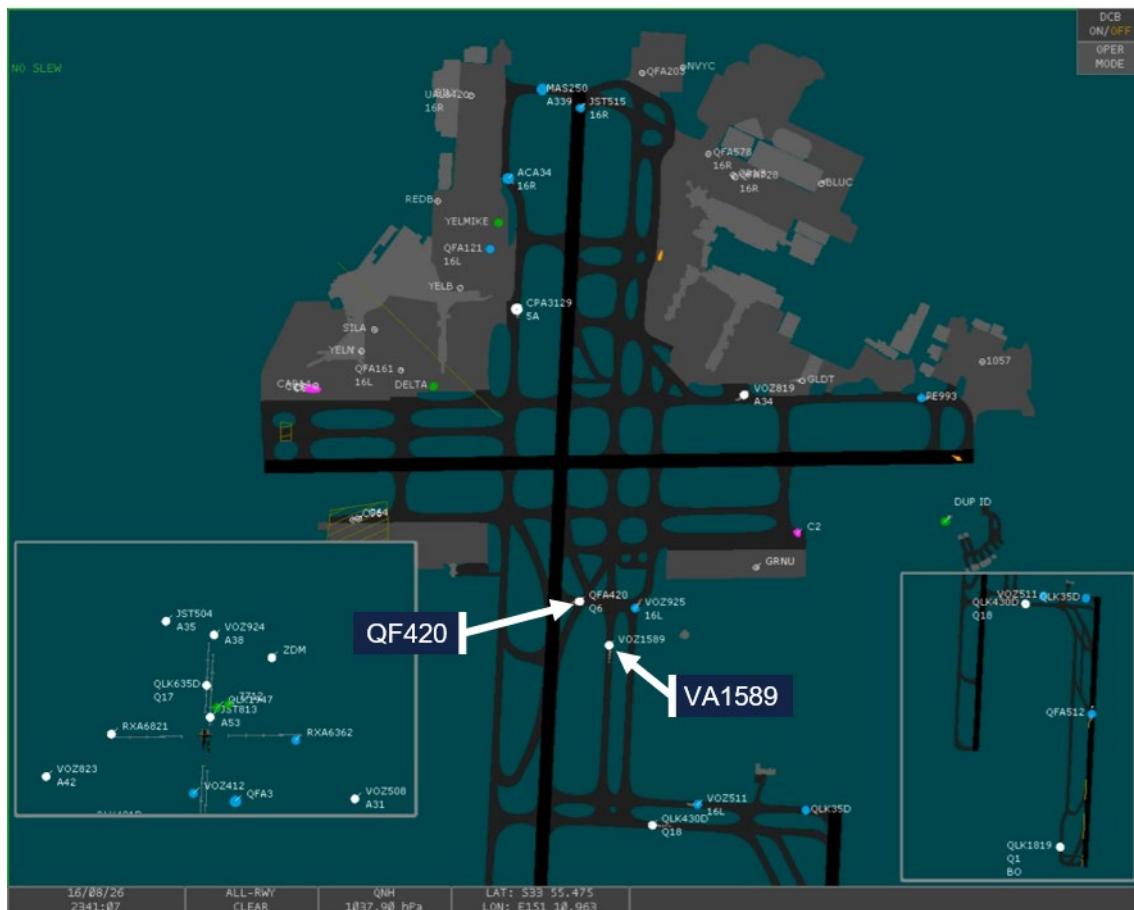
**Figure 6: Advanced surface movement guidance and control system prior to the conflict**

Airservices also provided a recording of the A-SMGCS display (Figure 6).

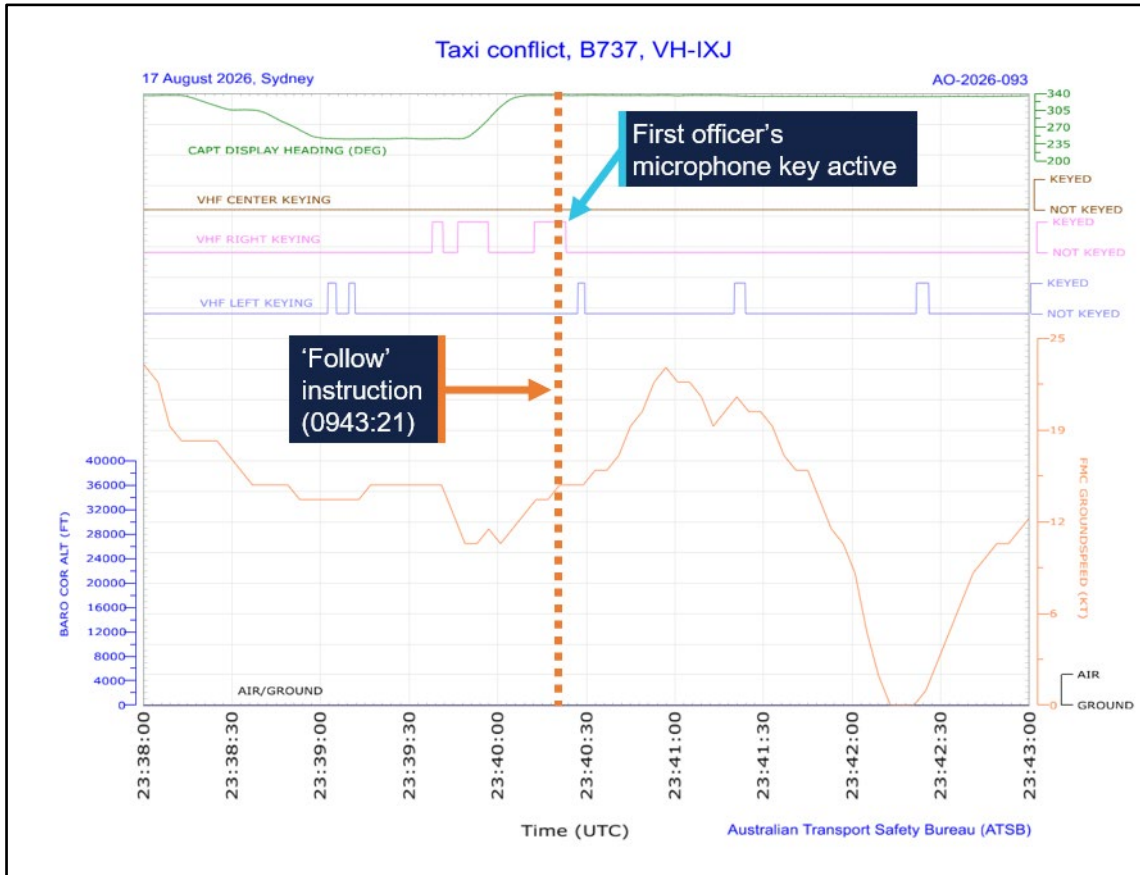
**Figure 7: Graphical representation of recorded flight data**

The quick access recorder data from VA1589 showed that at 0940:21, when the SMC east provided the 'follow' instruction, the first officer's microphone key was active (transmitting) (Figure 7).

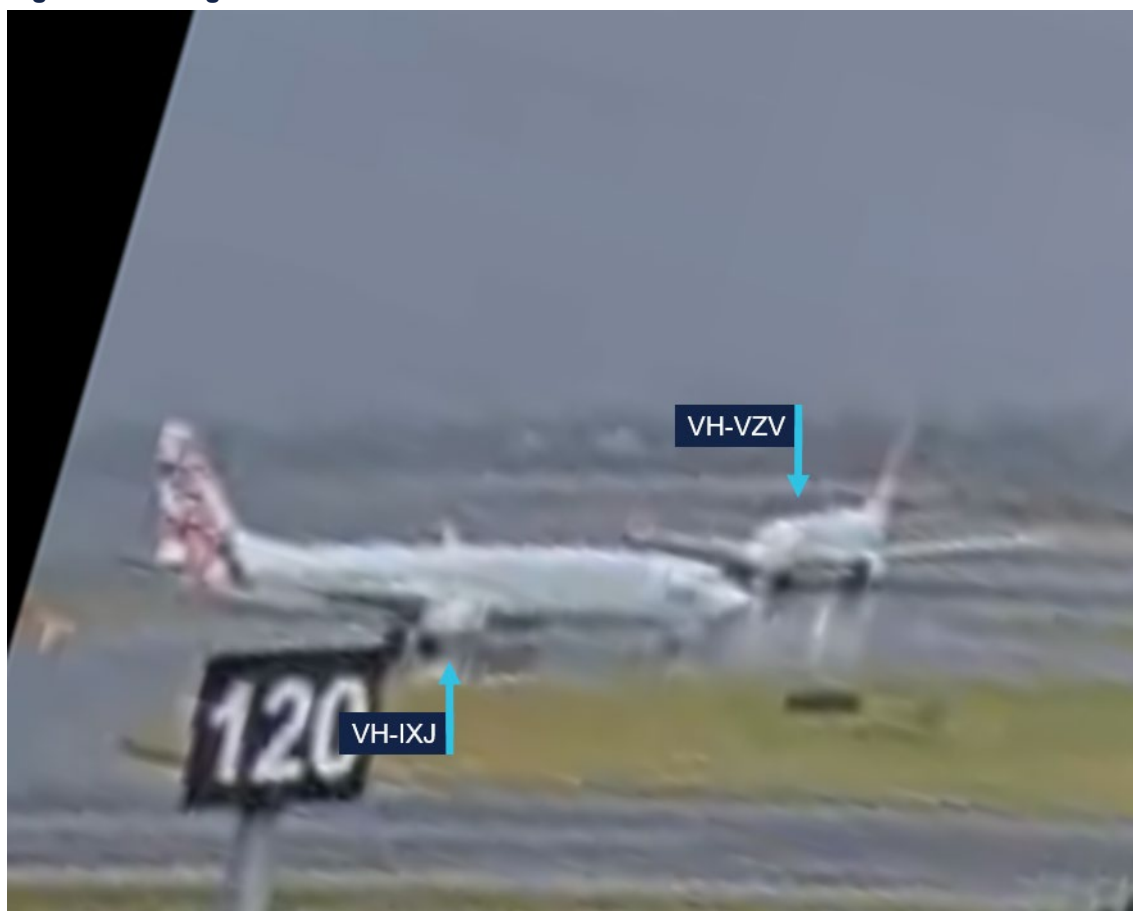
**Figure 8: Taxiing conflict**

Sydney Airport provided closed-circuit television (CCTV) footage from a camera directed towards the intersection of taxiways B and B8 (Figure 8). Footage was also provided that captured the movements of VA1589 and QF420 leading up to the conflict.
