# **Runway excursion and collision with terrain involving an Air Tractor AT-802A**

82 km north-west of Hopetoun, Victoria, on 4 December 2025

AB-2025-065

Final – 21 January 2026

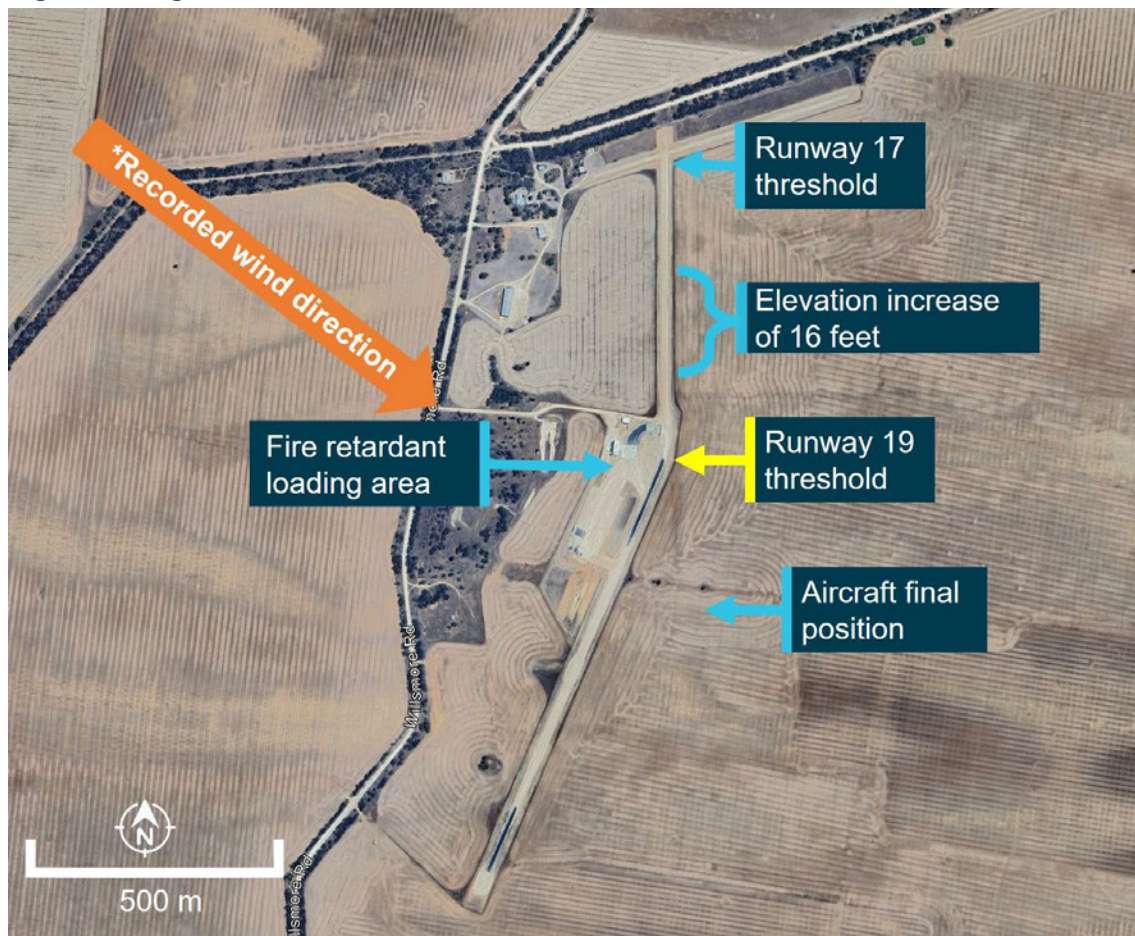
**Figure 1: Linga Airbase, Victoria**

On 4 December 2025, at 1720 local time, an Air Tractor AT-802A was preparing to conduct aerial firefighting operations from Linga Airbase, Victoria. Before departure the pilot briefly consulted electronic maps for Linga Airbase, however, did not observe that runways 17 and 19 were 2 separate runways with runway 19 commencing at the end of runway 17 rather than a single longer runway (Figure 1). After loading the aircraft with fire retardant, the pilot commenced taxi for runway 17, believing they were backtracking to use the entire length of runways 17 and 19. The pilot completed their take-off checks and commenced the take-off roll.

The pilot reported that during the take-off run, due to the upslope on runway 17, they were unable to see the threshold of runway 19 until the aircraft had crested the rise towards the end of runway 17. Unaware of the 20° right turn, on becoming visual with runway 19, the pilot assessed the turn was too sharp to navigate and the aircraft was travelling too fast to stop and not yet fast enough to become airborne.

The airbase manager reported other firefighting aircraft had been using runway 19 throughout the day. Linga Airbase runway 17 was about 660 m in length and joined the northern end of runway 19 which measured about 1,000 m in length. The aircraft was loaded with retardant to the western side of where runways 17 and 19 met.

Although they were an experienced agricultural pilot, they had not previously operated from that airbase. Although the pilot observed other aircraft depart using runway 19 while reloading, they assumed they were not using the entire length of the runway, and by taxiing and backtracking to the threshold of runway 17 believed they were increasing their take-off roll distance. Performance calculations indicated that due to the air temperature, weight of the aircraft and wind conditions, the aircraft would have required the full length of the longer runway 19 to become airborne.

Thorough pre-flight planning is essential to safe flight and is especially important when operating from unfamiliar airports. A clear understanding of the take-off distances available and runway configuration improves pilots' situational awareness, reducing the possibility of the unexpected during higher risk stages of flight such as take-off and landing.

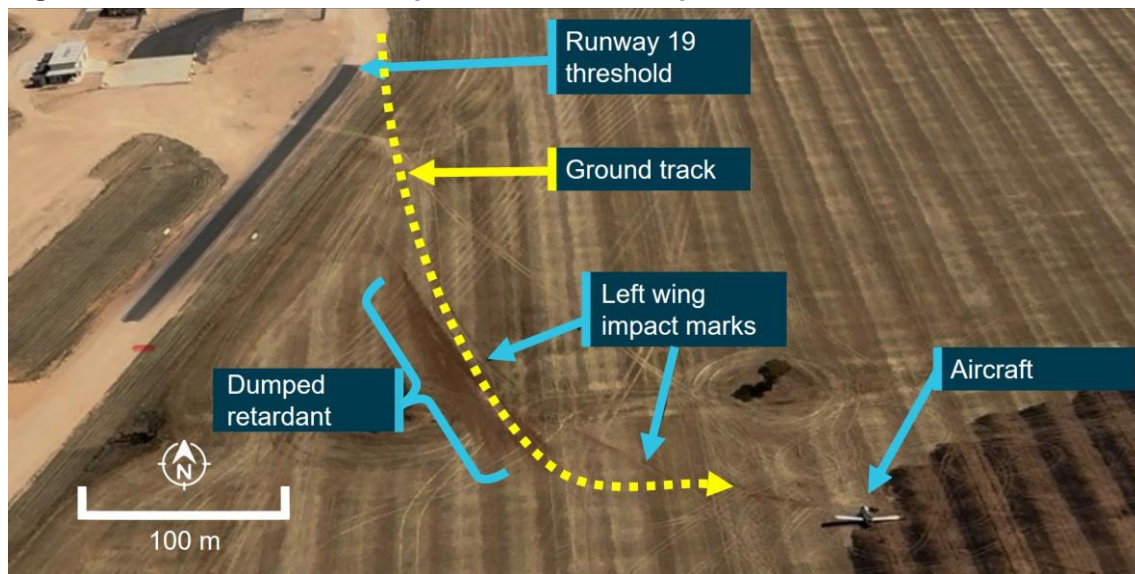
**Figure 2: Occurrence aircraft impact marks and final position**

The pilot maintained the runway 17 heading, and the aircraft overran the end of runway 17 into a field, impacting a fence, before becoming airborne. The pilot intended to release the load of fire retardant to reduce weight, however, due to their unfamiliarity with the location of the load release switch in that aircraft, instead activated the aircraft lights, before locating the correct switch and dumping the load. Images show the left-wing tip dragged along the surface of the field while the load was dumped. A witness reported the aircraft briefly became airborne with a nose high attitude and left wing down in a left turn before the left wing again contacted the ground and pulled the aircraft to the ground before coming to a stop (Figure 2).

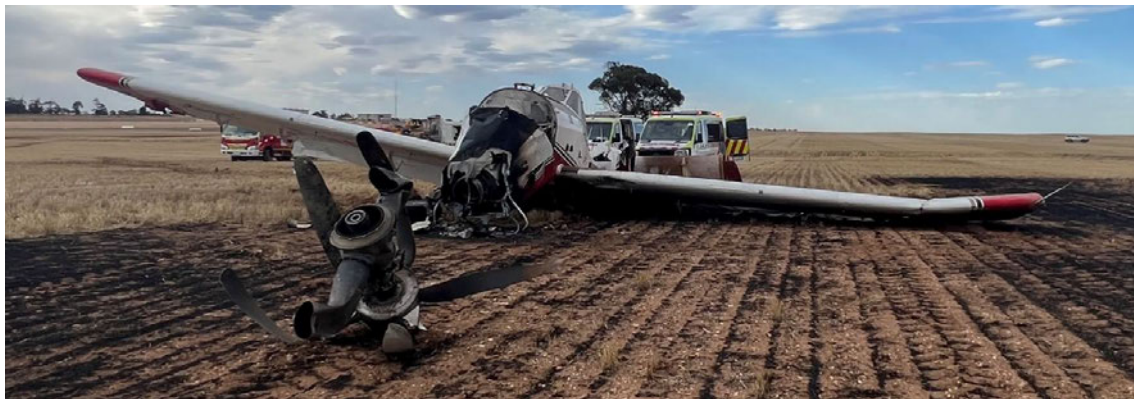
**Figure 3: Occurrence aircraft**

The impact was sufficient to liberate the engine and propeller from the aircraft which subsequently set fire to the field (Figure 3). The local airbase manager and 2 other state government employees attended the scene and were able to put the fire out in the vicinity of the aircraft and were then able to assist the pilot to egress the aircraft.

The pilot sustained minor injuries and was admitted to Mildura hospital. The aircraft was substantially damaged.
