# **Crew injury in the engine room of *RTM Weipa***

8 km from Gove, Northern Territory, on 23 June 2025

**ATSB Transport Safety Report**

MO-2025-006

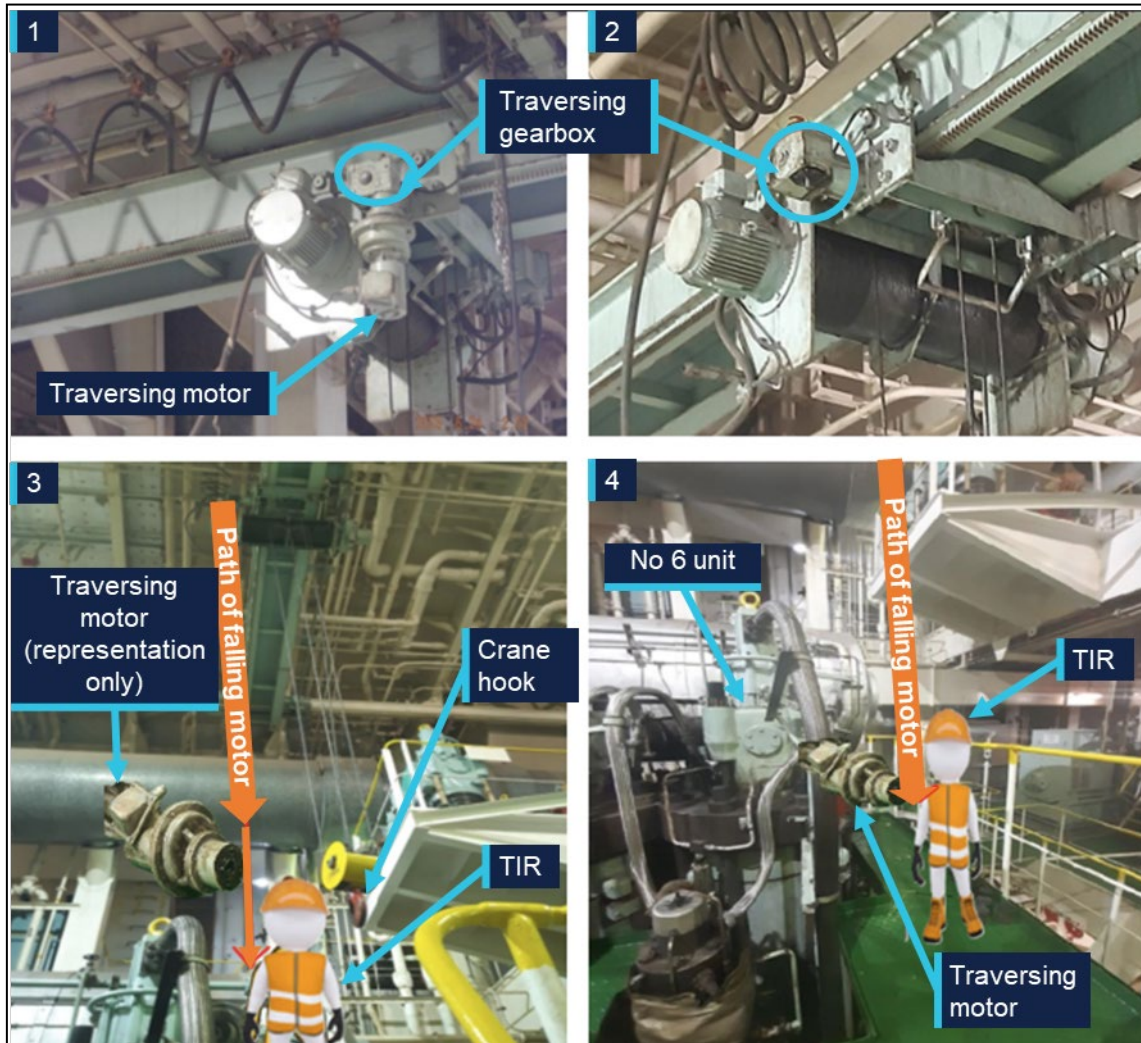
Figure 2: Incident representation (illustrative purposes only)

About an hour later, as the planned work progressed, the traversing motor of the gantry crane detached from its overhead mounting and struck the trainee integrated rating, resulting in minor injuries and minor equipment damage.

The engineers checked for damage around the incident site. The detached motor was found wedged between the cylinder head and a fuel pipe on main engine unit number 6, crushing the pipe. The motor's electrical cable had also been pulled out from its connection.

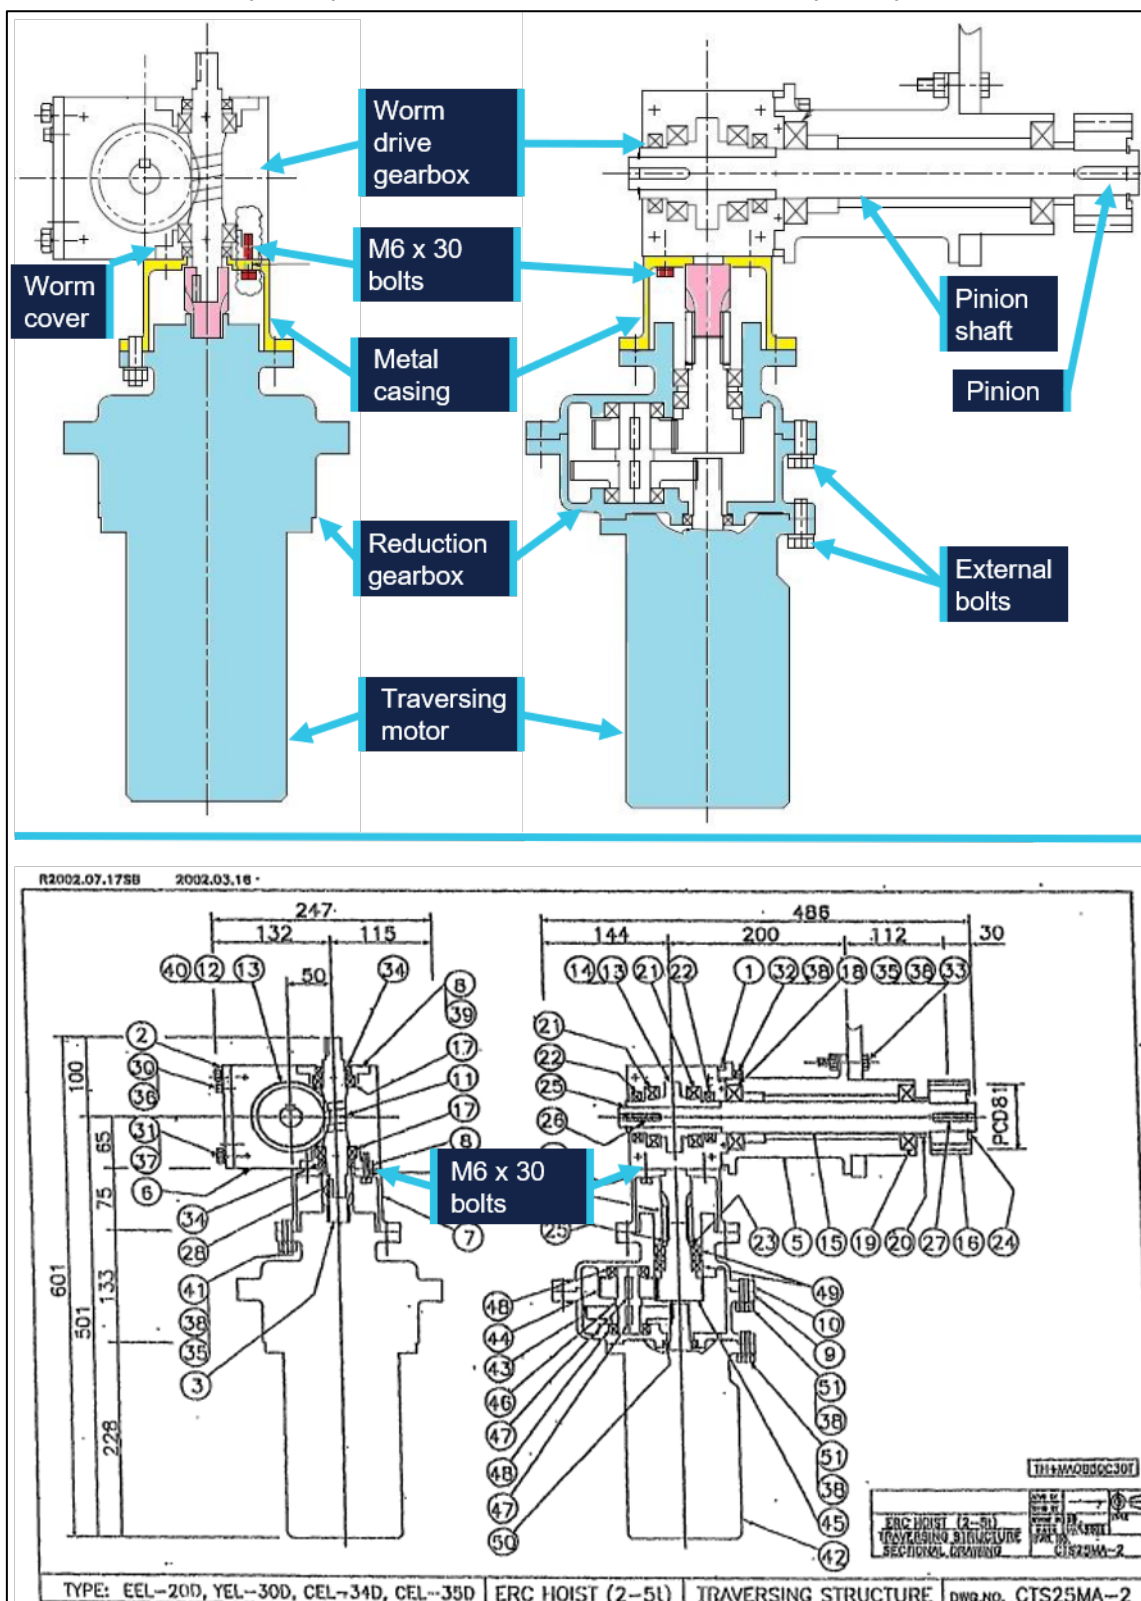
**Figure 3: Engine room crane traversing arrangement schematic – manufacturer supplied colour-coded view (above) and extract from instruction manual (below)**

Most components of the traversing arrangement were connected to each other by externally accessible (and visible) bolts and nuts. The connection between the metal

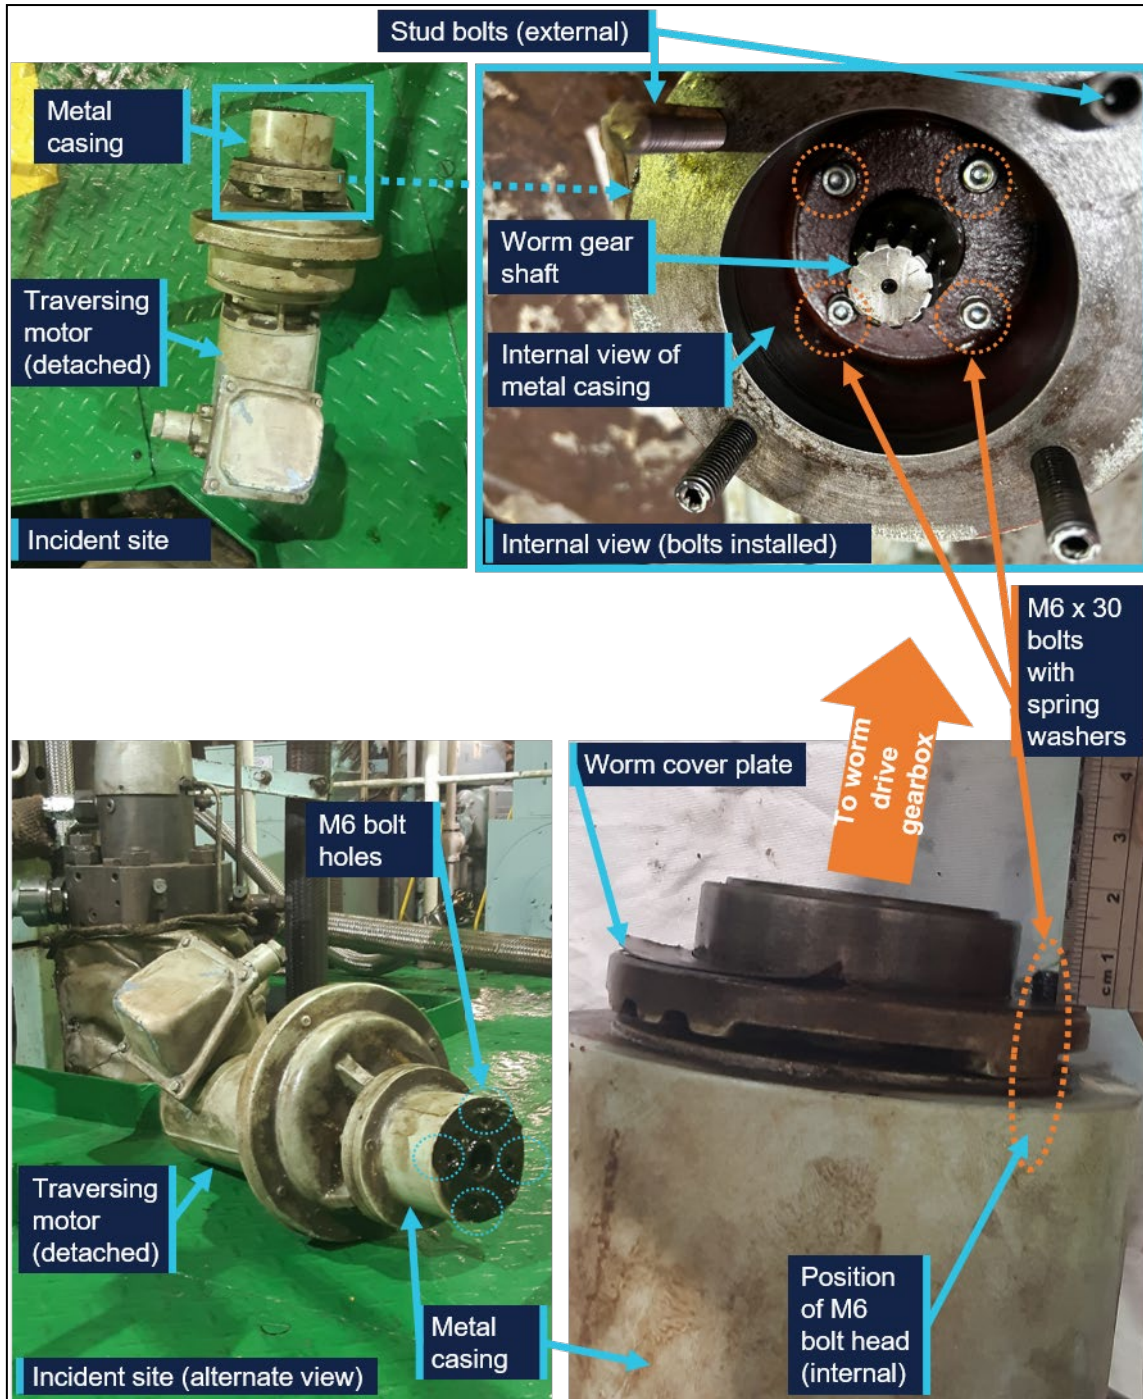
**Figure 4: Internal securing arrangement of engine room crane traversing motor**

adaptor casing and the worm drive gearbox was made using 4 SCM435 grade M6 x 30 mm bolts fitted with spring washers.<sup>4</sup> The bolts were first fed through the metal casing, then through a cover plate for the worm gear, and finally fastened into threaded blind holes in the worm drive gearbox (Figure 4).

In the crane's normal working condition, these bolts were not visible as they were contained internally within the metal casing, situated high above the working areas. In order to access these bolts, the reduction gearbox required to be disconnected from the metal casing (Figure 5).

The motor was connected to the gearbox by 4 internally mounted bolts. Subsequent examination of the bolts found no overstressing or damage to the engaged threads, indicating that they had loosened over time. The thread deformation observed outside the engagement region was consistent with repeated contact of the bolt threads against the worm cover plate and metal casing, likely following the loosening of the bolts.

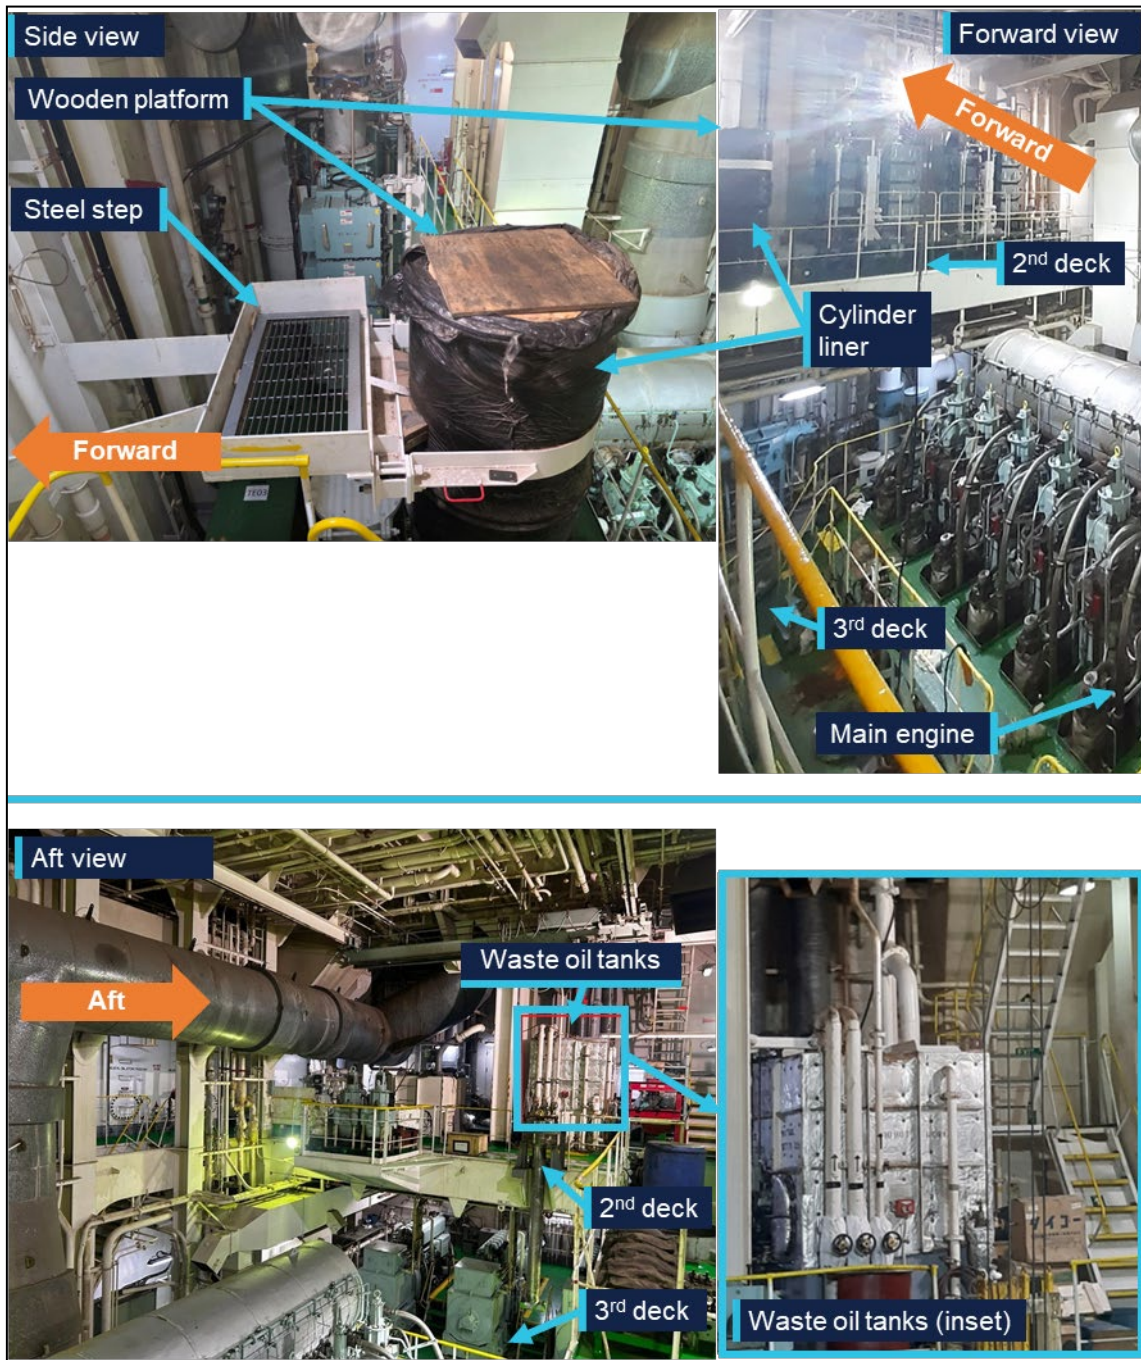
Figure 6: View of engine room – crane access arrangements

The ATSB was provided differing accounts regarding the methods used to access the higher, less readily accessible sections of the crane during preventive maintenance routines. One access arrangement involved a wooden platform attached to the spare cylinder liner, which presented a significant fall risk onto the third deck below. ASP later advised that inspections of the traversing arrangement were conducted from deck level only. While this mitigated the fall hazard, this considerably limited the crew's ability to undertake detailed inspections of the traversing arrangement. The top of the waste oil tank was another reported access location, however, this too presented trip and fall hazards from height due to various obstructions and an unguarded perimeter.

Although access to the crane traversing arrangement and gantry was routinely required for planned maintenance and was not straightforward, a dedicated, secure platform was not fitted to provide safe access. There was no standard procedure or practice to control safe access via a defined route. The incomplete and inconsistent identification of hazards and application of safety measures, including working aloft permits, indicate that risk controls were not discussed or correctly implemented. Consequently, the risks associated with crew access were normalised and extended across other ASP managed ships, increasing the risk to crewmembers fleetwide.

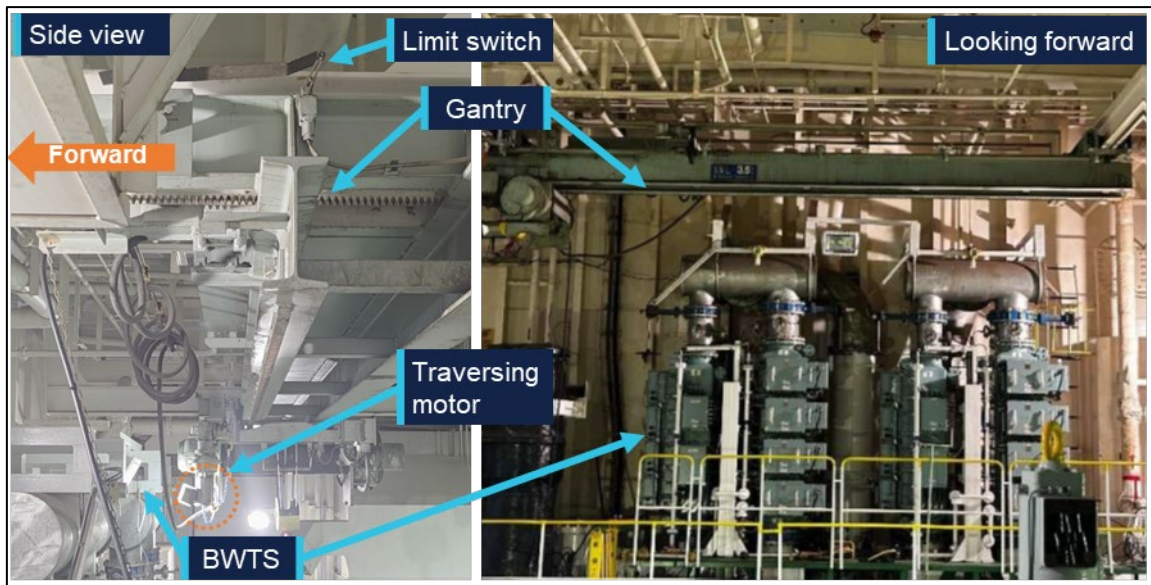
**Figure 7: Engine room crane and ballast water treatment system**

In or about August 2023, following the ship's departure from drydock, the crane's limit switch had been relocated to limit its forward travel distance. This was undertaken to prevent the crane traversing assembly from impacting the then newly-installed ballast water treatment system (BWTS), located at the forward end of the engine room second deck (Figure 7).

The relocation of the limit switch was not identified as a requirement during the BWTS installation but was later completed after the impact hazard was identified by the ship's crew. There were no available records confirming the date this was undertaken, nor any reports of actual impact.

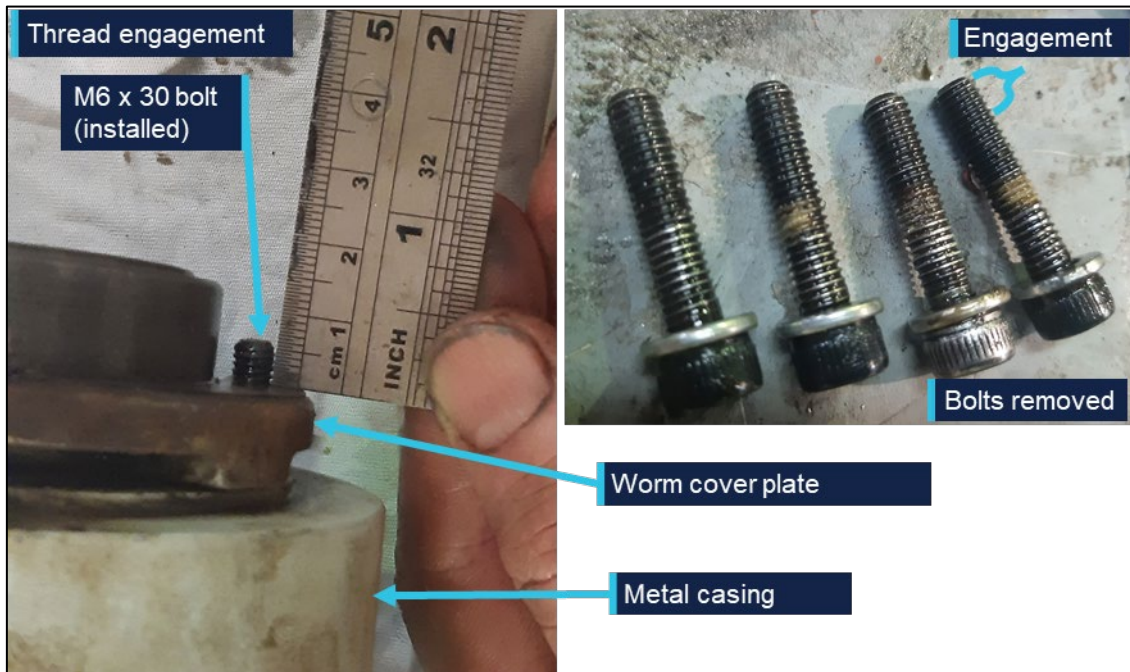
**Figure 8: Securing arrangement for engine room crane traversing motor**

- there was negligible damage to the threads of the 4 M6 x 30 bolts and the bolt holes
- two external casing bolts (unrelated to the internal M6 x 30 bolts) were damaged from impact during the motor's fall

- no evidence of structural damage or stress-related failure was observed on the crane's hook block, wire rope or control system
- the 40 mm (diameter) horizontal pinion shaft of the traversing gear was bent, with a deflection of approximately 1.5 mm measured between its ends, 405 mm apart.

- The bolts exhibited scoring on the thread flanks of about 4 full threads, which corresponded to an engagement length of 6 mm.
- Based on the bolt specifications, the recommended minimum thread engagement length in blind hole applications for mechanical strength, durability and reliability was about 5.5 to 6.0 mm.<sup>8</sup>
- While there was no deformation in the engagement region, the bolts exhibited thread deformation outside the region of engagement.
