SPECIAL INVESTIGATION REPORT

BASI REPORT B/906/3024

Relocation of Jump Seat on
QANTAS Airways Ltd
Boeing 747-438, VH-OJF

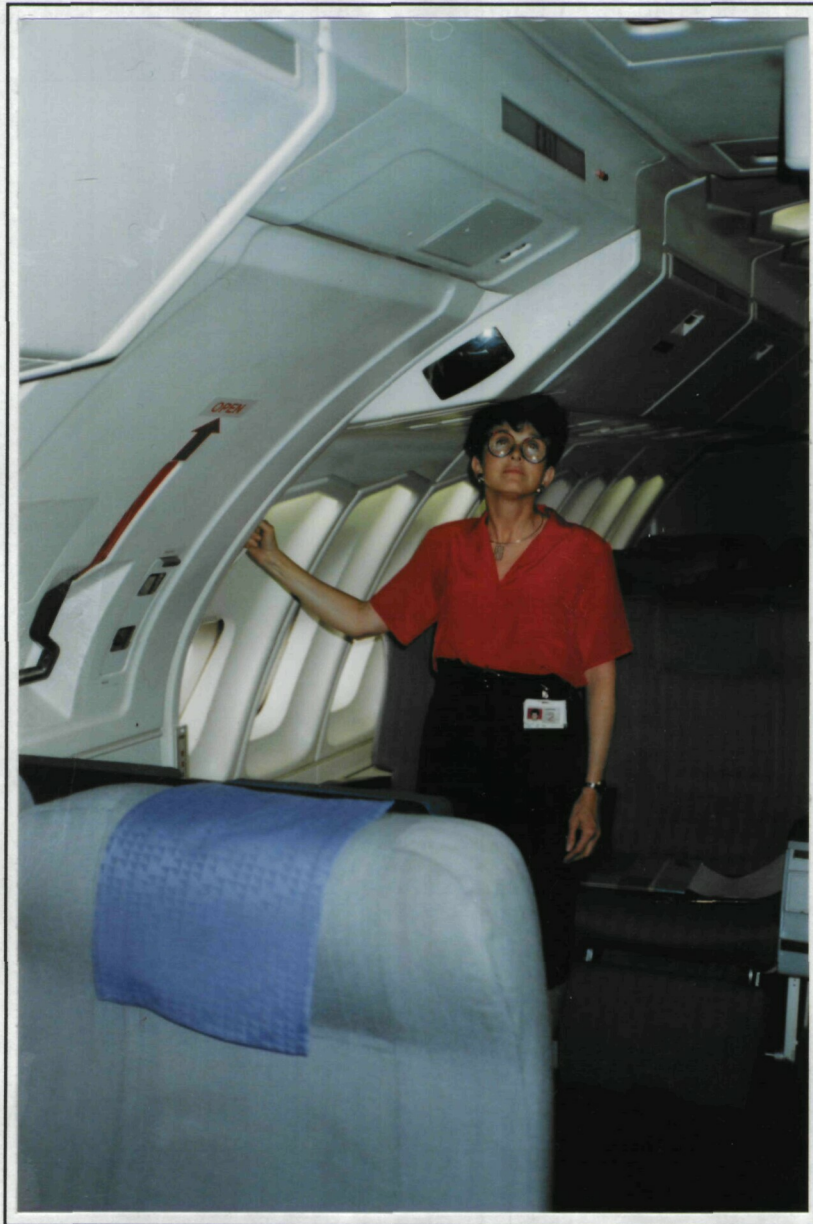
The original configuration has a passageway to the exit of 45" (1143mm) when the jump seat is retracted. No dedicated assist space is available for the primary flight attendant during an evacuation. Qantas's emergency procedures are such that the flight attendant is positioned with his/her back to the aft passenger seat proximate to the exit. This is shown in Figure 1.

Figure 1: Assist position, original seating configuration
Upper deck, Boeing 747- 400

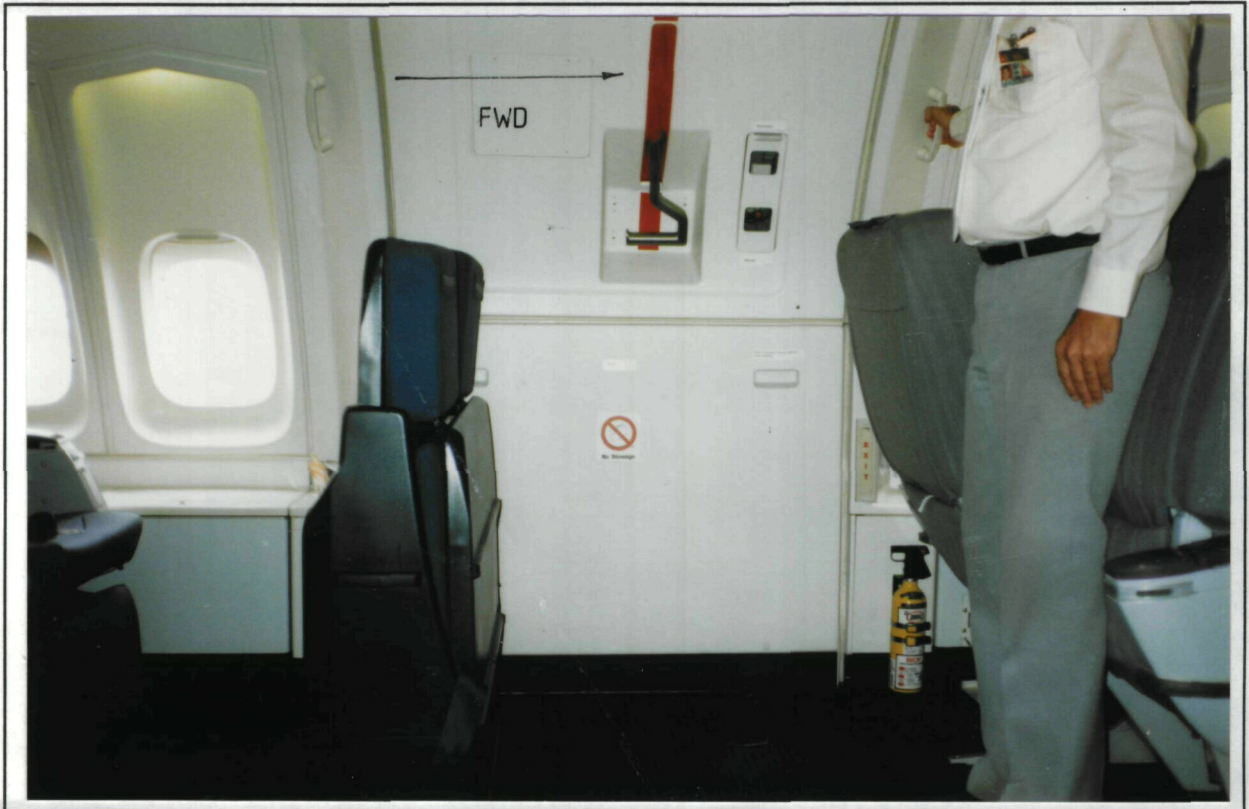
In the new configuration, the exit still qualified as a Type I, as the seating configuration necessitated that the passageway to the exit is 35.4" (900mm). The assist space on the newly configured aircraft is certainly a deterioration of that on the original configuration, however it still meets the requirements (see Figure 2).

Figure 2. Assist position, new exit seating configuration, upper deck Boeing 747- 400 VH-OJF

NOTE: To achieve the assist position it is necessary to break-forward the passenger seat in the row forward of the exit.

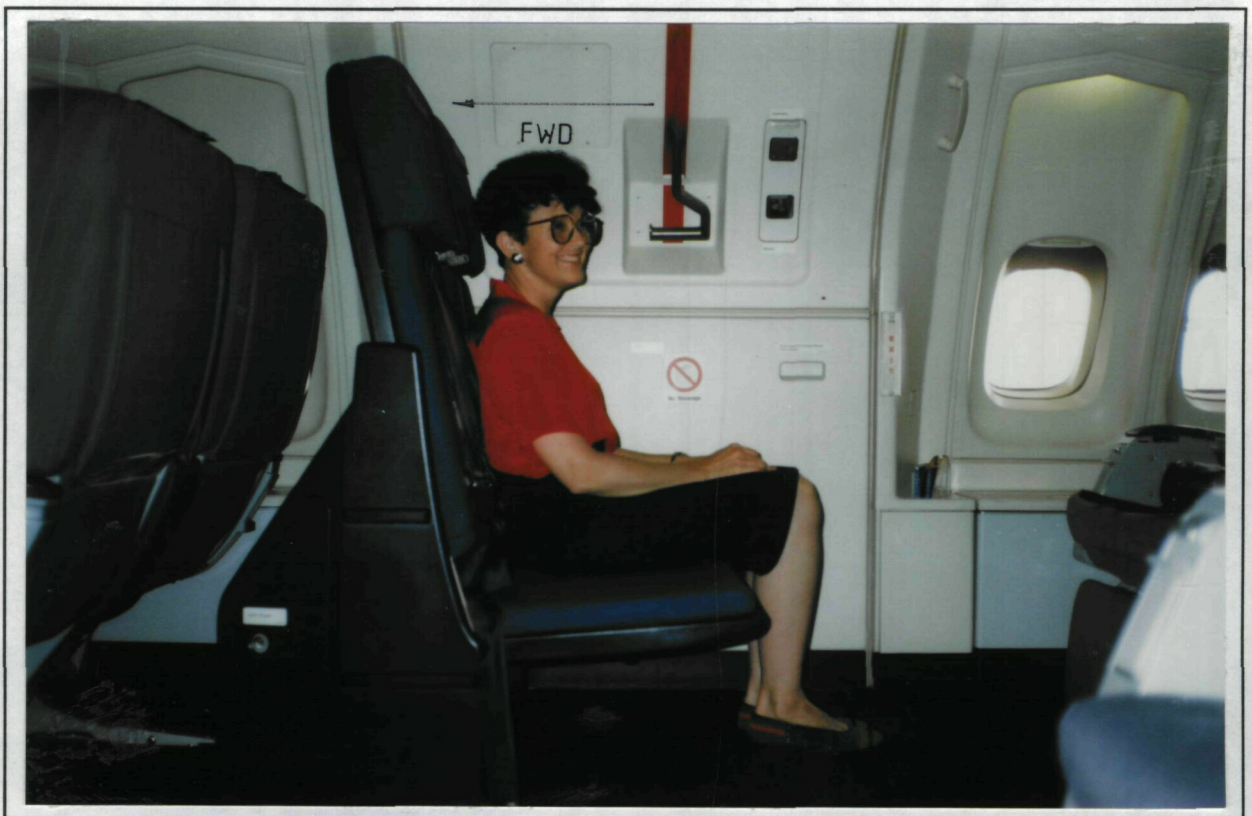
Figures 3 and 4 indicate the position when the flight attendants are seated. Problems would certainly be encountered if flight attendants were incapacitated during the impact phase of an accident and it became necessary to operate the exit adjacent to the jump seat. The difficulties encountered by passengers would probably be greater if the new configuration was in situ, as passengers would have to egress over the flight attendants rather than being able to move across the passenger seats to the exit (see Figures 3 and 4).

To achieve the prescribed assist space on the newly configured aircraft, it is necessary to break-forward the seats in the row forward of the exit (see Figure 3). To state that no assist space is available is incorrect, however the new configuration provides little natural assist space and as such is certainly not as satisfactory as that on the originally installed seating layout.

Figure 3. Flight attendant seated, original seating configuration
Upper deck Boeing 747- 400 VH-OJF

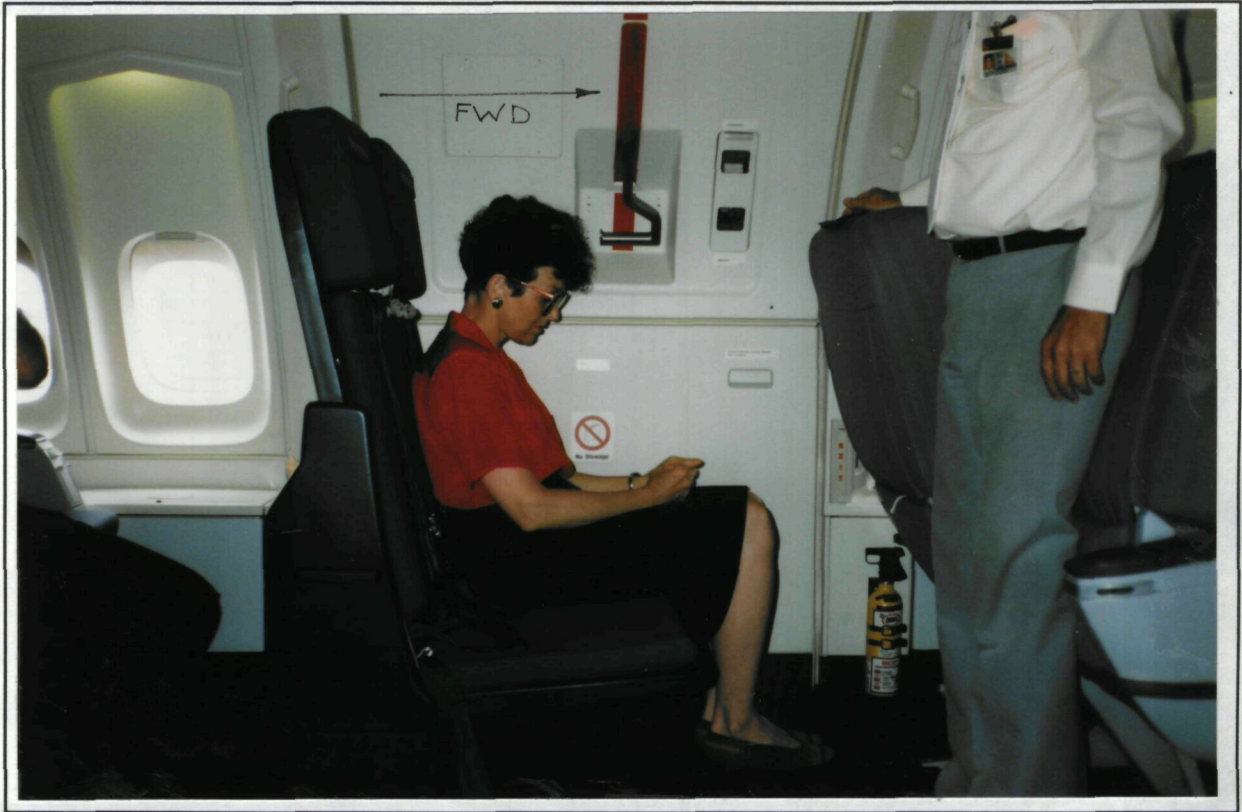
The cramped conditions in the new configuration are a function of the backs of the seats in the row forward of the jump seat bordering on the exit (see Figure 4).

Figure 4. Flight attendant seated, new seating configuration
Upper deck Boeing 747- 400 VH-OJF

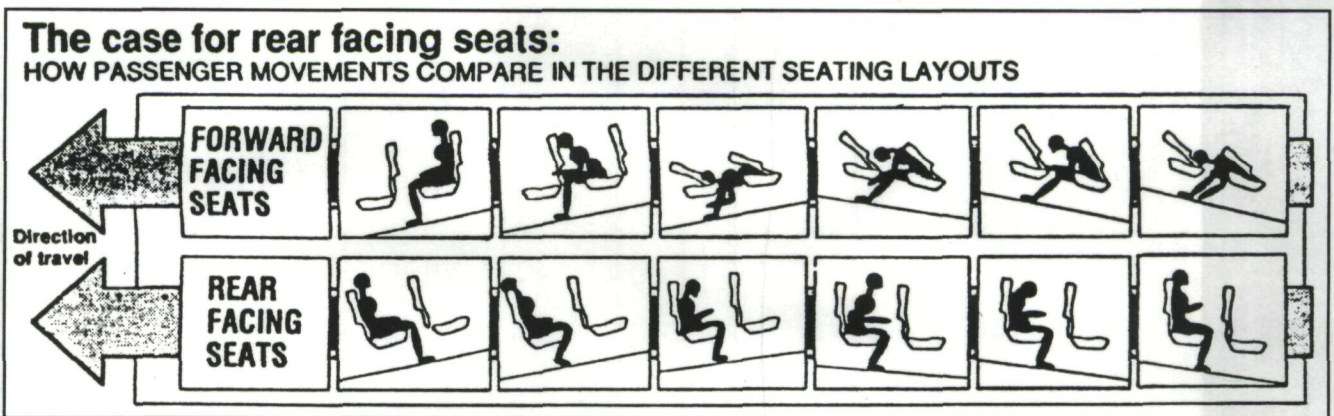
The general consensus of opinion is that the best protection for flight attendants can be provided by rearward facing jump seats. This orientation generally protects the occupants by supporting the body and head against the deceleration during a crash (see Figure 5). Additionally, the fixtures required to attach a free-standing seat to the floor have greater strength if the seat is to face rearwards, due to the higher centre of gravity. As such the rearward facing jump seats may have greater crashworthiness.

Occupants of jump seats are usually secured by a full harness, which ensures that they are less likely to rotate around the lap belt. The harness prevents the upper body from flailing, yet it provides no protection for the head, a part of the body which is at greater risk when the seat is facing forward (see Figure 5). However, while the heads of the flight attendants may flail around, the jump seat is so positioned that flight attendants are not likely to impact with a passenger seat nor are passengers likely to impact with the jump seat.

Figure 5. The case for rearward facing seats
NOTE: The occupants are only wearing lap belts.
