**BUREAU OF AIR SAFETY INVESTIGATION
REPORT**

**BASI Report
B/926/1005**

**Beechcraft Baron 95-B55
Tarago, New South Wales
19 June 1992**

Beechcraft Baron 95-B55 VH-JDL
Tarago, New South Wales
19 June 1992

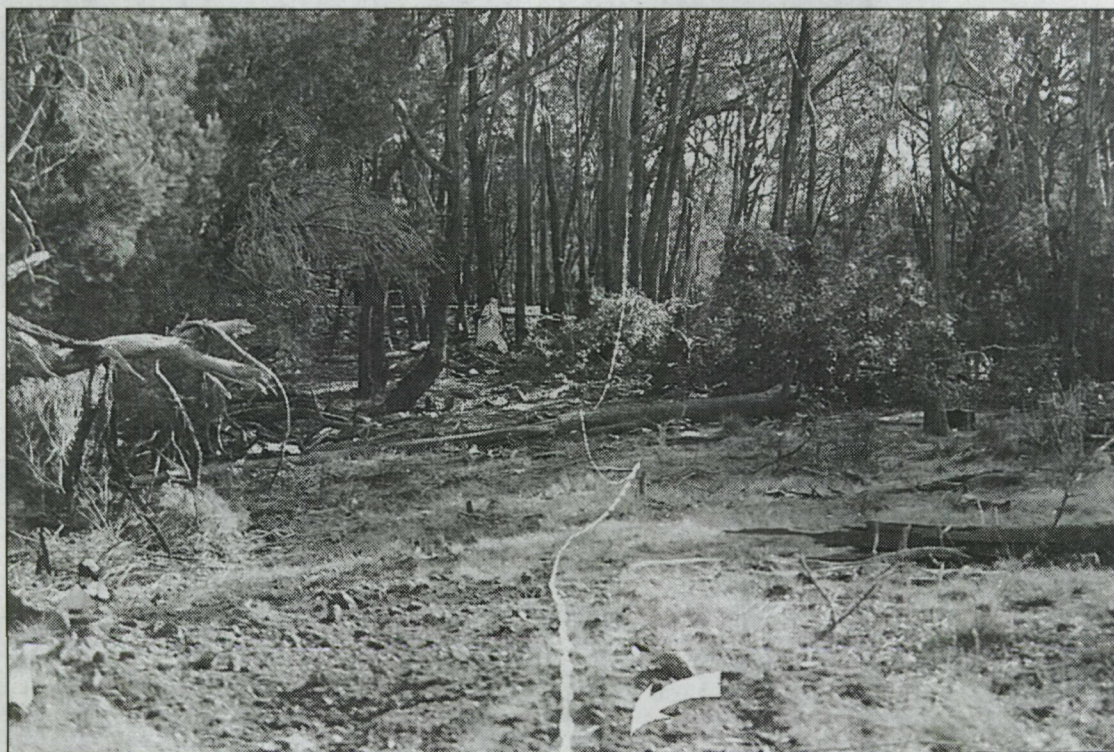
Both wings were damaged as the aircraft descended through trees, while in a right-wing low, nose-down attitude, heading in a westerly direction. Seventeen metres beyond the first tree contact, the aircraft struck the ground heavily, right engine first, followed immediately by the fuselage and then the left engine. The force of this initial ground contact caused substantial

Impact trail (looking in direction of flight). Initial ground impact point indicated.

deformation of the primary structure, rupturing of the fuel tanks, and the separation of some components. The aircraft then bounced about 20 m before colliding with a large log which ruptured the fuselage.

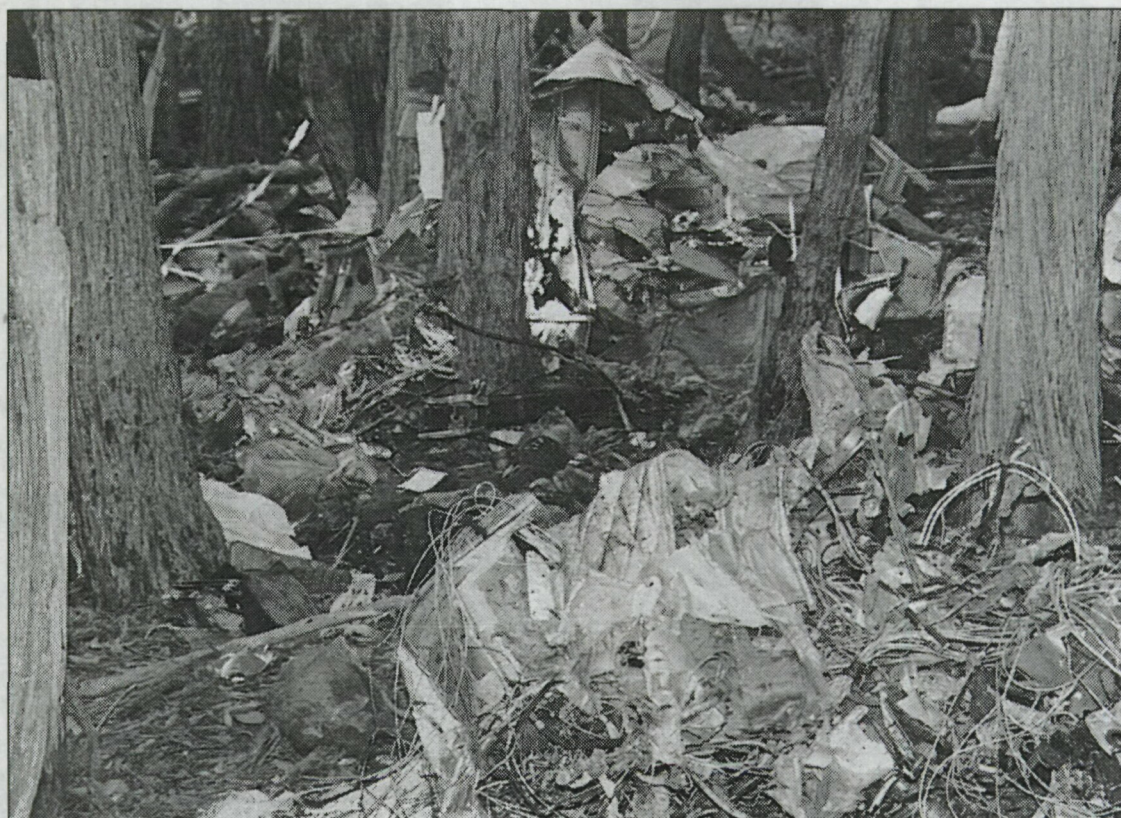
Continuing with little directional deviation, the aircraft encountered numerous trees of 8–12 m in height, which caused the disintegration of almost the entire structure. The engines were torn from the wings and the wings and horizontal stabilisers separated from the fuselage. The fuselage had broken near the wing trailing edge, and the cabin roof was torn away. Both propellers had separated from the engines. The left propeller remained attached to the crankshaft mounting flange, which was sheared from the crankshaft. Two blades had separated from the left propeller, while all three blades separated from the right propeller. The landing gear was found to be in the retracted position and wing-flap actuator settings indicated that the flaps were also retracted at impact.

The main wreckage area

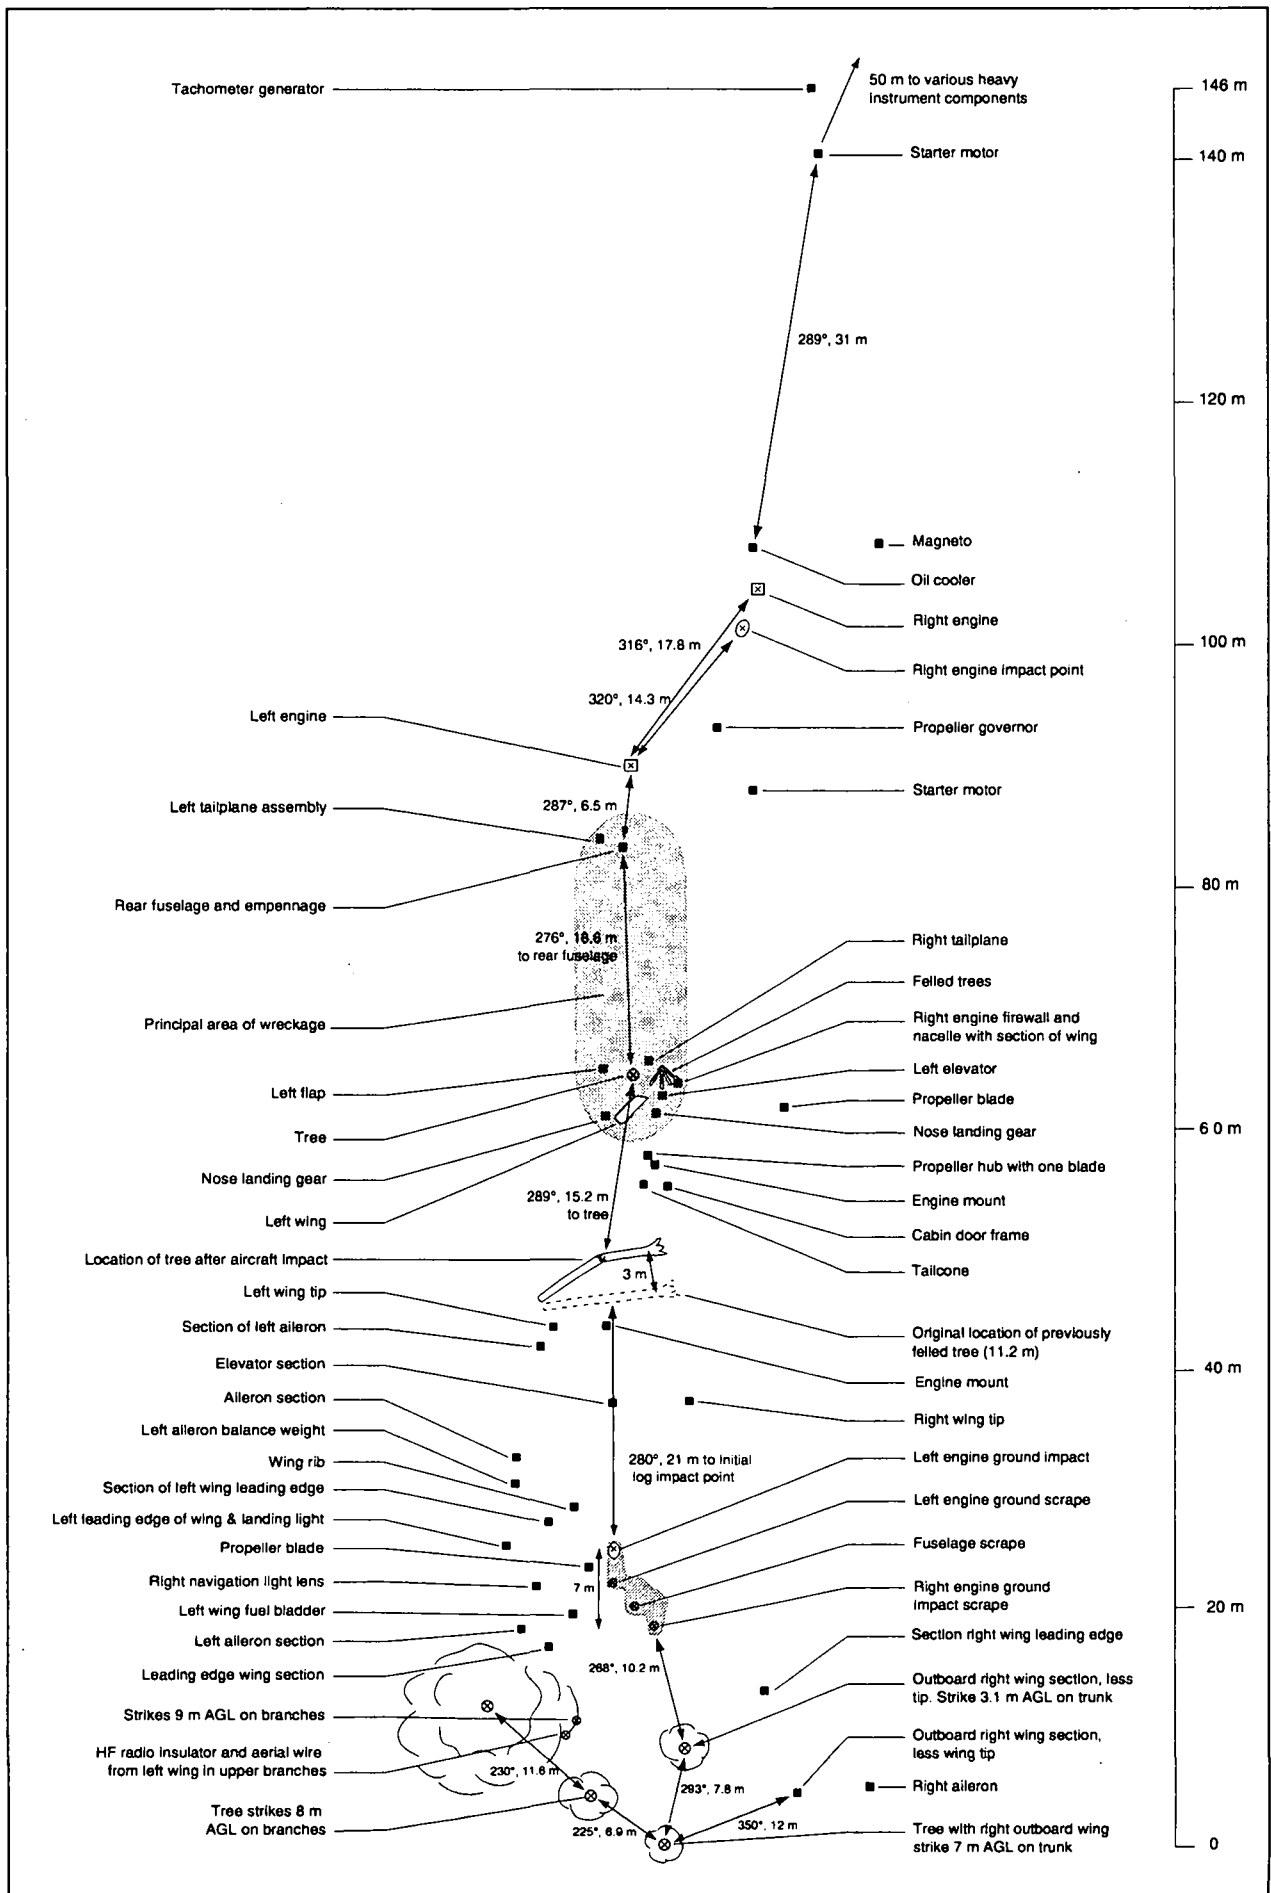
Figure 1 (All directions are °M)

The main wreckage area was located between 40 m and 60 m from the initial ground contact point, and the engines were displaced up to 40 m further along the wreckage trail (see figure 1).

The final descent angle relative to the horizontal was determined to have been about 35° and the aircraft nose attitude was about 7° down, resulting in a relative angle of attack of about 28°. The ground slope at the impact point was 7° up. The aircraft was banked about 23° to the right at the initial tree contact and this angle increased as the aircraft descended to ground impact. The speed of the aircraft was estimated to have been 150–180 kts immediately before contact with the trees.
