**BUREAU OF AIR SAFETY INVESTIGATION  
REPORT**

**BASI Report  
B/925/3042**

**British Aerospace BAe 146-200A  
Near Meekatharra, Western Australia  
22 March 1992**

**British Aerospace BAe 146-200A VH-JJP**  
**Near Meekatharra, Western Australia**  
**22 March 1992**

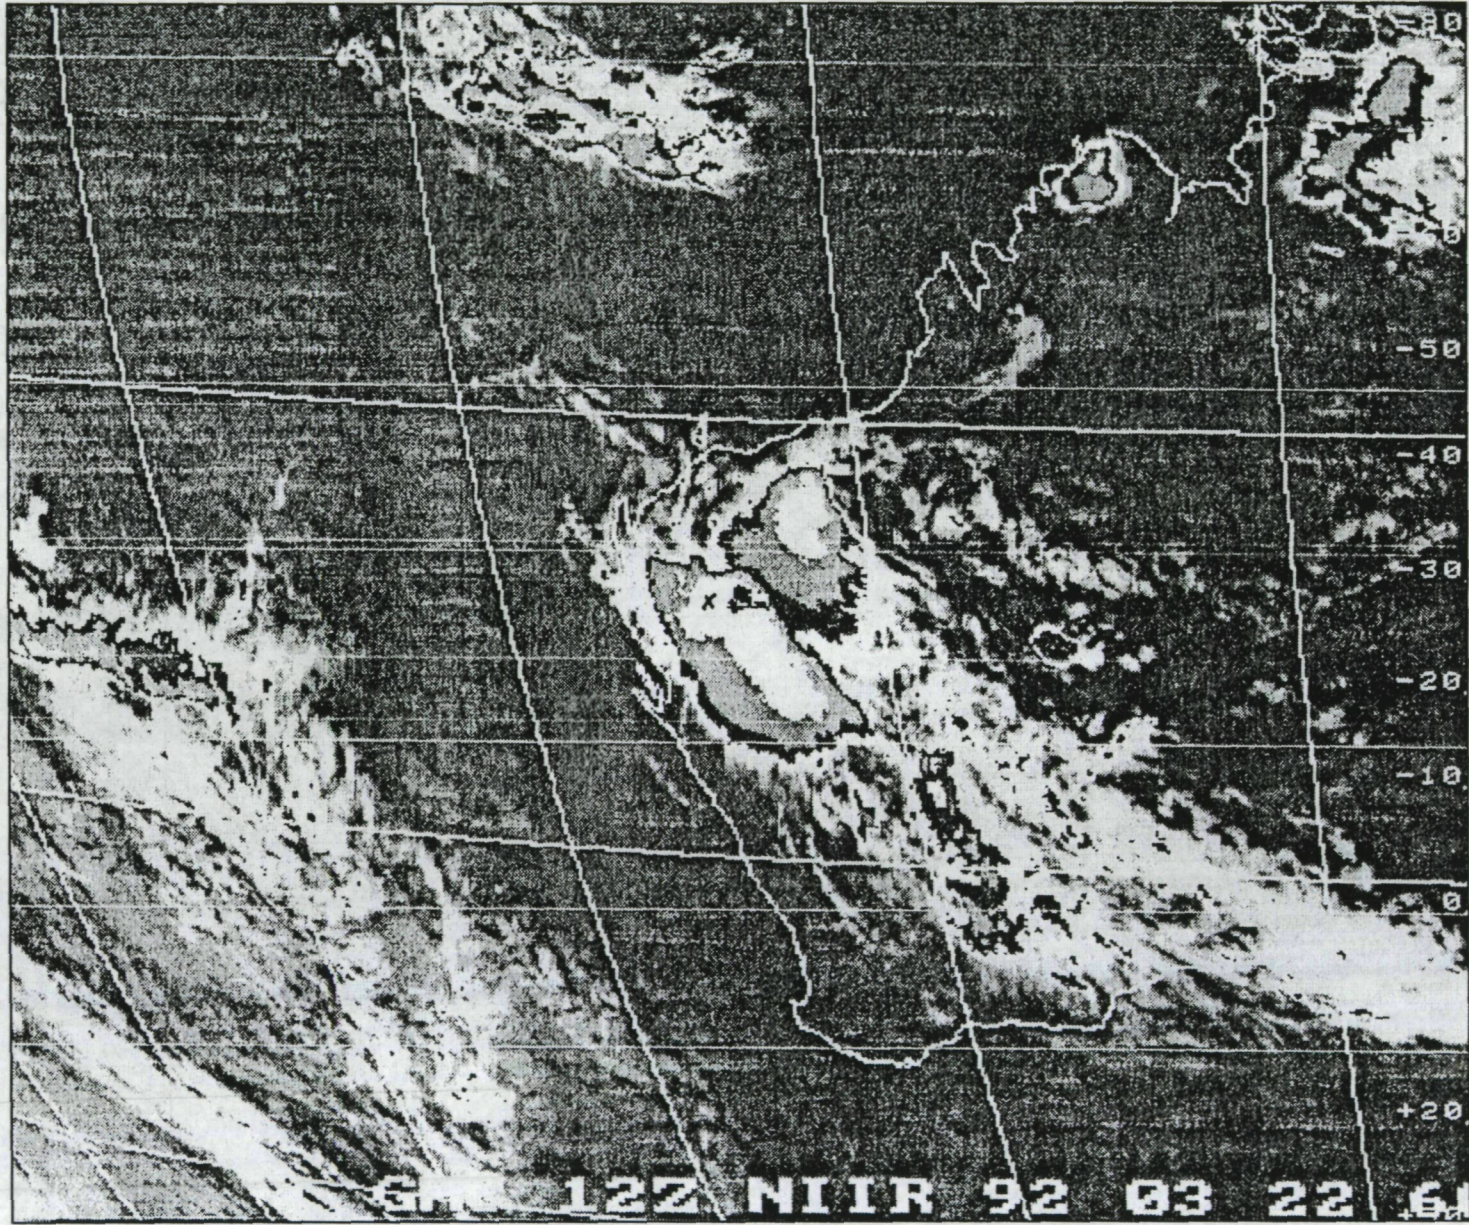
The satellite imagery suggests that the cloud tops were being blown off towards the southeast, consistent with the observed northwesterly environmental flow. The cloud pattern is asymmetrical, with the black (coldest) area displaced to the east of the main cloud mass. This may have been the result of earlier convection to the west which was in the process of dissipating at the time of the imagery. The pilot (personal communication) mentioned that there appeared to be decaying cells in the area.

Figure 5: Enhanced Infrared Imagery (GMS4) for Western Australia for 1200Z 22 March 1992. Approximate location of incident denoted by (x).

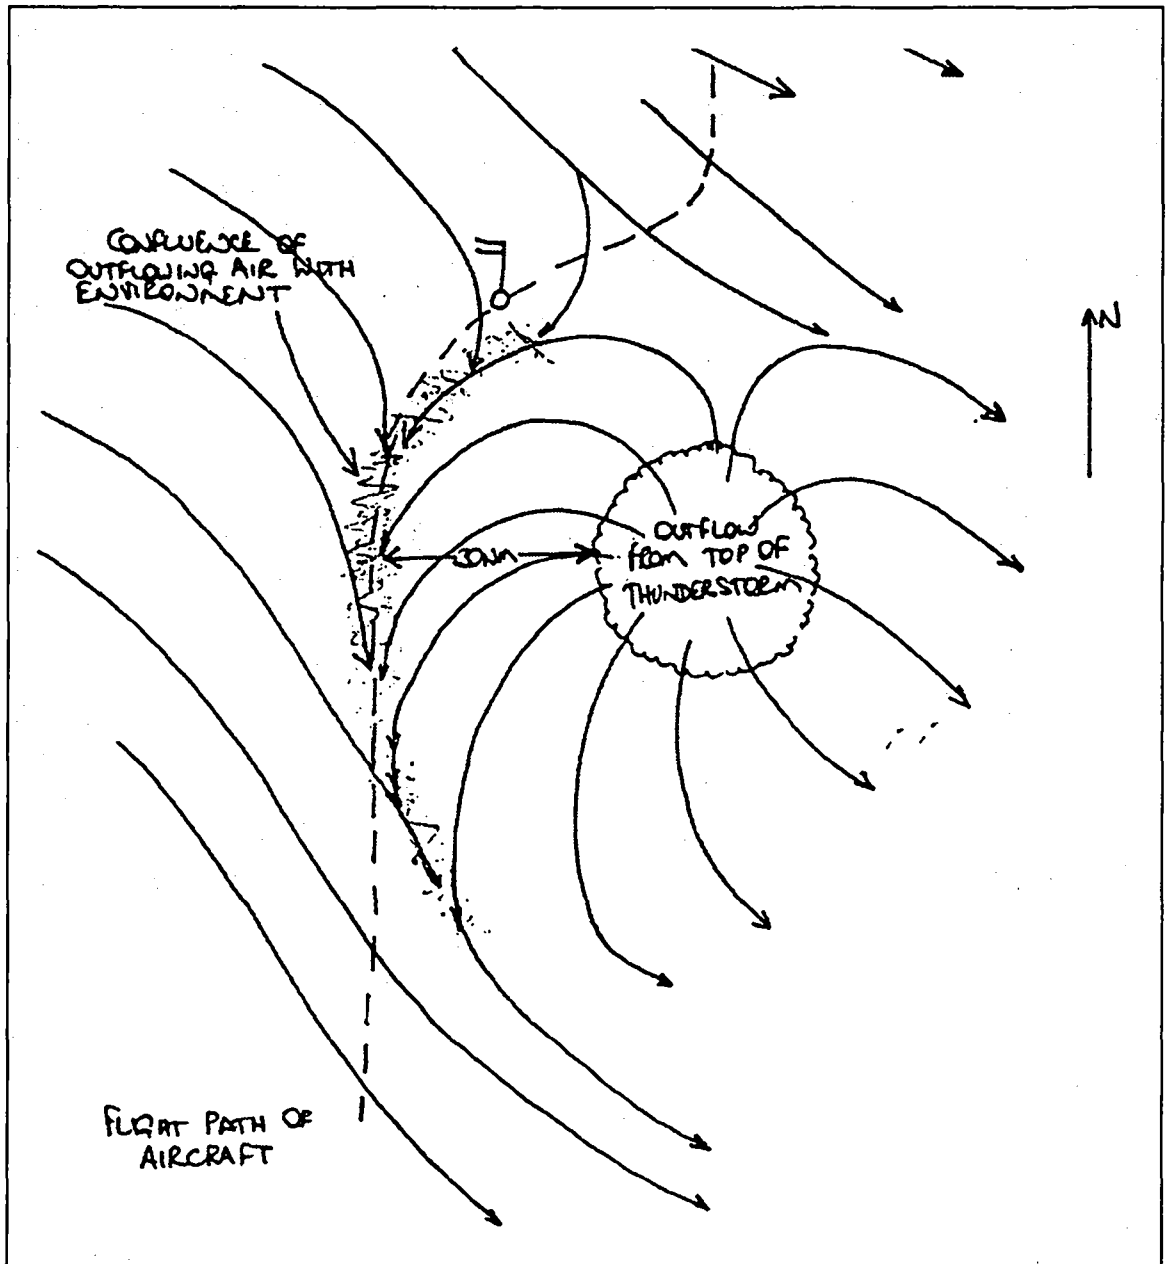
It is most likely that air flowing out of the thunderhead encountered environmental northwesterly winds. This confluence of air of differing origins and physical characteristics would have caused the outflowing air on the western flank of the thunderhead to return from the stratosphere to the troposphere (Fig. 6) and, in descending, to rapidly warm. Adiabatic warming of a parcel from the top of the thunderhead (temperature of around minus 62°C determined from infrared satellite imagery) to the flight level of the aircraft (31000 feet) would produce a temperature near to minus 28°C which is in good agreement to the reported anomaly (Fig. 7).

Figure 6: Schematic of interaction between environmental northwesterly winds and thunderstorm outflow. Airep from BAe146 is plotted relative to the storm.

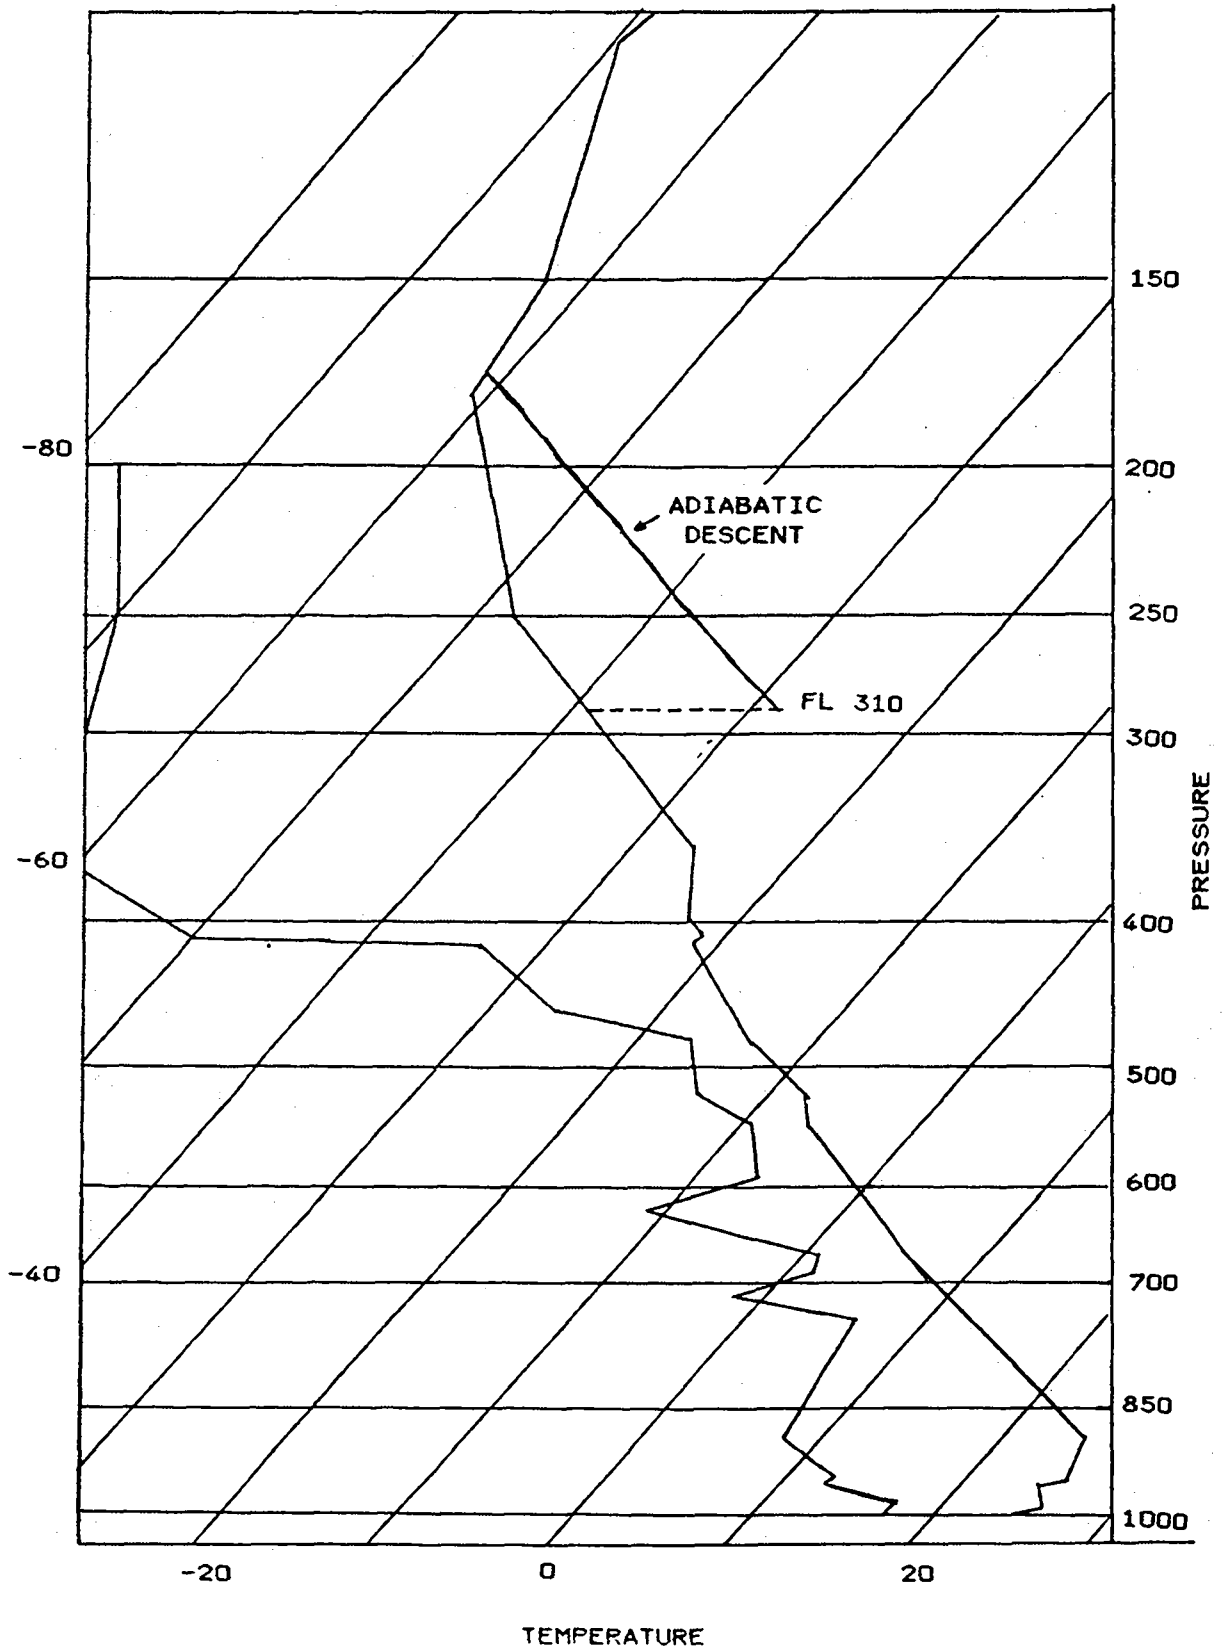
LEARMONTH RADIOSONDE 2300Z 22/03/1992

Figure 7: Temperature profile from Bureau of Meteorology station closest to incident (Learmonth)

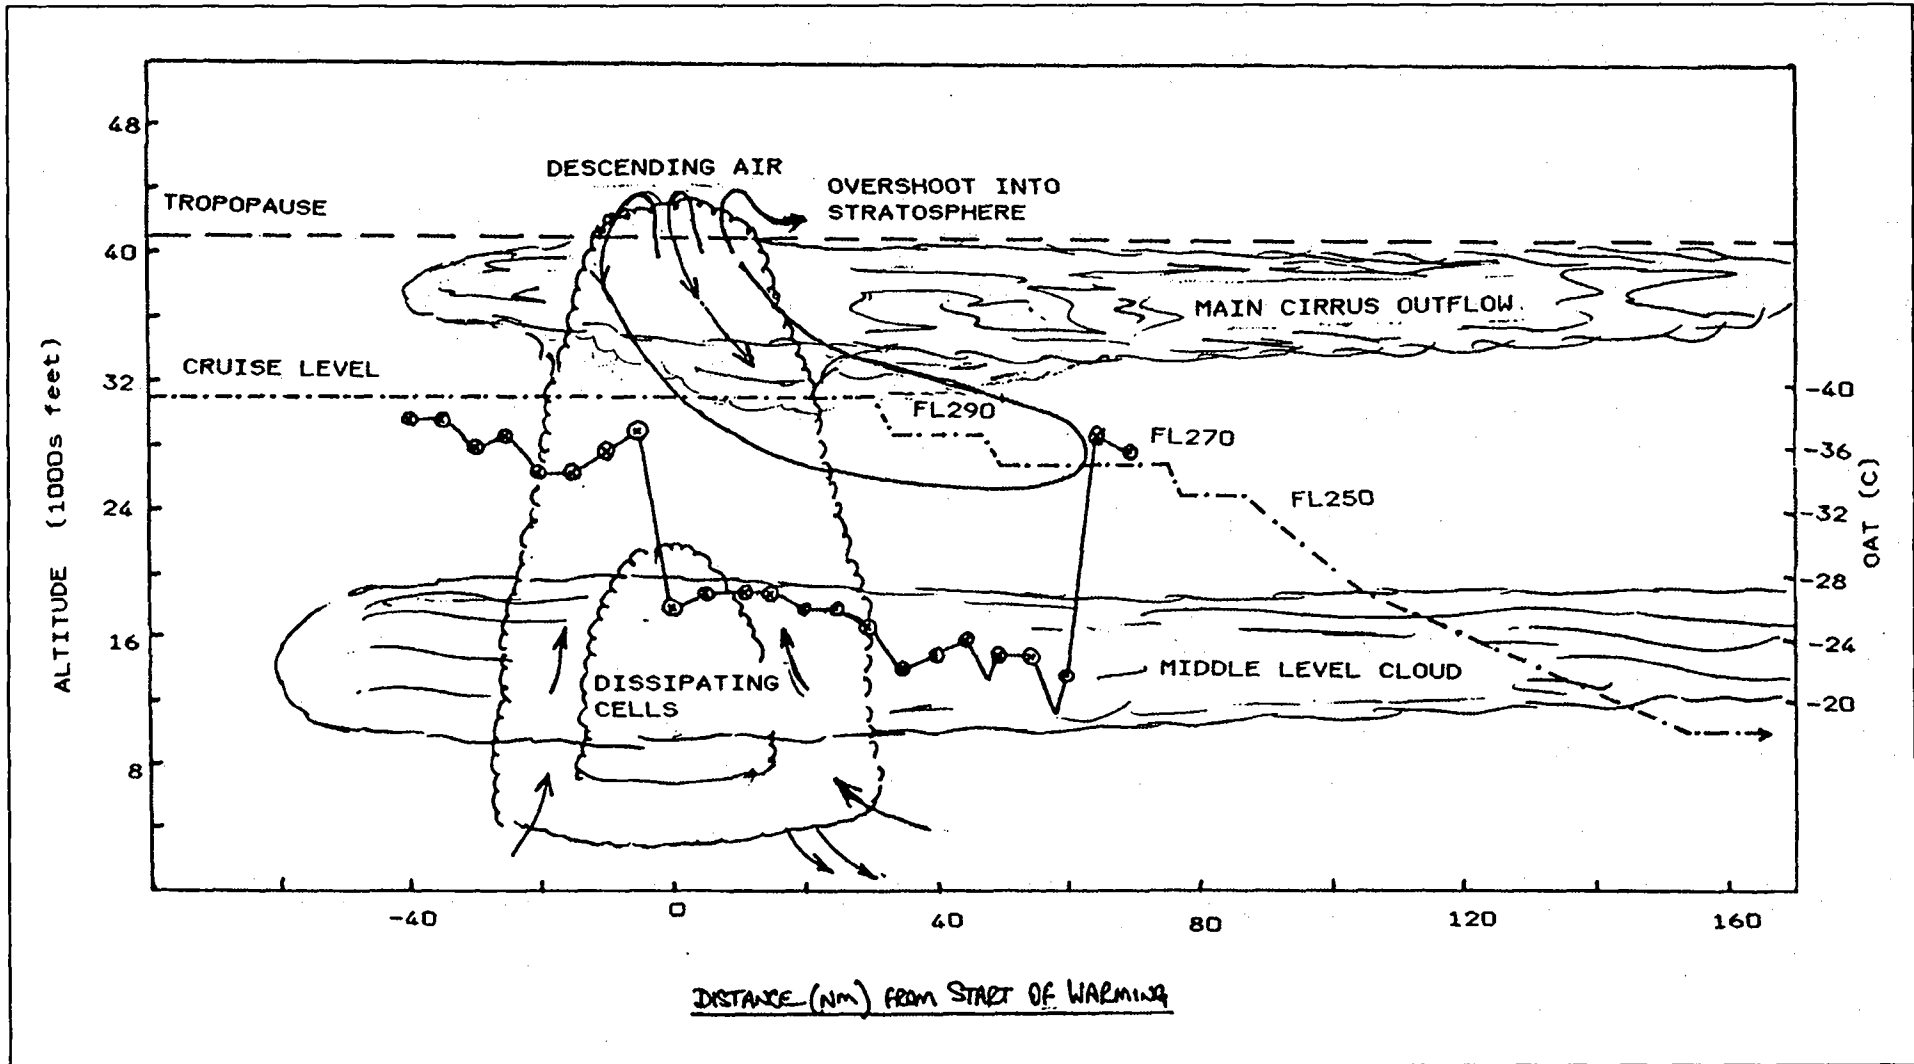
The probable cause of the warming was the descent of air from the stratosphere, associated with the interaction of air outflowing from the thunderhead and the surrounding environmental air. Estimation of the extent of warming by descent of an air parcel gave close agreement to OAT recorded by the aircraft.

The probable vertical extent of the temperature anomaly was from around 38000 feet (where the anomalous warming of descending air from the stratosphere became greater than 5°C) to around 28000 feet, where the anomaly was observed to abruptly stop.

Figure 8: Schematic north/south cross-section of atmosphere at time of incident showing most likely cloud structure. Outside air temperature (OAT) from BAe146 showing warming relative to storm position is also plotted.

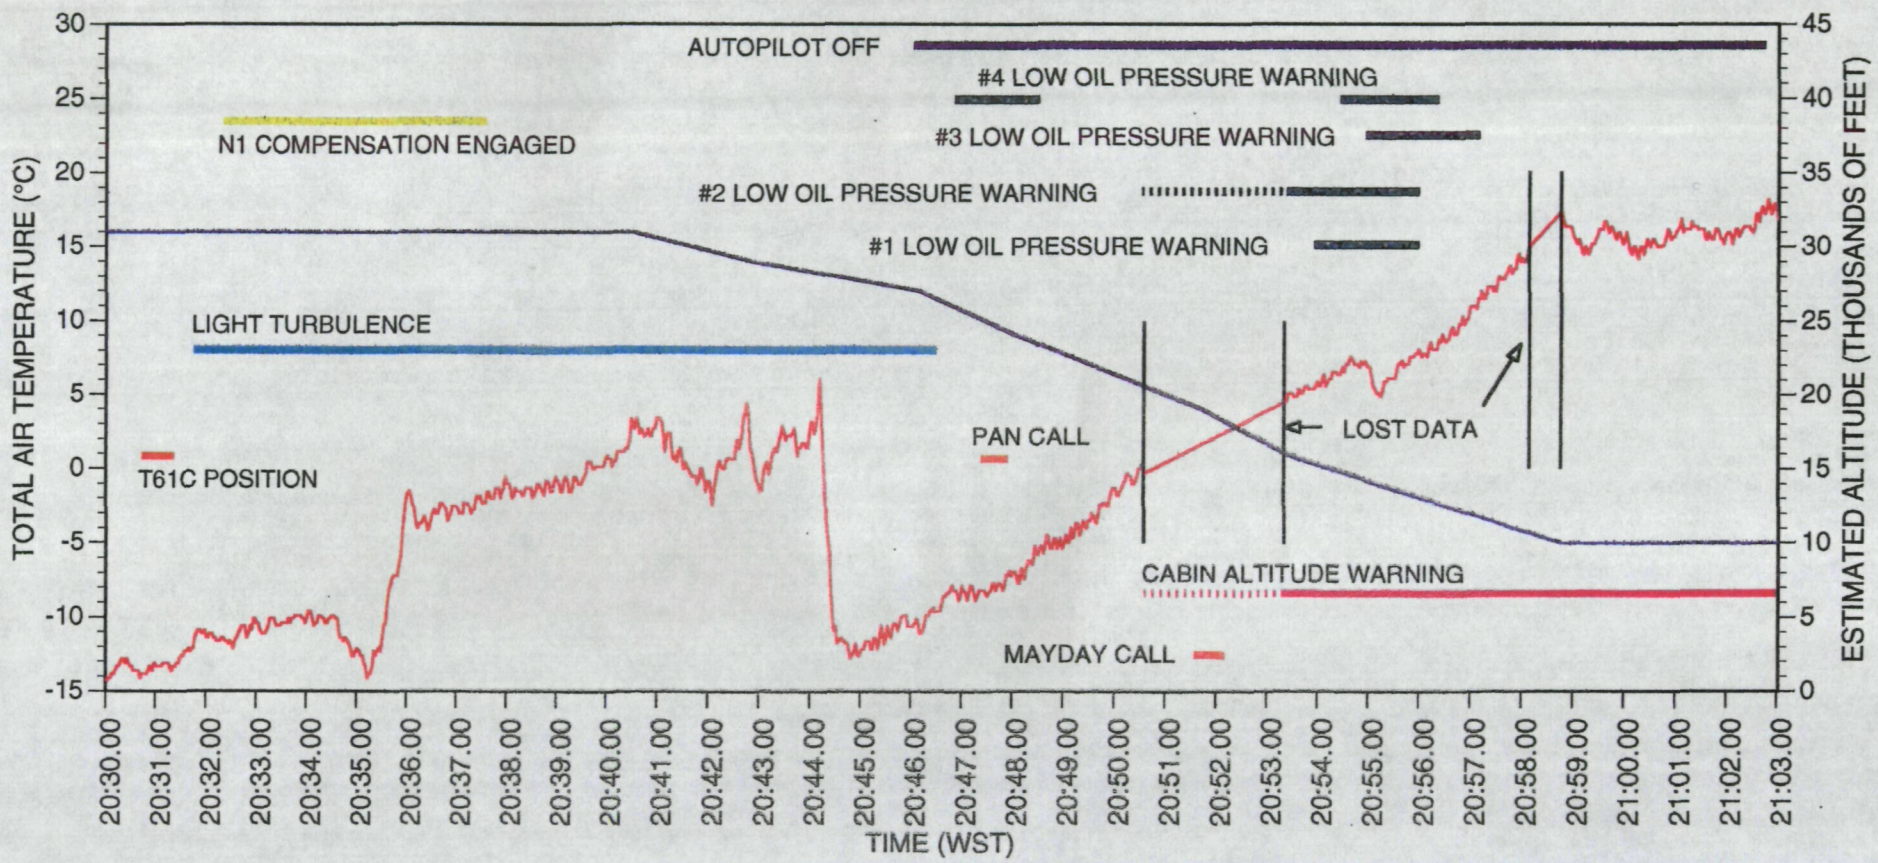
### BAe146 VH-JJP FLIGHT RECORDER DATA PLOT

Examination of the recorder indicated that there had been a failure of the reference voltage to the sensors for these parameters. The fault was traced to a voltage regulator. The equipment manufacturer reported that this was the only such failure recorded for this type of recorder. Despite the failure, the recording did contain useful data. A plot of selected parameters was produced for the period 2030:00 hours to 2103:00 hours, covering the time of this incident (appendix 2).

ELC data shows that the N2 RPM for all engines remained steady until the N1s had decreased to below about 60% when the N2s also began falling. While the N2s remained constant, the TGTs were maintained at the MCT value by the FCUs. After the N2s fell below about 88%, the TGTs also began to decrease, indicating a lower fuel-air ratio. These trends in TGT indicated correct operation of the FCUs. The engines continued to roll back until a sub-idle condition was reached.

Note: The Altitude values used in this chart are estimates based on pilots reports recorded on the AVR tape. Intermediate values have been interpolated to provide straight lines between the reported altitudes.
