**BUREAU OF AIR SAFETY INVESTIGATION
REPORT**

**Investigation Report
9301481**

**Boeing 747-400 and Federal Airports
Corporation Safety Vehicle, Car 9,
Runway Incursion at Sydney
(Kingsford Smith) Airport NSW
24 May 1993**

**Boeing 747-400 PH-BFA and
Federal Airports Corporation Safety Vehicle,
Car 9, Runway Incursion at
Sydney (Kingsford Smith) Airport NSW
24 May 1993**

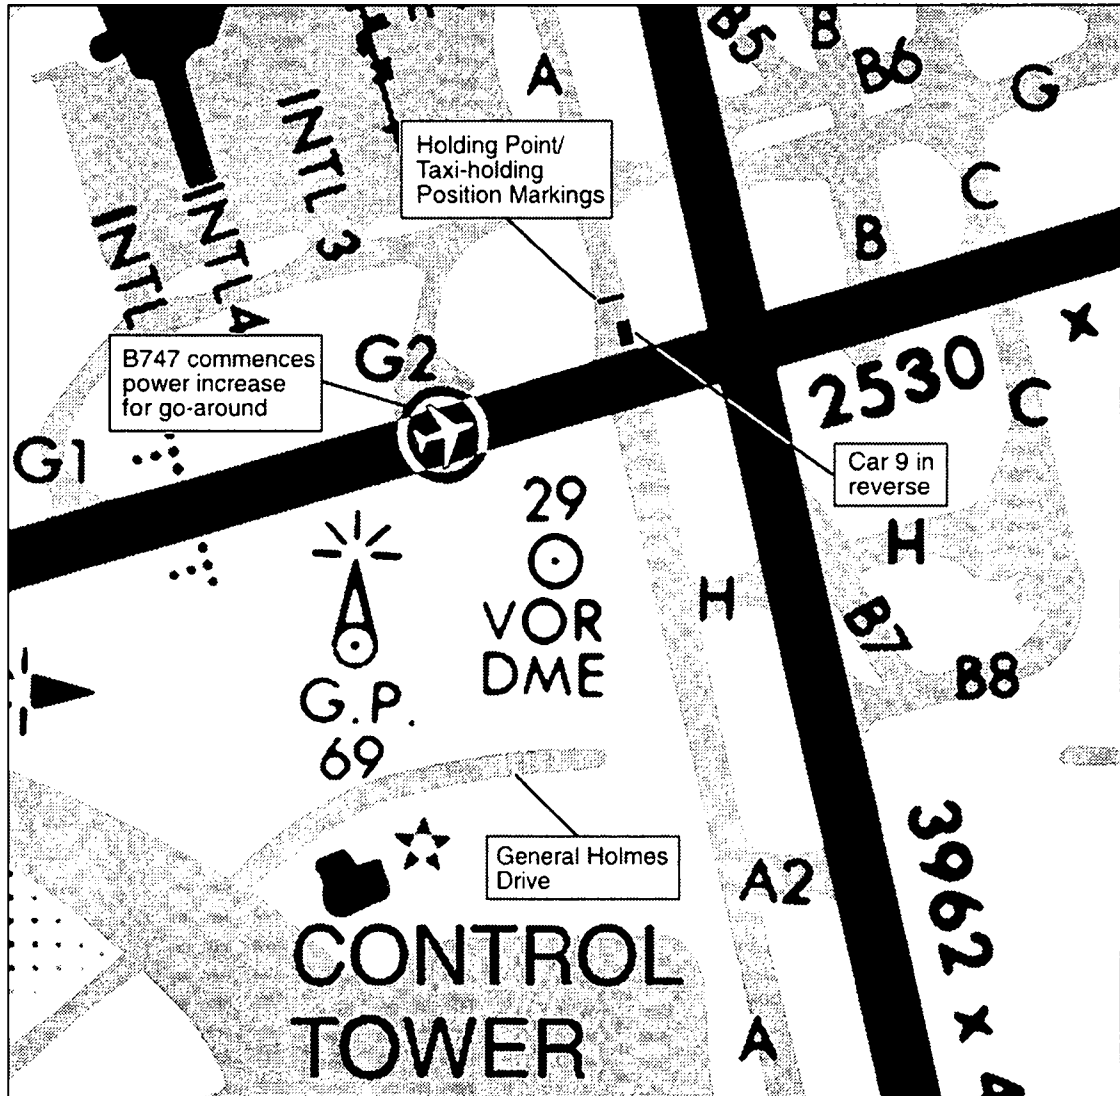
Figure 2: Approximate Positions of PH-BFA and CAR 9 at the commencement of power for the go-around [aircraft and vehicle not drawn to scale for ease of identification]

As PH-BFA flared for landing (see figure 2), the captain observed a vehicle approaching the runway. He immediately instructed the first officer to go around and, at approximately 2016, PH-BFA was observed to commence a go-around from a position near taxiway 'Alpha'. The crew carried out this manoeuvre from a height of about 4 ft and the aircraft was radar vectored by ATC for a landing on runway 16 at 2031. During the initial overshoot, the captain reported to ATC that there had been a car on the runway.

strip before realising his error. The driver commenced a turn to the right but saw an approaching aircraft, apparently on the runway. He stopped the vehicle with heavy braking and immediately reversed back along taxiway 'Alpha'.

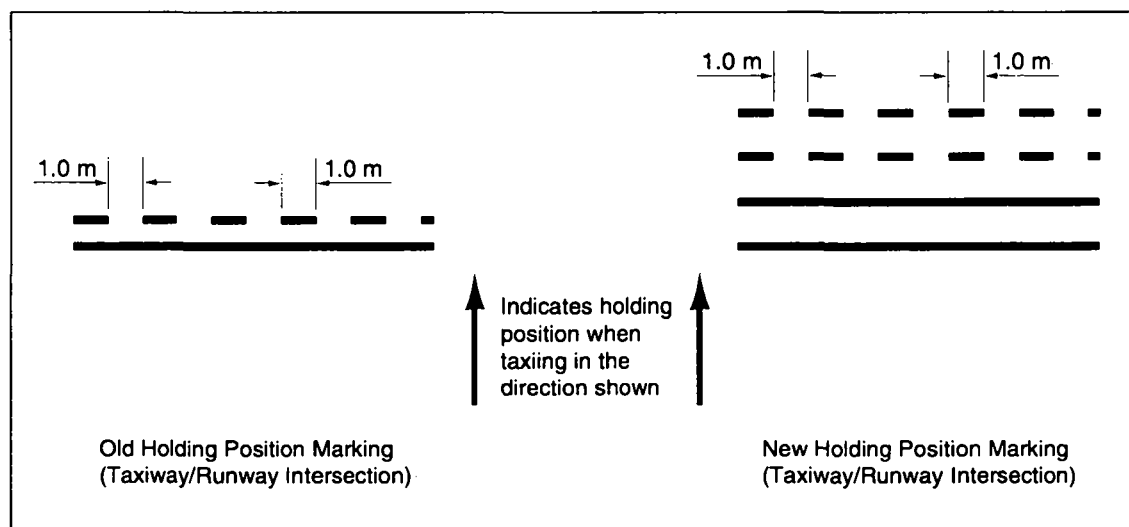
Figure 3: Difference between the Old and New Holding Position Markings

Most taxi holding positions at Sydney Airport were marked in the old manner and not in accordance with the current ICAO Annex 14 recommendations (see figure 3). However the Aeronautical Information Publication AGA and the Rules and Practices for Aerodromes indicate that Australia will be progressively changing to the ICAO-recommended markings as taxi holding positions are repainted.

The safety officer slowed as he approached the holding point lights; however his attention was centred on locating the debris rather than the lights. He noticed a patch of concrete dust and tried to determine whether this was the debris which the aircraft had mentioned. He did not recognise the proximity of the dust to the holding point lines. Although the officer stated that the dust was somewhat north of the holding point lights, BASI investigators noted that this patch was actually in the vicinity of the holding point markings, slightly obscuring them.

Whereas the taxiway lighting met the basic ICAO recommendations, the unidirectional shielding had the effect of dimming the intensity of the three amber lights significantly when viewed from the side. When this factor was combined with the situation where the yellow holding point markings were of the old style, and were partially obscured by concrete dust, the safety officer probably would have had some difficulty recognising the exact location of the holding point.

IR930091: The Bureau of Air Safety Investigation recommends that the Federal Airports Corporation accelerates the implementation of the New Taxi-holding Position Markings, with particular emphasis on airports with high traffic volume and/or complex runway/taxiway systems.

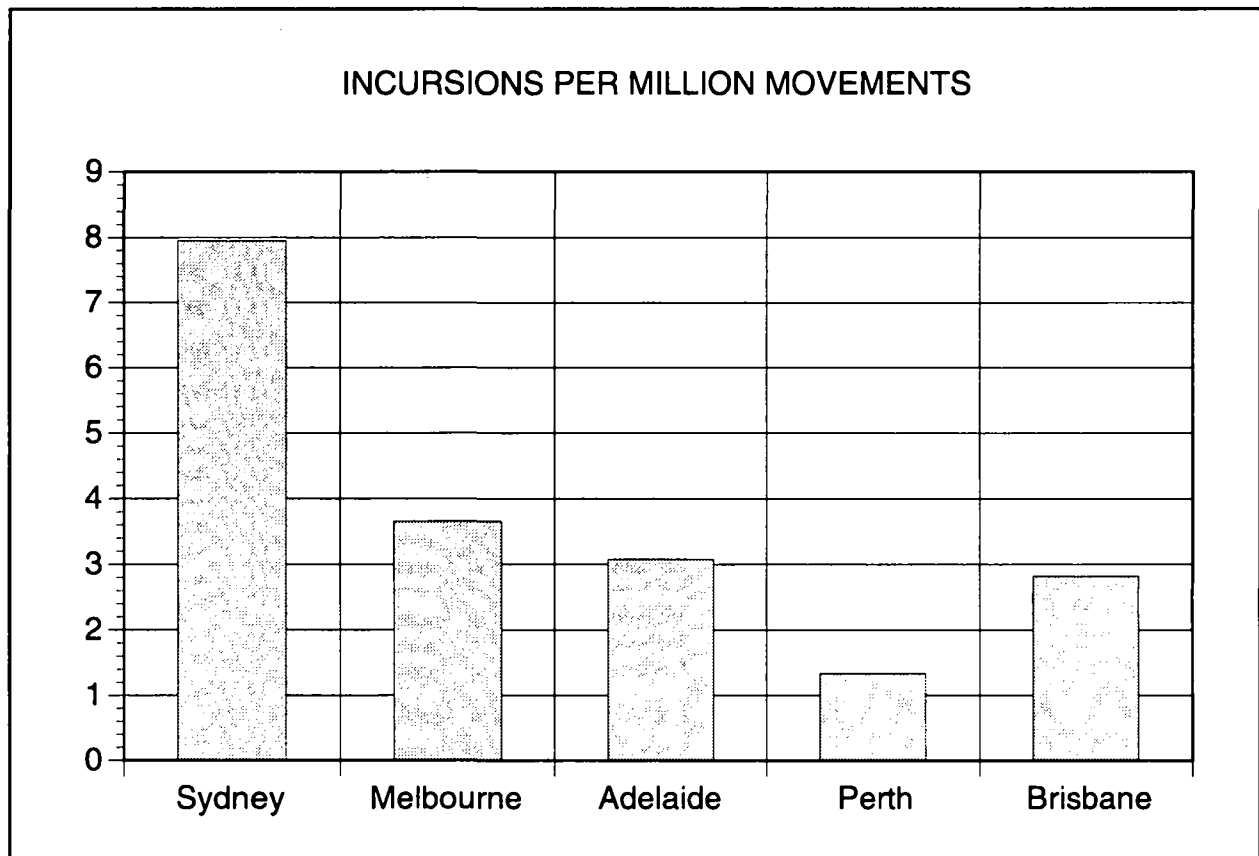
Figure 4: Australian runway incursion rates 1982–1992

Figure 4 depicts the rate of runway incursions per million aircraft movements in five major Australian airports. These figures were derived from information held in the BASI occurrence database and from Department of Transport and Communication movement figures. They cover a 10-year period from 1982 to 1992.

The figures show that Sydney Airport has 7.95 incursions per million movements with Melbourne having the next highest rate at 3.66, indicating that Sydney has an incursion rate well over twice that of Melbourne.

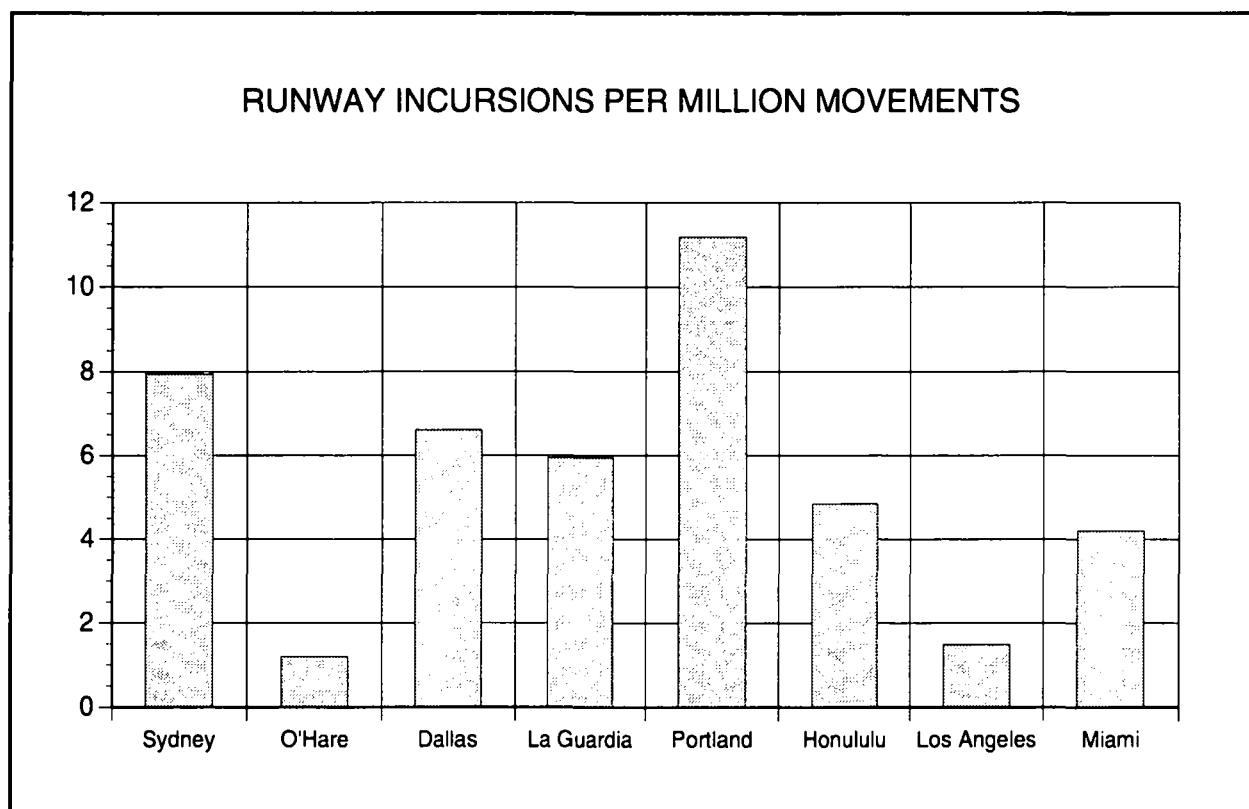
Figure 5: Comparison of runway incursion rates

Figure 5 also portrays runway incursions per million aircraft movements and compares Sydney Airport to a series of major airports in the United States. The figures for Sydney were again taken from the decade 1982-1992. The US figures are from 1991-1992 and are derived from the *Aviation Safety Statistical Handbook* published by the Federal Aviation Administration (FAA) in June 1993.
