Australian Government

Australian Transport Safety Bureau

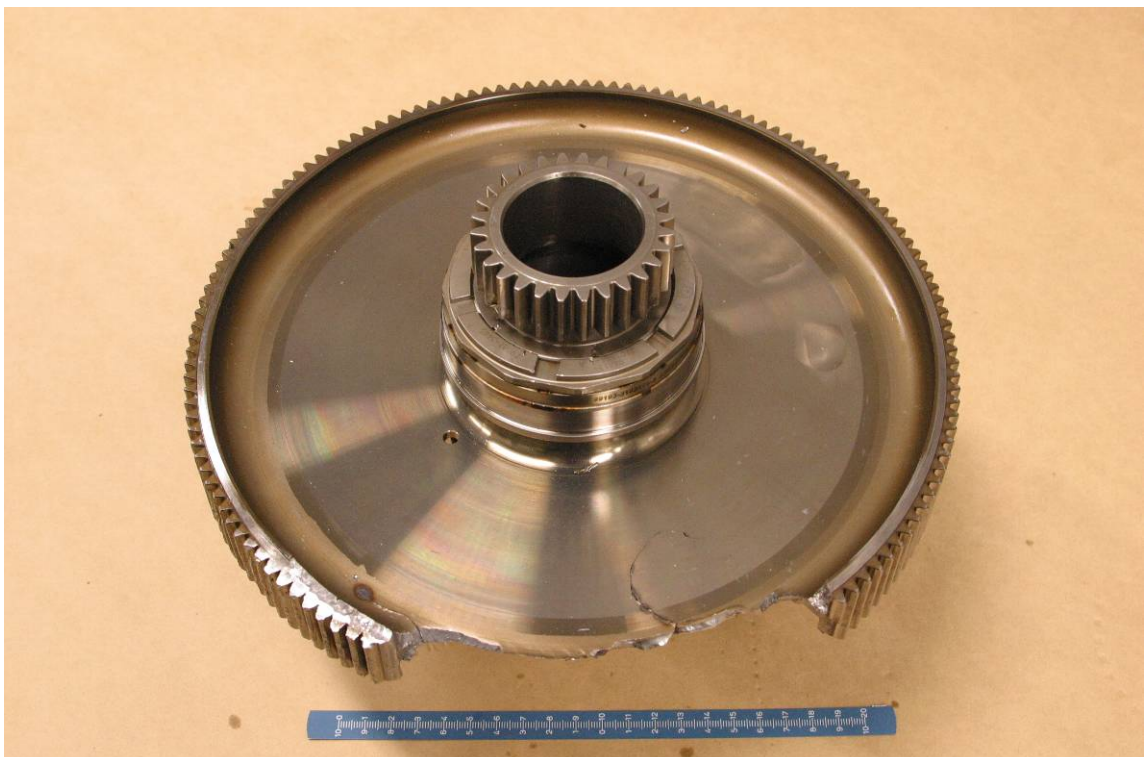
Figure 2: Forward face of the bull gear showing the primary fracture path and associated cracking. Arrow indicates direction of gear rotation

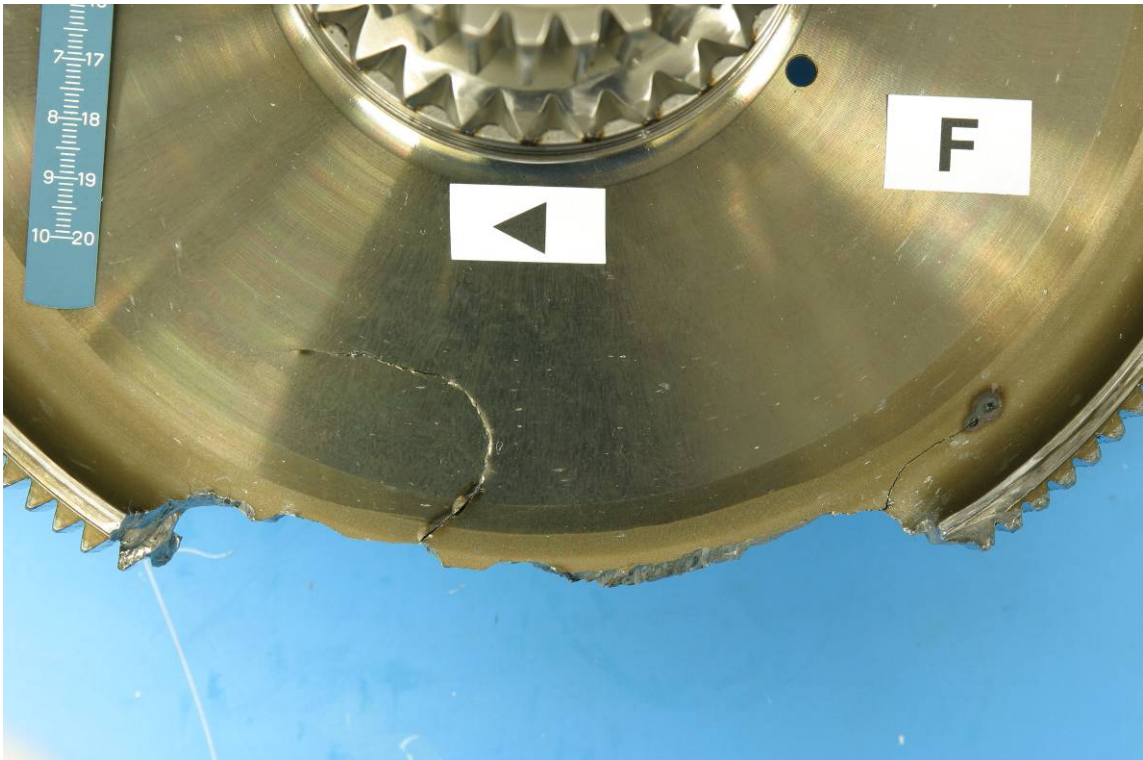
Figure 3: Detailed view of the web crack path

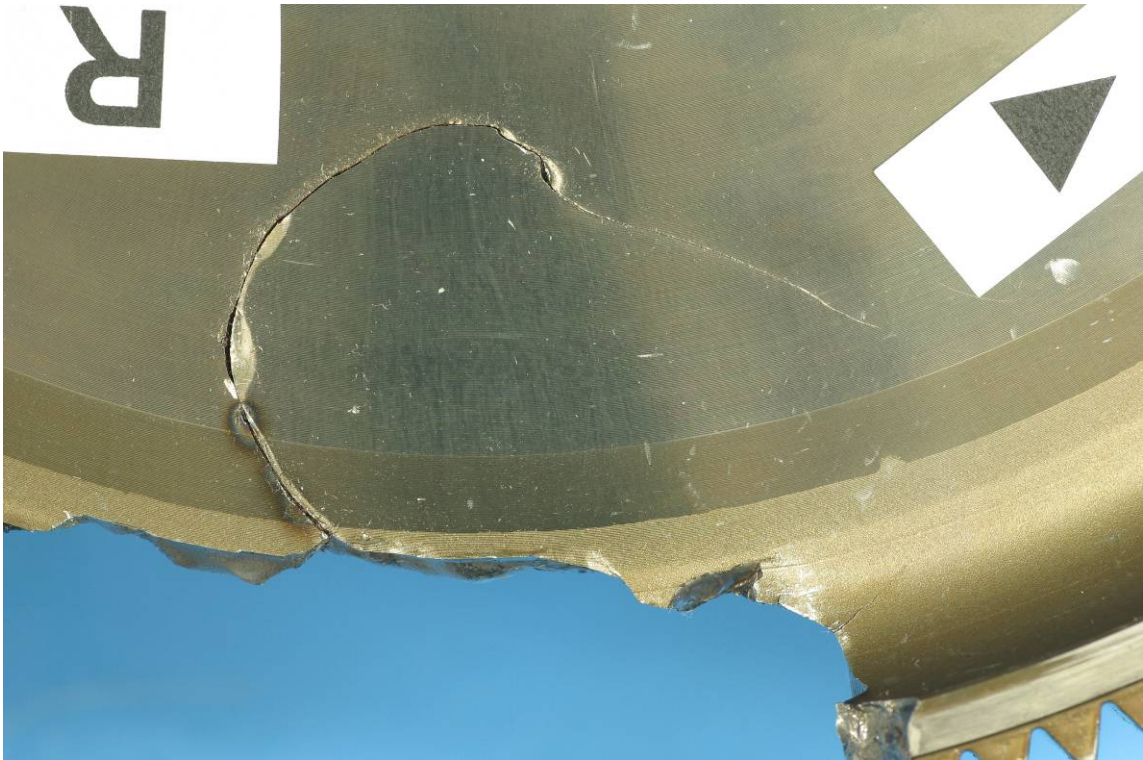
The majority of the exposed fracture surfaces had sustained varying degrees of mechanical rubbing and surface metal flow as the crack surfaces moved against each other before the rim section separated (figure 4). Evidence of progressive crack growth was noted in areas along the fracture surfaces, presenting as bands of parallel markings running through the web and rim of the gear. An area of fracture extending through the web and into the rim at one end did not exhibit rubbing and metal flow features and was characterised by a dull, uniform morphology (figure 5) that was typical of final overload failure of the web as the rim section was released.

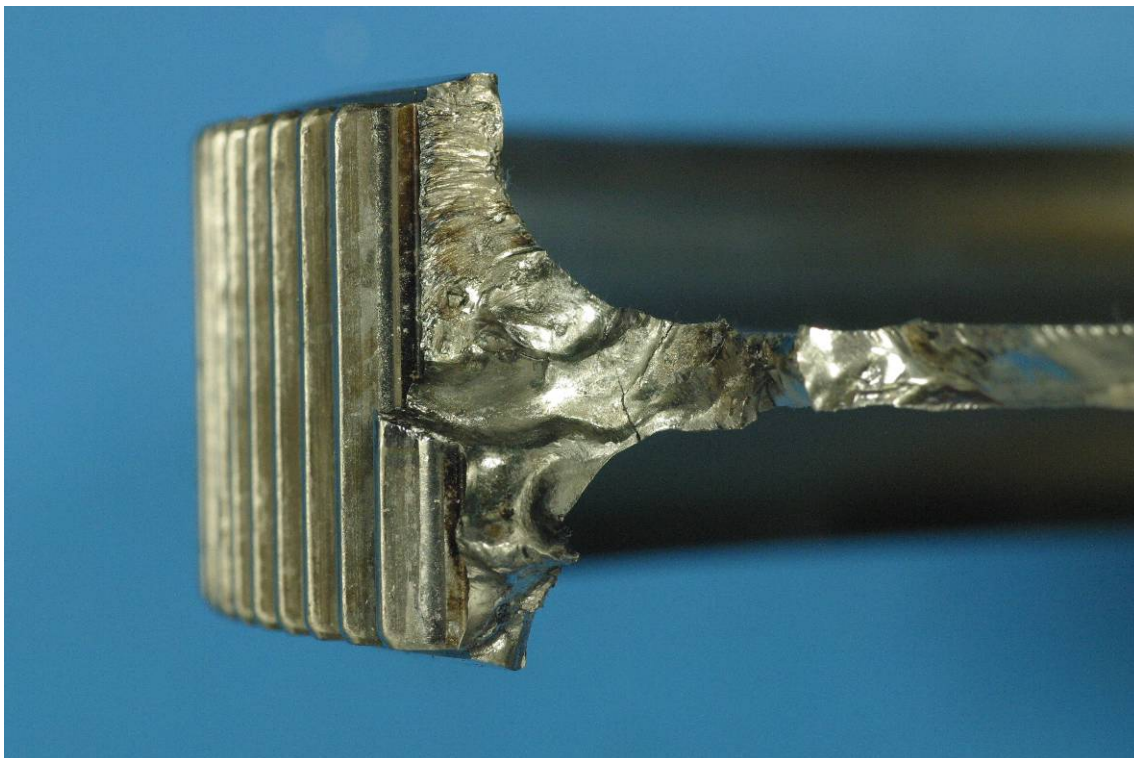
Figure 5: Opposite end of the rim fracture to Figure 4 above. Web fracture was characteristic of ductile overload

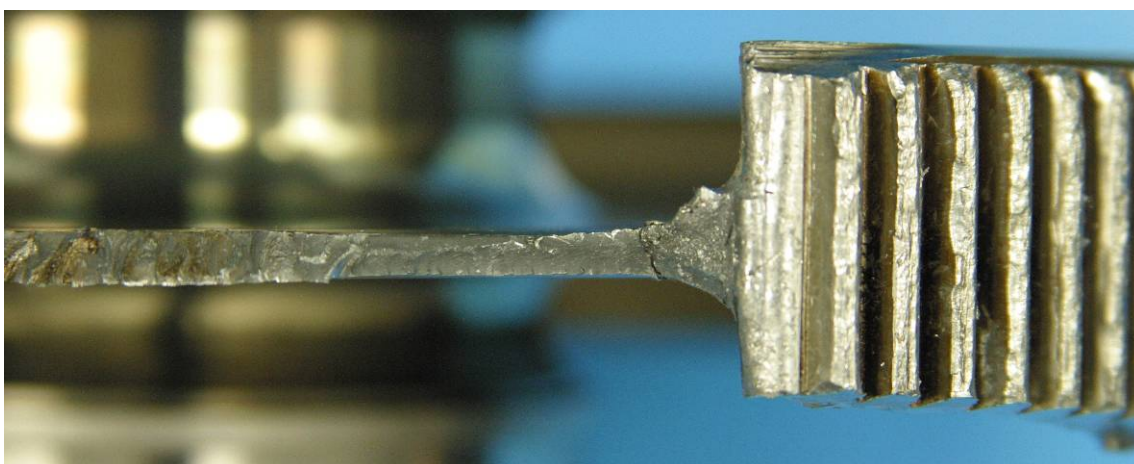
1.4.1.2 Crack origins

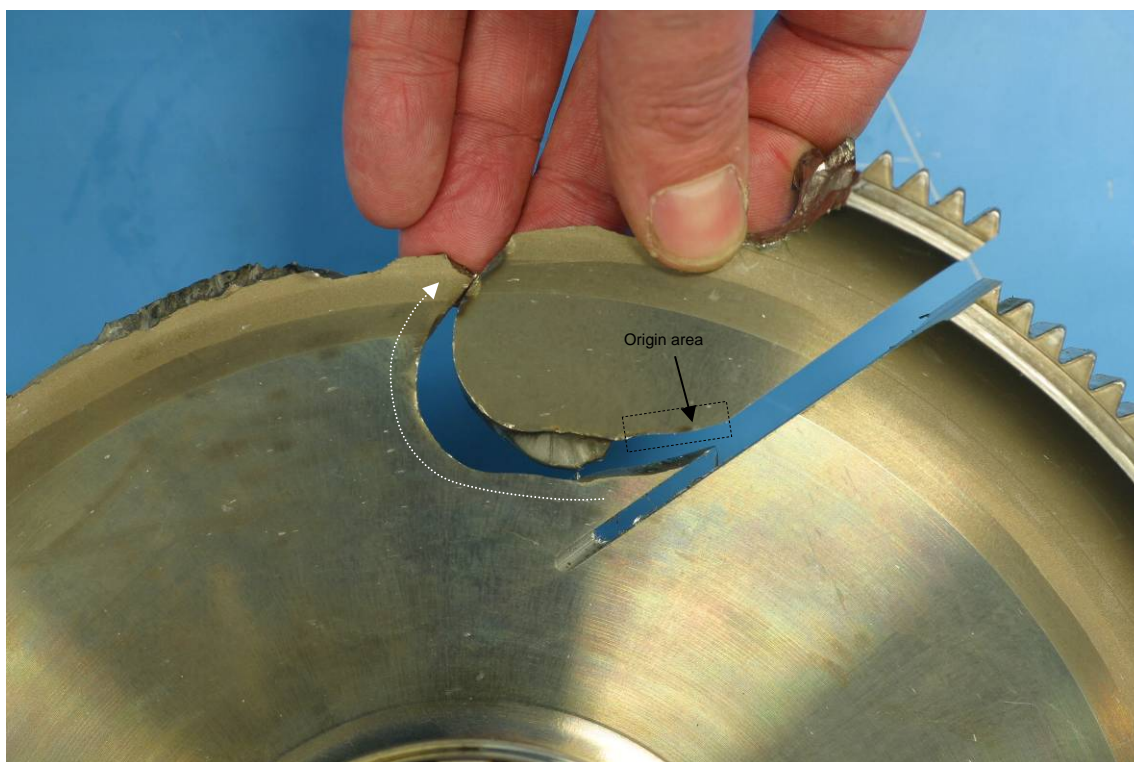
Figure 7: Fatigue crack progression markings evident on the crack surfaces exposed in the boxed area shown in figure 6 above

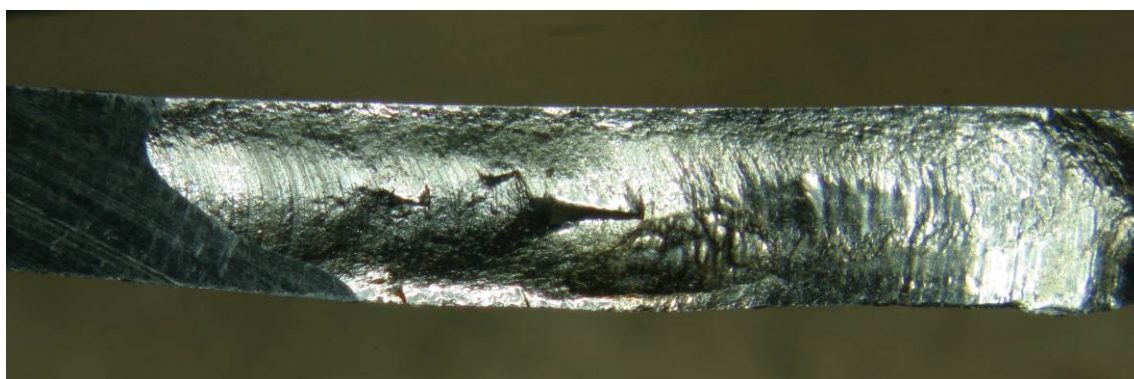
1.4.1.3 Tooth profile

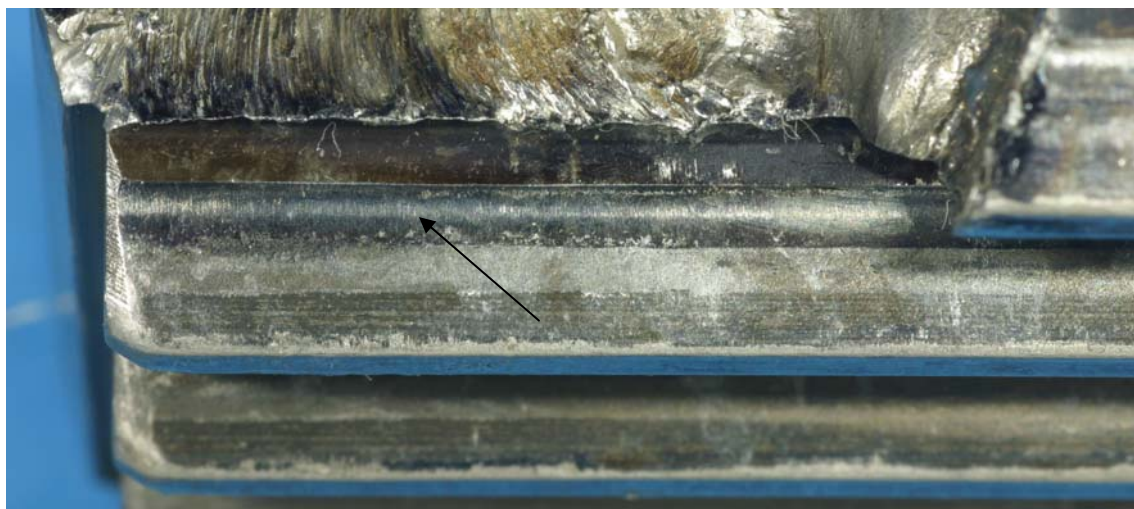
1.4.1.4 Microstructure

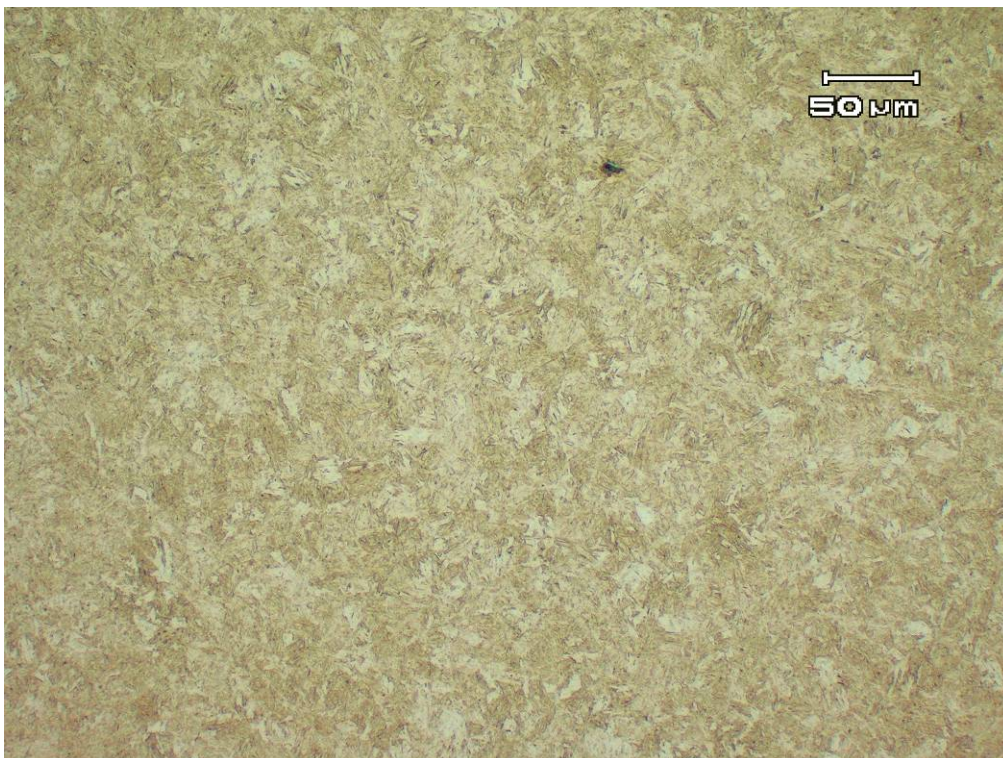
Figure 10: Case – core microstructure transition region of the bull gear (1% Nital etch)

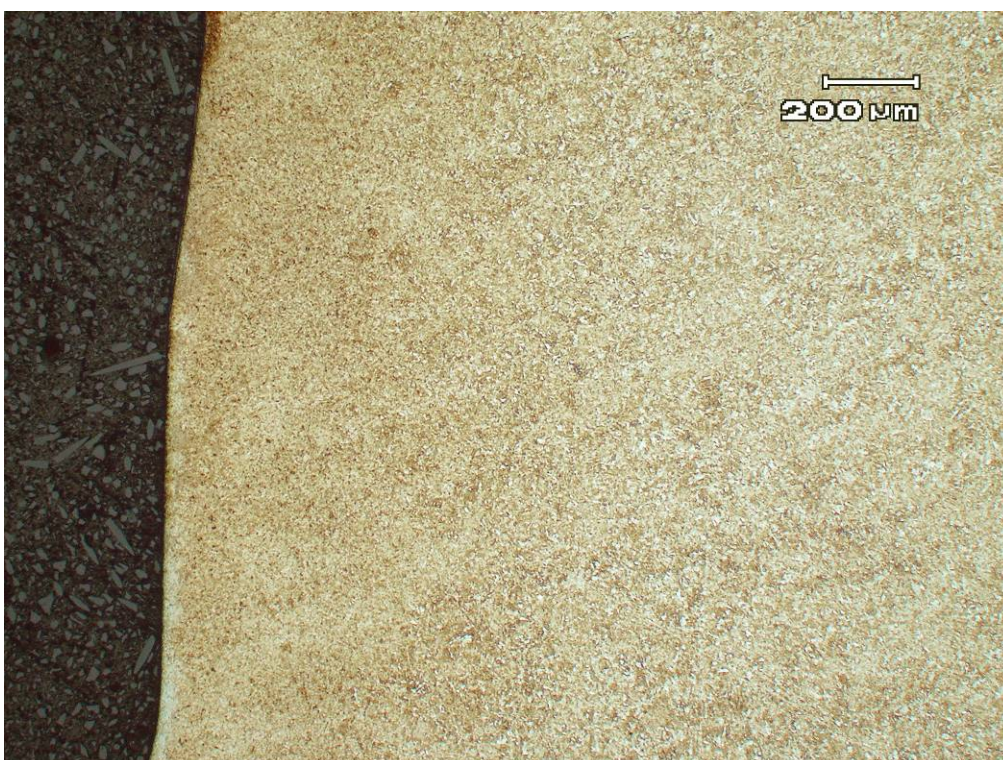
Figure 11: Cross-sectional view through a bull gear tooth, illustrating the visible region of wear on the tooth driven face (1% Nital etch)

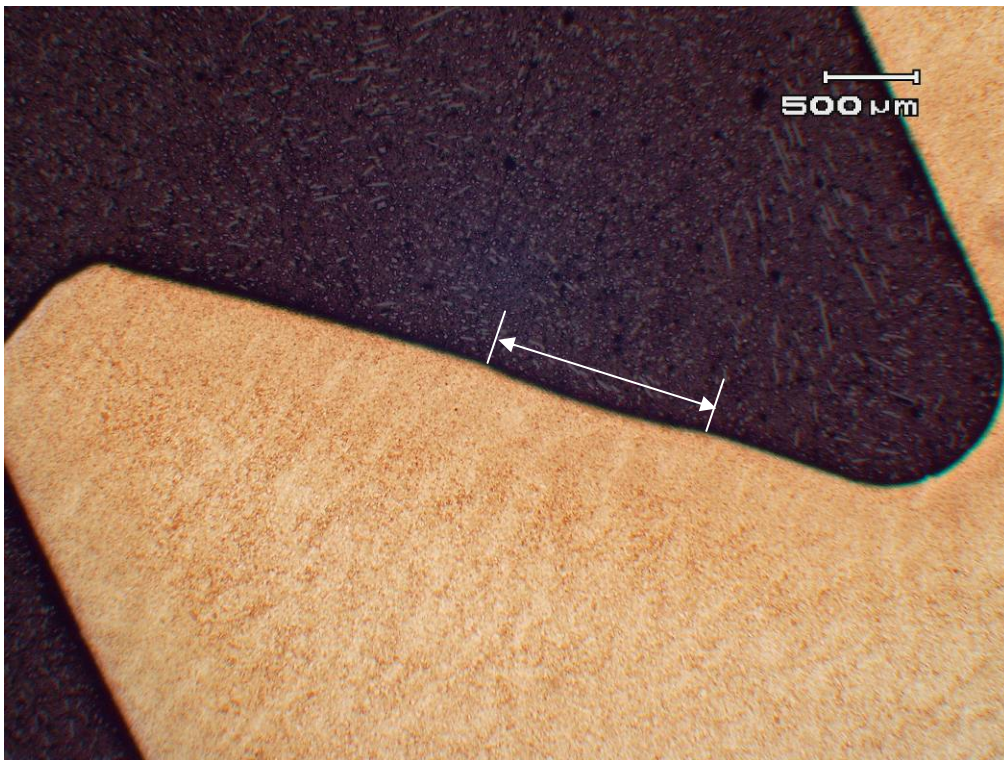
Figure 12: Closer view of the region of wear shown in figure 10 (1% Nital etch)

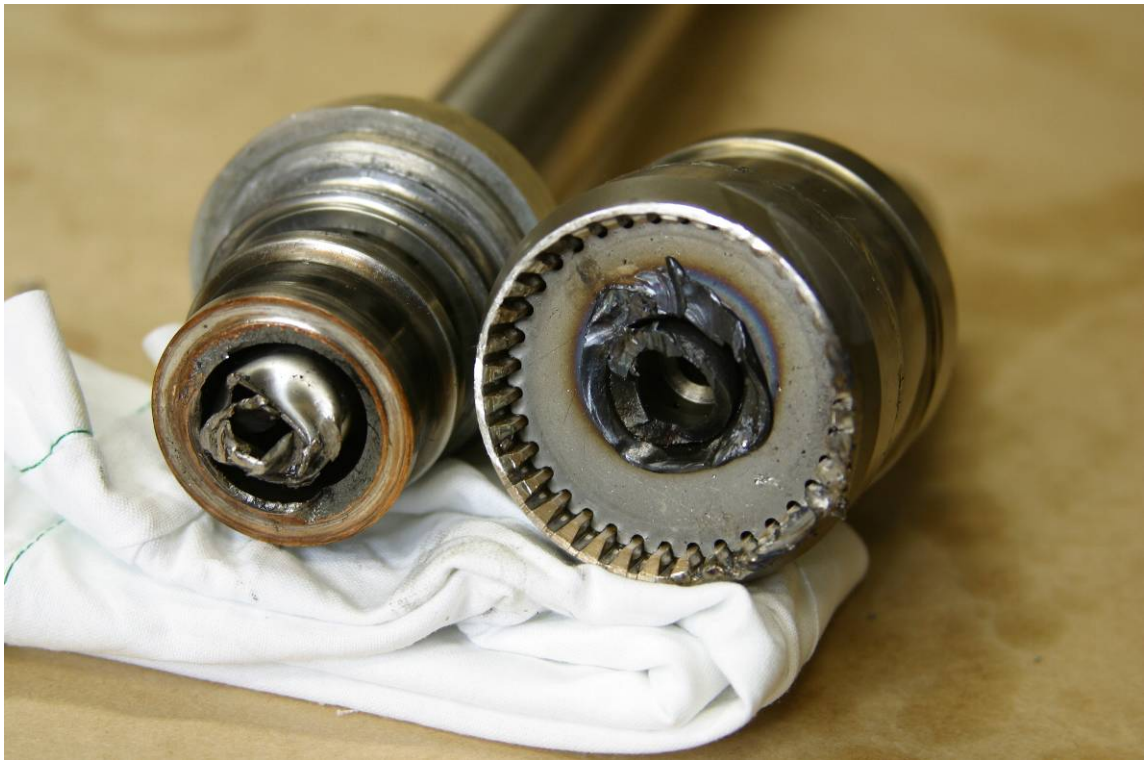
Figure 14: One of the high speed pinion teeth recovered from the reduction gearbox

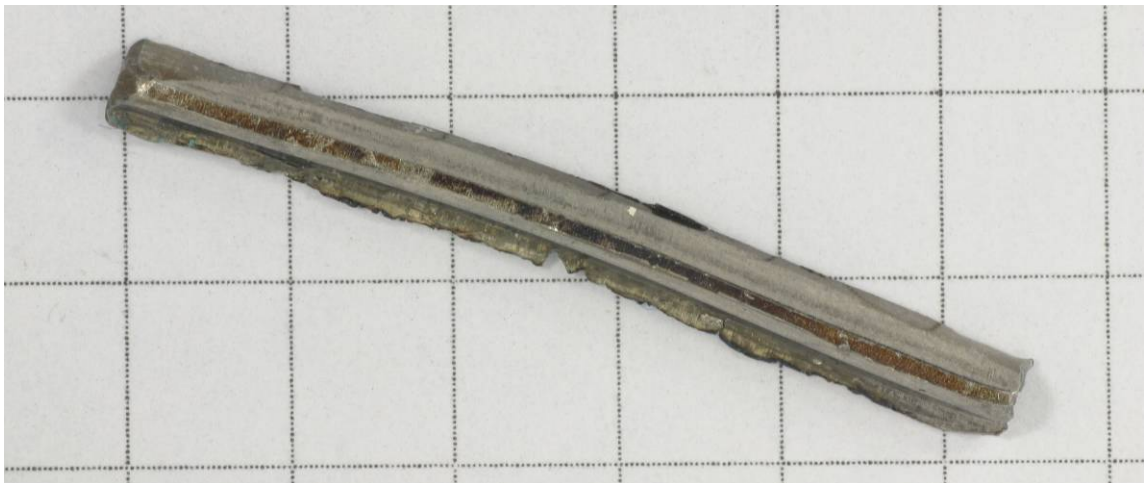
1.4.2.1 Microstructure

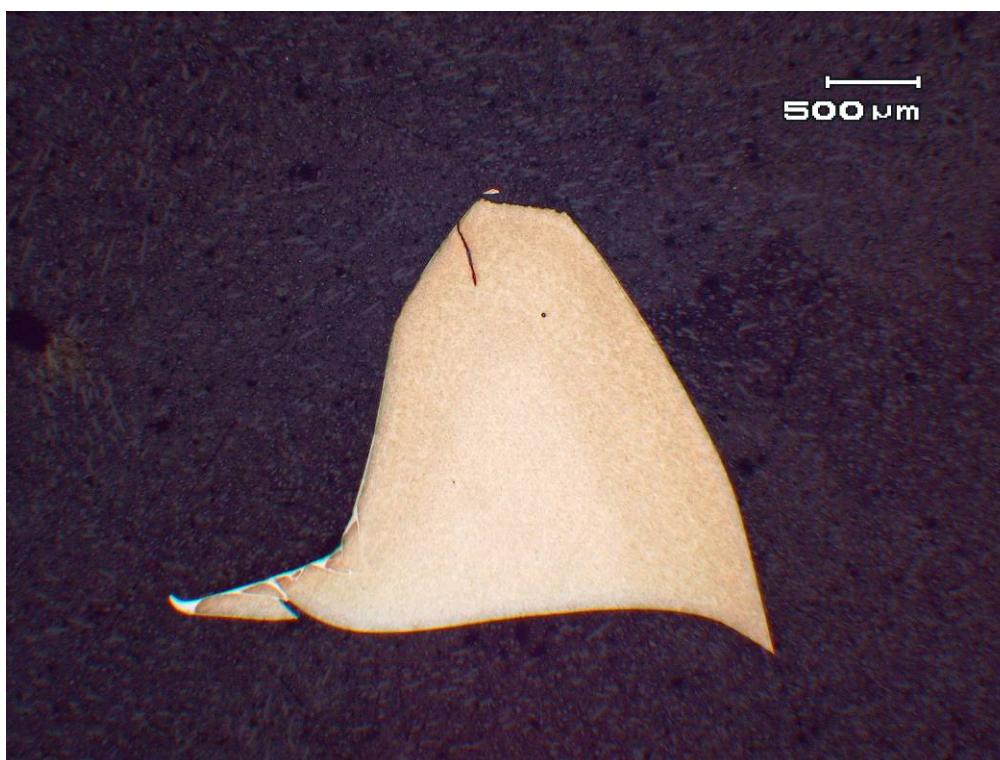
1.5 Previous failures

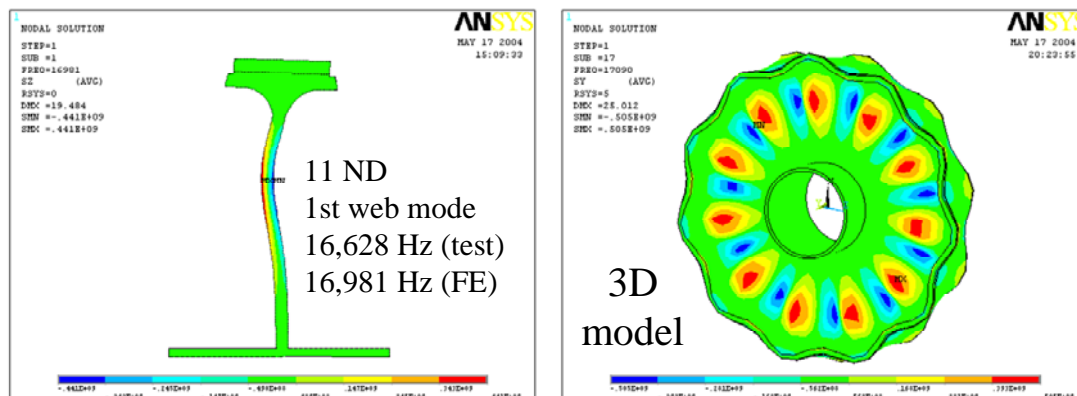
Figure 16: Manufacturer's stress analysis³ of an earlier gear design, illustrating the resonant response within the web section. The areas highlighted red represent peak tensile stress levels and hence the regions most likely to initiate fatigue cracking under vibrational excitation
