Aviation Occurrence Investigation – AO-2007-063

Fumes event

19 km E Melbourne Airport, Vic.

Boeing Company 767-338

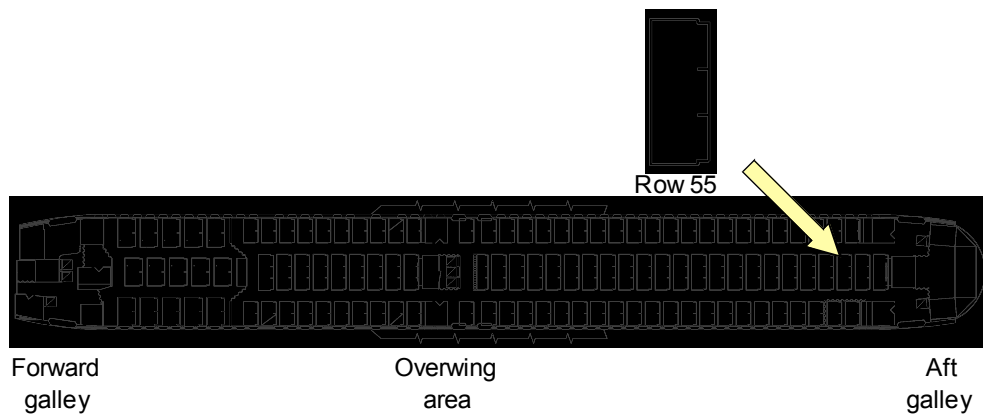
Figure 1: VH-OGG cabin layout

At about 1455, a male passenger in seat 55E (Figure 1) reported to a flight attendant that he could smell fumes coming from the gasper air vent above his seat and that these fumes were making him 'feel sick'. The passenger later reported that the fumes smelled like jet exhaust. The flight attendant put her nose near the vent but could not detect any odour. She then shut off the gasper air vents above that seat, and notified the customer service manager (CSM). The CSM then notified the flight crew about the ill passenger.
