INFRA-08537

External Assistance to Recreational Aviation Australia (RA-Aus) – Collision with water 22km NNW Gold Coast Airport, Qld Zenith Zodiac CH601 XL 7 March 2008

Abstract

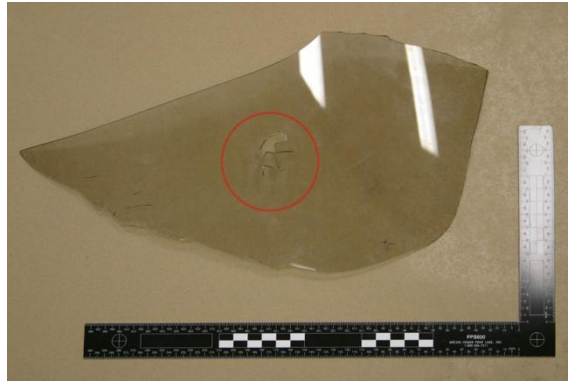
One of the canopy pieces showed a central puncture, approximately 20 - 25 mm in size (Figures 3 and 4). Under the stereo-microscope at high magnifications, a series of radiating river lines² were observed extending from the inner surface through to the outer surface. A radiating fracture in the manner observed suggested that the puncture had originated on the inner surface and propagated through to the outer surface. The fracture features also suggested that the canopy had been punctured from a single impact event of short duration.

Figure 3: The punctured canopy piece referenced in Figure 2

It was noted that while five of the fragments were 'undamaged', one of the canopy fragments had been punctured from the internal surface. Fracture surface morphology around this region suggested that the canopy had been punctured in an outward manner. Numerous related indentations were also located around the puncture on the internal surface and small cracks had initiated from some of those sites due to repeated impact loading. Given the confined spread of that damage, it is probable that the puncture had been produced by an object from within the cockpit while the canopy was still intact. A birdstrike to the aircraft was considered unlikely to have been a factor leading to canopy failure. A detailed ultraviolet light inspection of the canopy pieces did not reveal any evidence of biological matter. Had a bird been struck, it is expected that residual evidence from such an event would have been found.
