ATSB TRANSPORT SAFETY REPORT

Aviation Occurrence Investigation – AO-2006-002

**Collision with terrain - 19 km NE of Collarenebri, NSW
9 December 2006
VH-CJZ
Air Tractor Inc. AT802A**

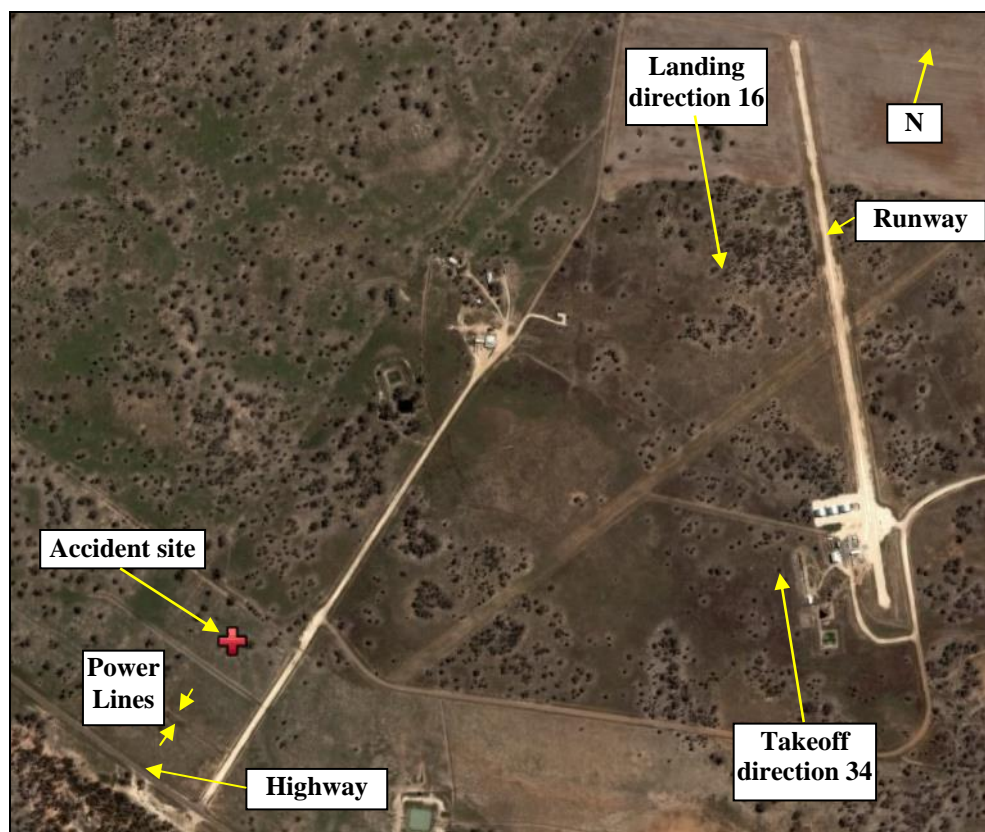
Figure 2: Airstrip and accident location

The aircraft impacted the ground in flat, open terrain that was sparsely covered with trees of about 15 to 20 m in height (Figure 2). A powerline ran parallel to the nearby highway, about 100 m from the initial point of impact. There was no evidence that the aircraft had contacted either the trees or the powerline.

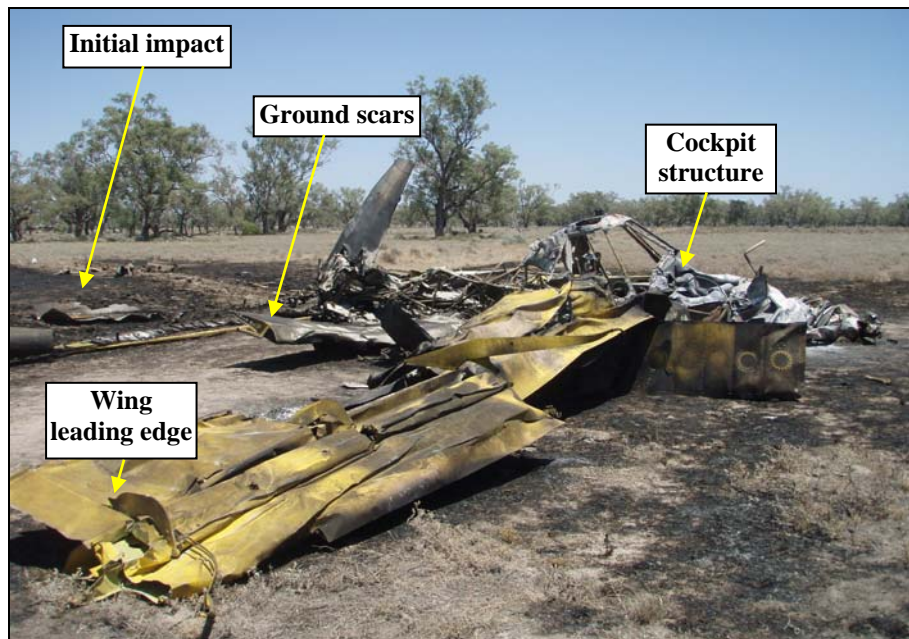
Figure 3: Aircraft wreckage and wreckage trail

The wreckage trail was about 45 m in length. Wreckage examination and on-site evidence indicated a probable impact angle of between 7 and 27 degrees, which was steeper than a normal landing approach (normally 3 to 5 degrees).

The cockpit, fuselage, wings and engine suffered serious damage⁶ from impact forces and an intense post-impact fire (Figures 3 and 4). Vegetation in the vicinity of the initial impact point to the most forward portion of the wreckage was burnt.

Both wings were ruptured and deformed from fluid pressure and impact damage adjacent to the wing integral fuel tank. This was consistent with fuel moving foreword with inertia in a confined space.

The aircraft's wing flaps were estimated to be at an angle of about 10 degrees, which was consistent with the landing approach configuration.

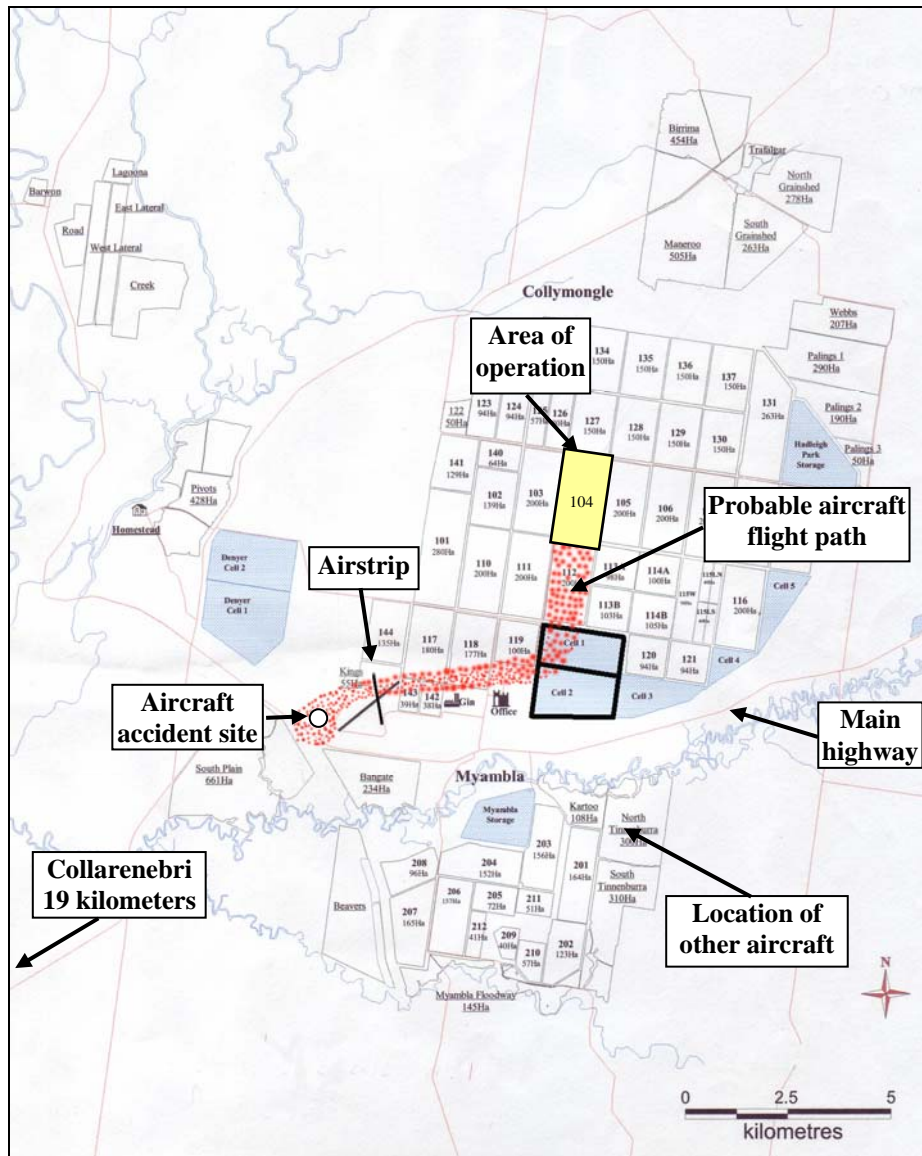
Figure 5: Site location

Witnesses on the ground reported seeing the Air Tractor fly from the vicinity of field 104 (Figure 5) in a southerly direction, over cells 1 and 2, then overfly the airstrip in a south-westerly direction. A witness near the airstrip, who was overflown by the accident aircraft, reported that '...the aircraft descended with a high rate of descent in a flattish attitude...', and that the aircraft's landing light was illuminated. In addition, that witness reported that a truck was travelling along the highway in a westerly direction, in the vicinity of the aircraft flight path, with a '...lot of lights on...'. That report was subsequently clarified as truck side-running lights, and not headlights or driving lights. The witnesses reported that the aircraft appeared to be operating normally, with no unusual flight characteristics or sounds.
