## Airprox

# VH-YJD, Dornier Werke GMBH DO 228-202 K VH-FGW Cessna Aircraft Company T210M Princess Charlotte Bay, Qld

25 April 2007

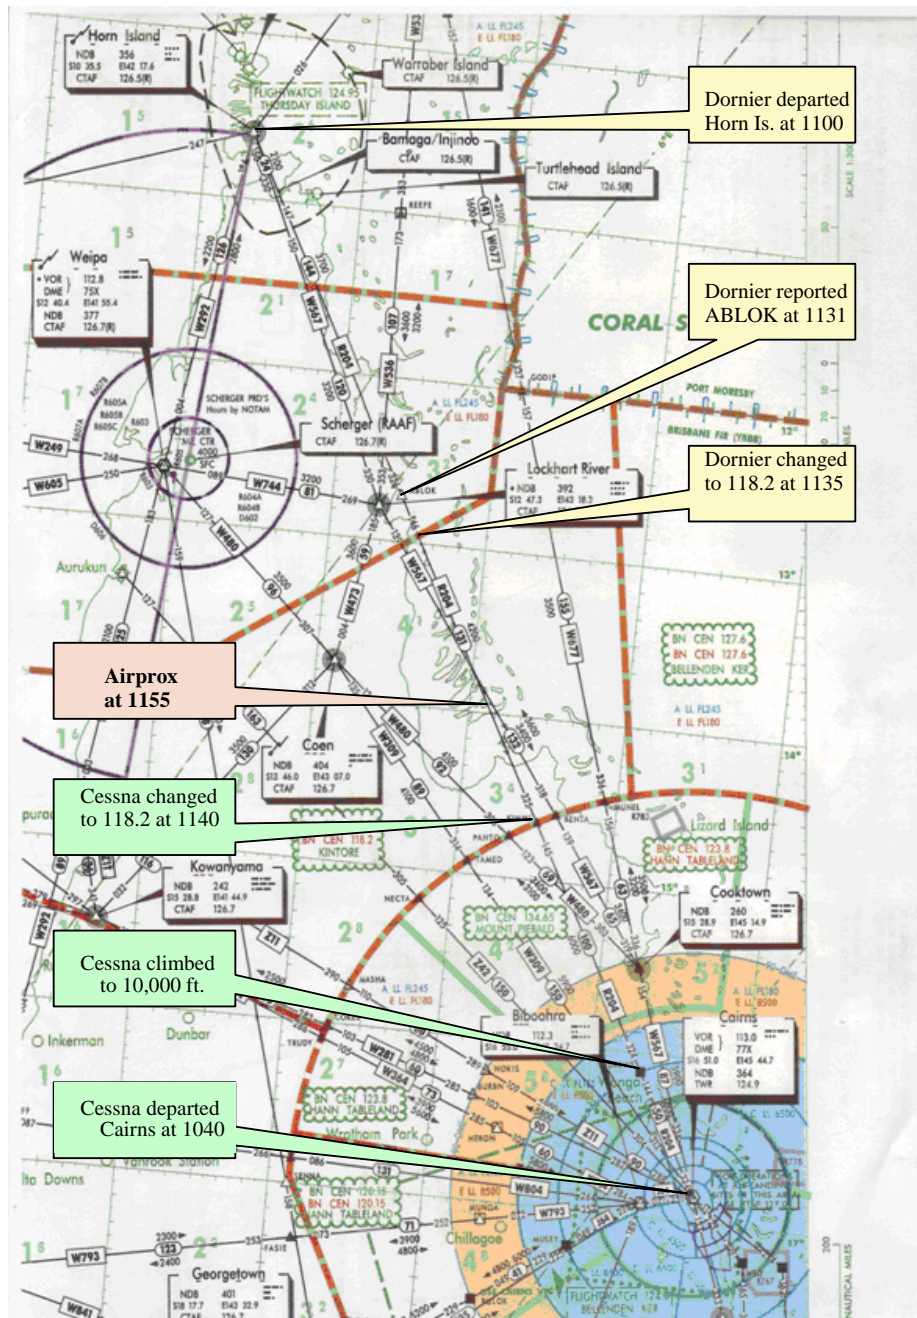
Figure 1: Flight progress and position of airprox

At approximately 1040, a Cessna Aircraft Company T210M (Cessna), registered VH-FGW, departed Cairns, Qld, for Horn Island, Qld, on a private flight conducted under the visual flight rules (VFR). The Cessna tracked north via air route R204 and climbed to 8,500 ft above mean sea level (AMSL). The pilot was the only person on board the aircraft. At approximately 50 NM (92 km) north of Cairns, the cloud increased to an extent that precluded VFR flight at 8,500 ft, so the pilot climbed the Cessna to 10,000 ft AMSL (Figure 1).

At approximately 1155, while over Princess Charlotte Bay, both pilots in the Dornier sighted an aircraft approaching at the same altitude from the opposite direction. The copilot immediately climbed and turned the Dornier to the left to avoid the approaching aircraft. The pilots of the Dornier reported that the other aircraft did not change heading or level and passed below the right wing at a distance estimated to be 50 to 100 ft. There had been an Airprox.

The PIC of the Dornier contacted air traffic control and advised that they had just passed an aircraft flying in the opposite direction, at the same level, at 45 NM (83 km) north of position reporting point KIMMI.
