Aviation Occurrence Investigation AO-2007-058

Wirestrike

20 km north of Elliott, NT

Cessna Aircraft Company 172N

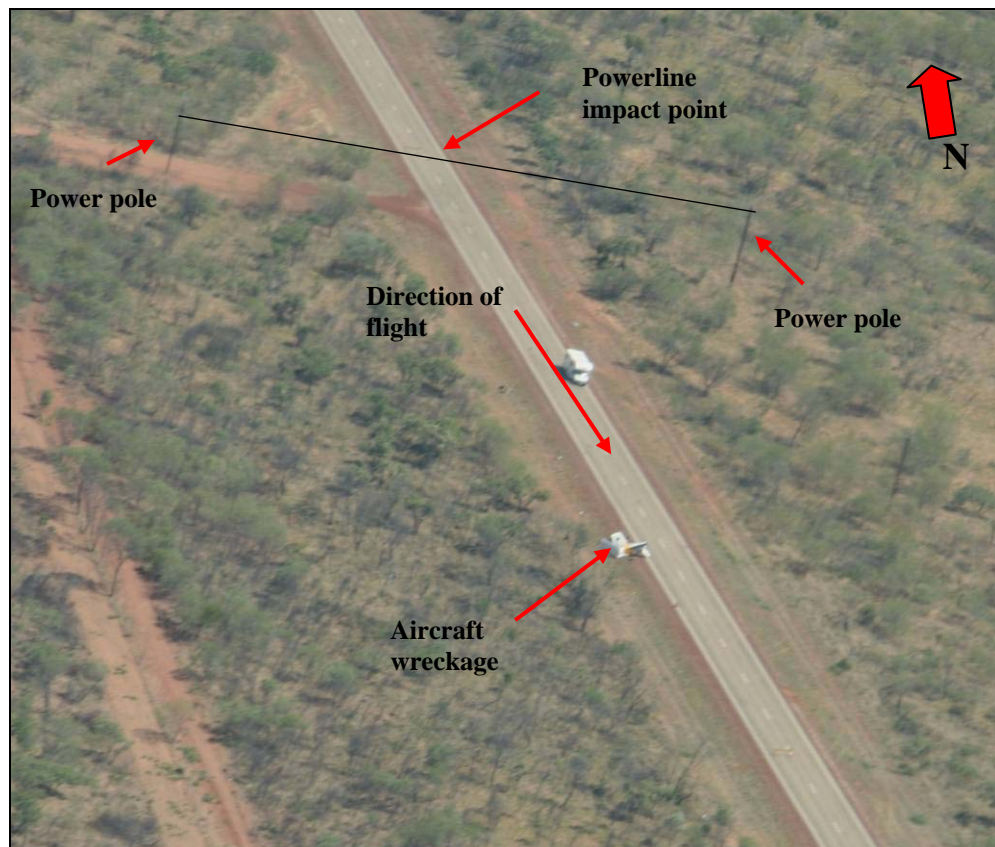
Figure 1: Accident site

The aircraft's tail section contacted the powerline, breaking the tail rearwards from the aft fuselage and rendering the aircraft uncontrollable. The aircraft impacted the highway in a steep nose-down attitude and came to rest inverted on the verge beside the highway, approximately 150 m south of the powerline (Figure 1). The three occupants were fatally injured. The aircraft was destroyed.

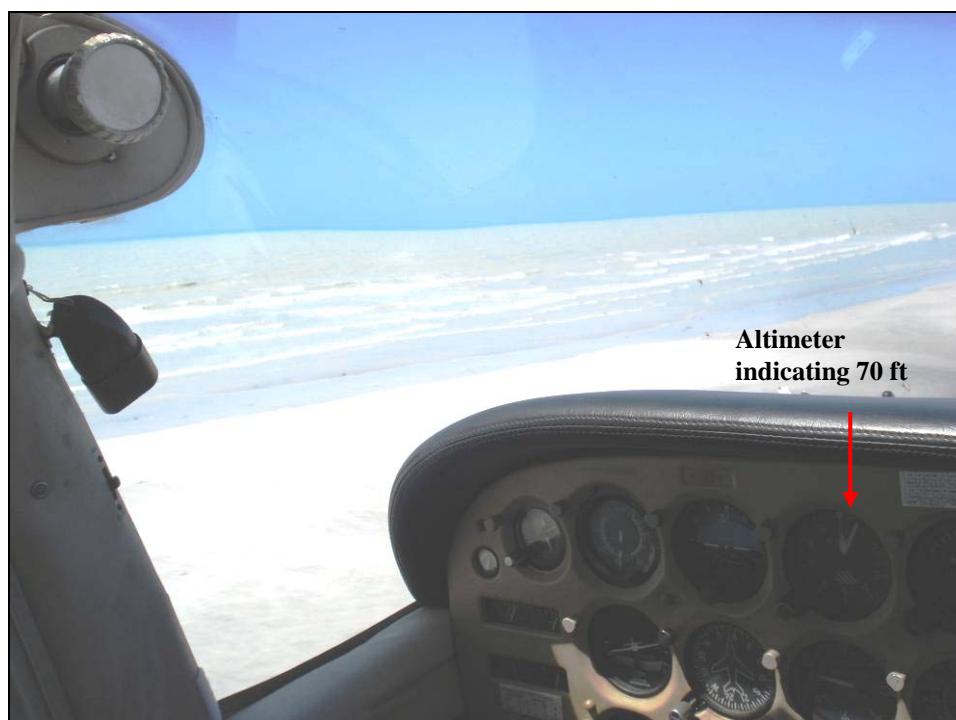
Figure 2: Picture taken from the aircraft 1 week prior to the accident

A number of digital still images and some video footage were recovered from personal cameras that were found amongst the aircraft wreckage. The recovered still images showed that, 1 week before the accident, the accident aircraft and one of the other aircraft were flown below 500 ft above ground level (AGL) along a WA beach. On that flight, the aircraft's pressure altimeter² indicated an altitude of 70 ft above mean sea level (AMSL)³ (Figure 2).

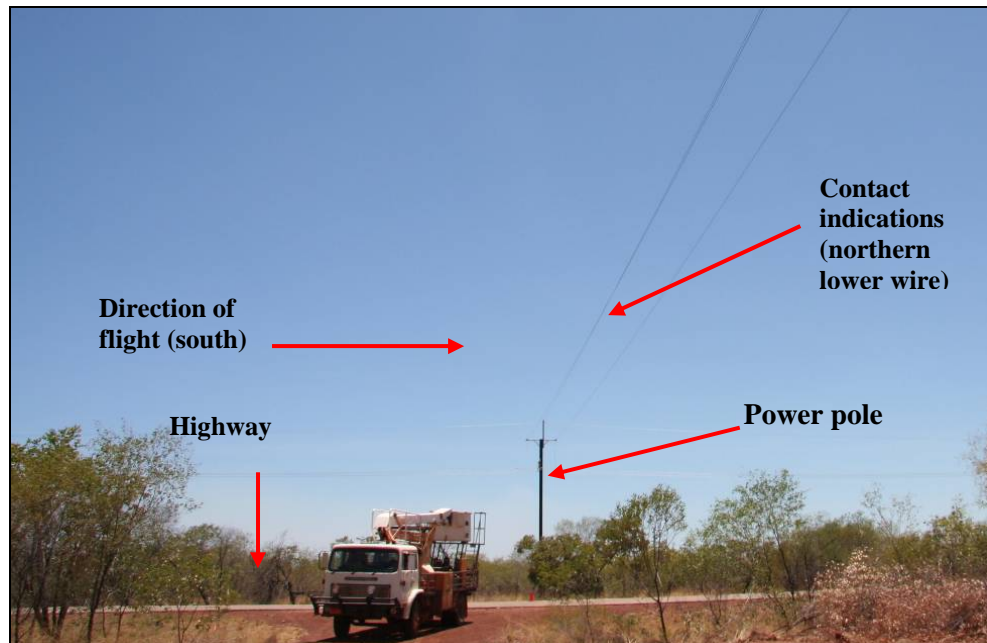
Figure 4: Powerline across the Stuart Highway (upper wire not visible)

The powerline included three wires that were strung between two power poles set about 60 m apart amongst low scrub on either side of the highway. The two lower wires were about 15 m (49 ft) and the upper wire about 16 m (52 ft) above the highway (Figure 4). The northern lower wire had indications of paint transfer from the aircraft's vertical stabilizer and it had also been damaged where it connected to the transformer on the western power pole.

The powerline did not include any markers to increase its visibility, nor did it require such marking in accordance with either standard.

The aircraft struck one of the two 15 m high wires that spanned the Stuart Highway (Figure 4). After striking the powerline, the aircraft travelled 70 m before impacting the ground in a steep nose-down attitude, tipping over and sliding inverted for a further 80 m before coming to rest inverted on the highway verge (Figure 5 – viewed from directly beneath the powerline).

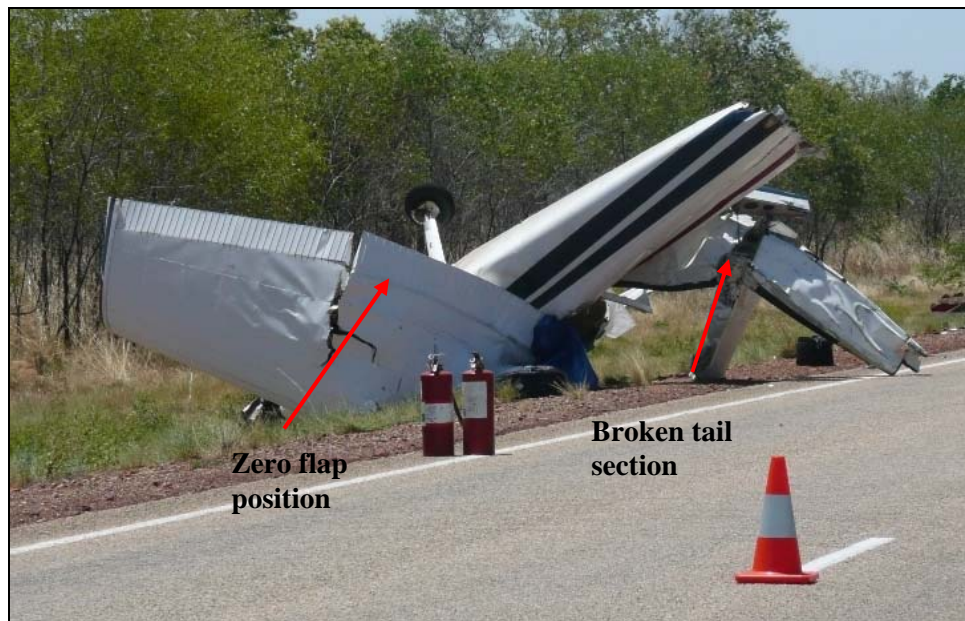
Figure 6: Main wreckage

The tail assembly was broken rearwards from the aft fuselage by the impact with the powerline, but remained attached to the fuselage by the rudder and elevator control cables (Figure 6).

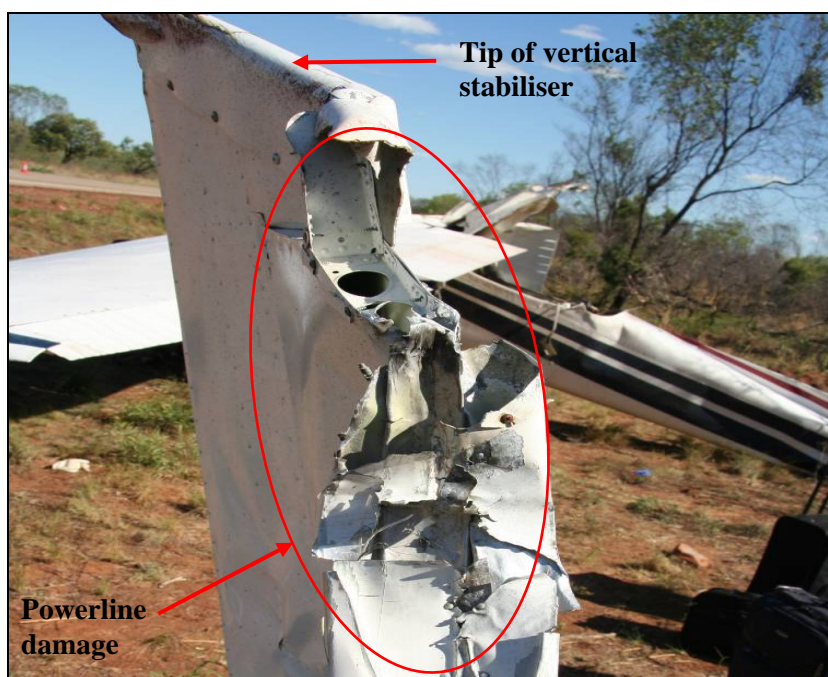
Figure 7: Vertical stabiliser showing powerline contact damage

Damage to the leading edge of the aircraft's vertical stabiliser indicated it struck the powerline about 50 cm from the tip of the stabiliser (Figure 7)⁸.

⁸ The elevator and rudder cables were cut to facilitate the removal of the tail assembly, which was then moved from where it came to rest following the accident. Figure 7 is not, therefore, indicative of the post-impact position of the vertical stabiliser.

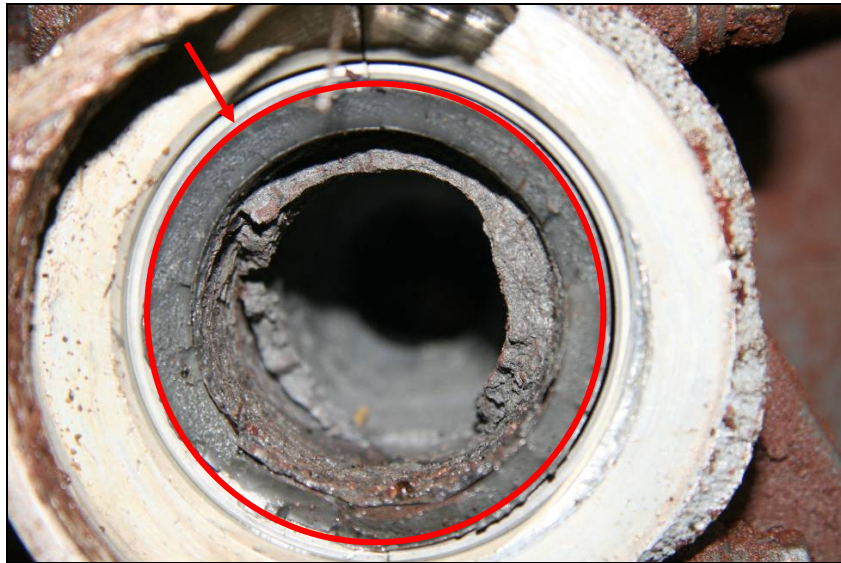
Figure 8: Engine crankshaft fracture surface

The engine crankshaft was fractured at the crankshaft flange. The fracture surface indicated that the fracture occurred under large bending loads, consistent with the aircraft impacting the highway nose-first, in a steep, nose-down attitude (Figure 8).

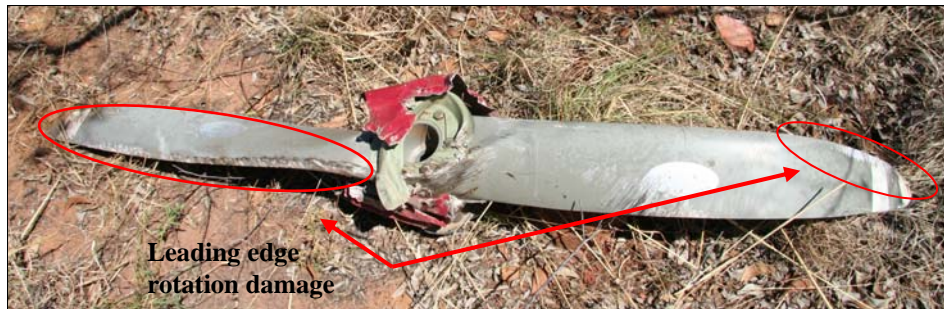
Figure 9: Propeller and spinner

The propeller was located in scrub a short distance to the west of the highway. No defects were found during the on-site investigation regarding the serviceability of the propeller prior to impact. The damage to the spinner and leading edges of the propeller blades indicated that the propeller was rotating at impact, although the amount of engine power at that time could not be determined (Figure 9).
